**Flood Control
District of
Maricopa County**

**CANDIDATE ASSESSMENT REPORT
Upper Camelback Walk Wash
Flood Control Project
FCD Contract 98-24
Assignment No. 3**

Revised
March 12, 2001

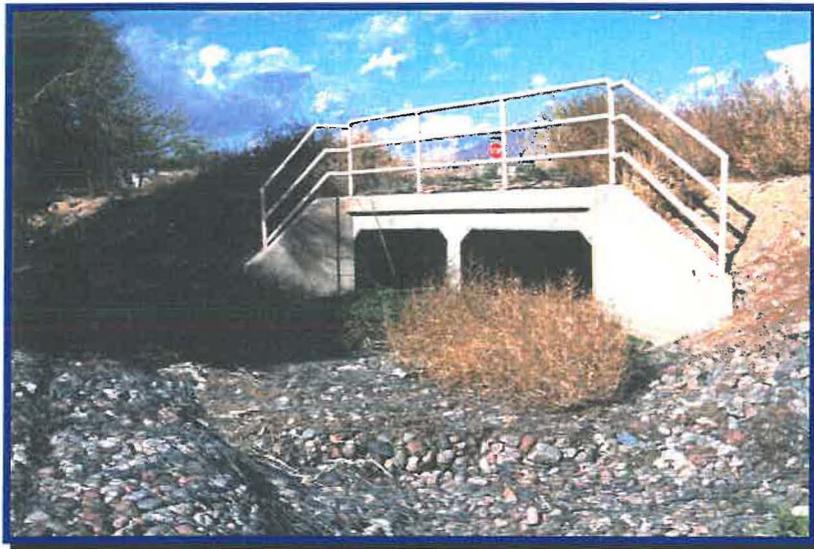
Pic 2A.9:

Looking upstream at the 2-barrel box culvert crossing 96th Street.

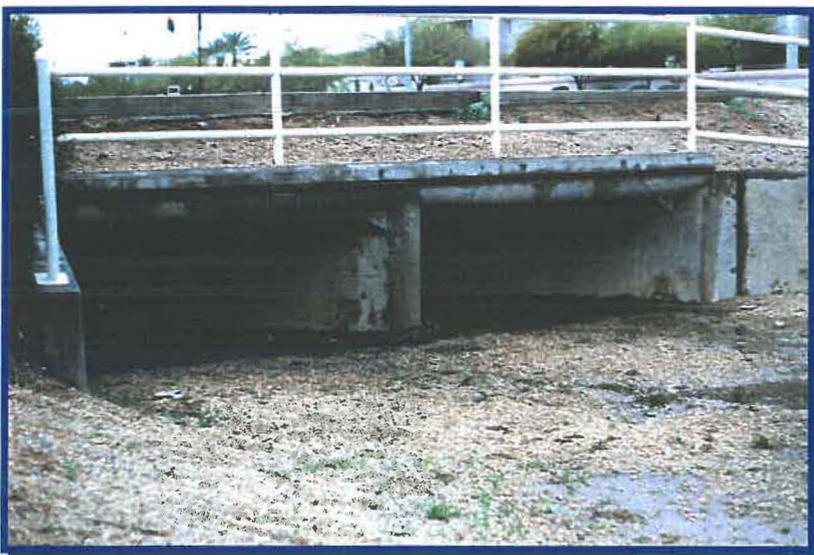
Pic 2A.10:

Looking upstream of Pic 2A.9 on the east side 96th Street.

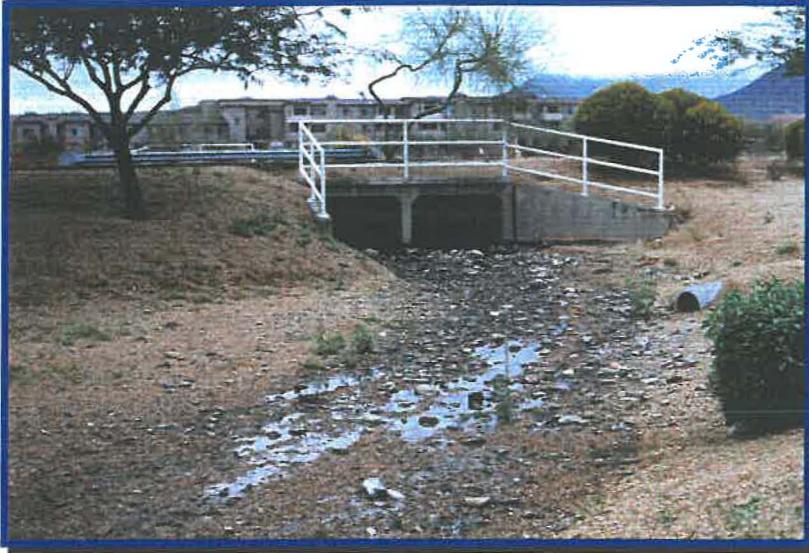
Pic 2A.11:

Looking upstream at the 2-barrel box culvert crossing Redfield Road.

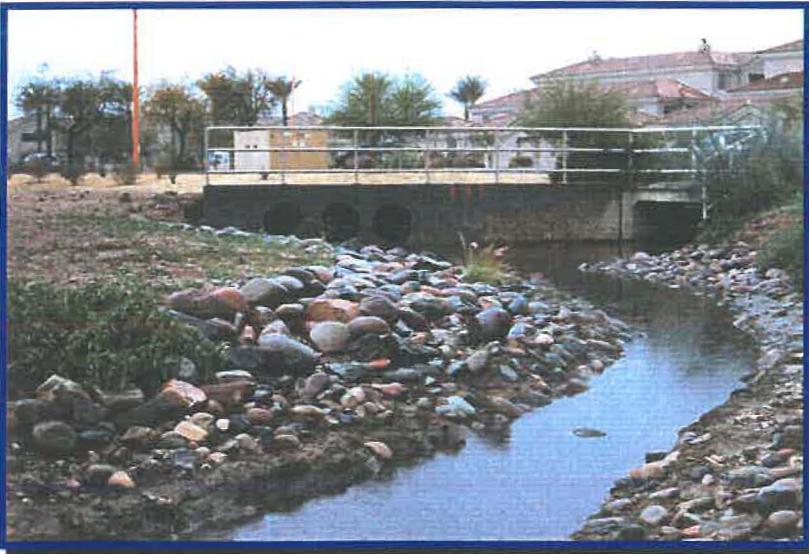
Pic 2A.12:

Looking upstream at the 3-barrel 24"-RGRCP pipes conveying flows across Frank Lloyd Wright Blvd (FLW) from the Mirada subdivision & the box culvert crossing Frank Lloyd Wright Blvd conveying flows north of FLW.

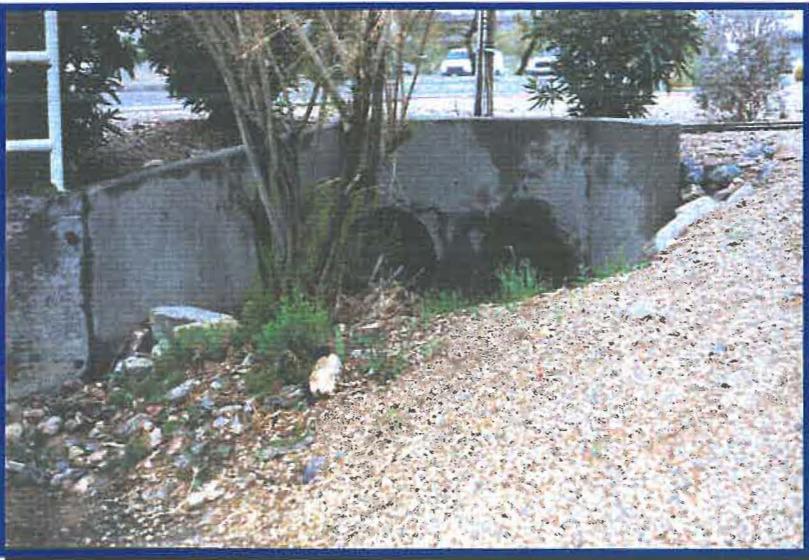
Pic 2A.13:

Looking upstream at the 2-barrel RCP pipes conveying flows from Wash-2A.3 located on the north side of FLW.

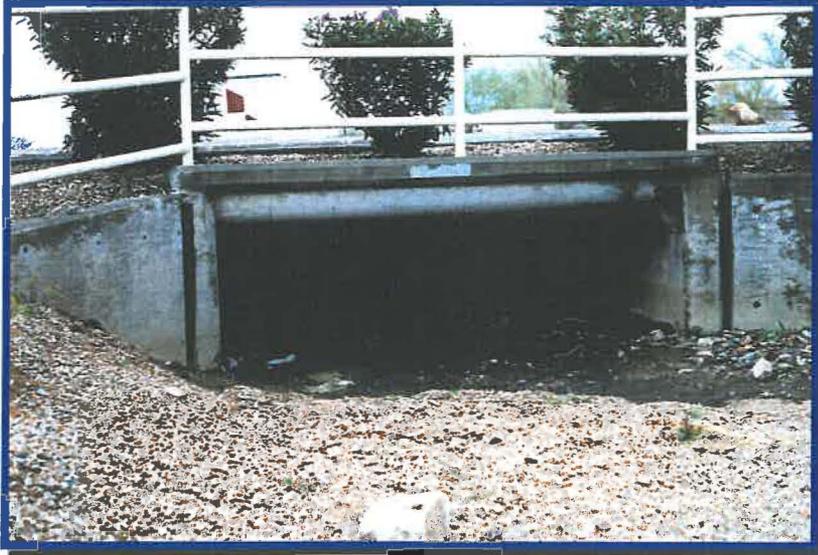
Pic 2A.14:

Looking downstream at the
box culvert crossing FLW
located on the north side of
FLW.

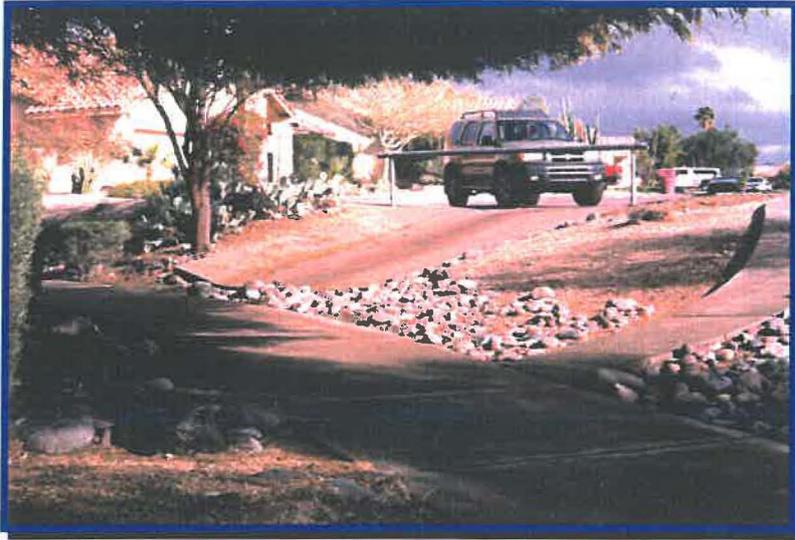
Pic 2B-2.1:

Concrete Valley Gutter and walk-way discharging flows from Sweetwater Ranch Foothills into Wash-2B-2.

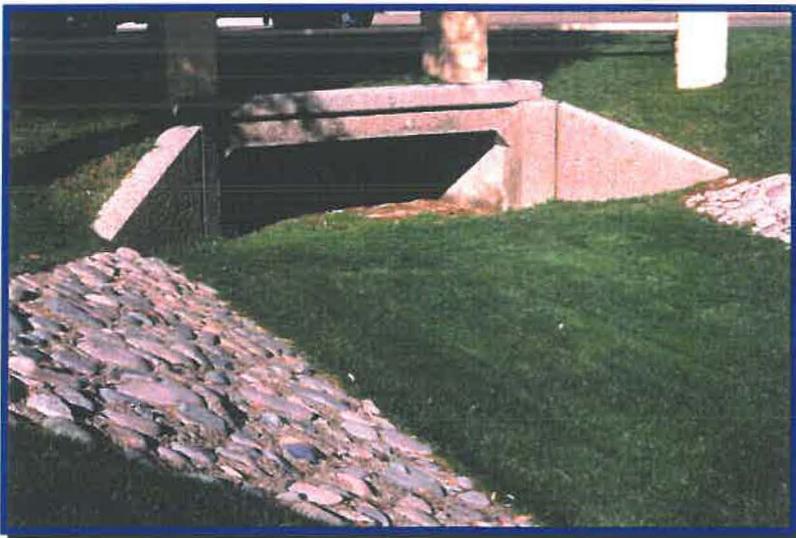
- Pic 2B-2.2:

Looking upstream at the concrete box culvert crossing Pershing Avenue approximately 500-feet east of 96th Street.

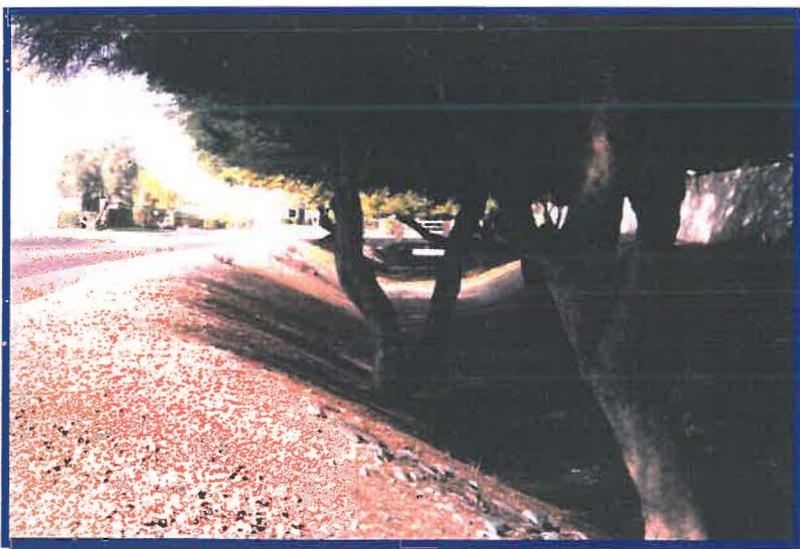
Pic 2B-2.3:

Looking upstream at the improved earthen channel north of Pershing Avenue and east of 96th Way.

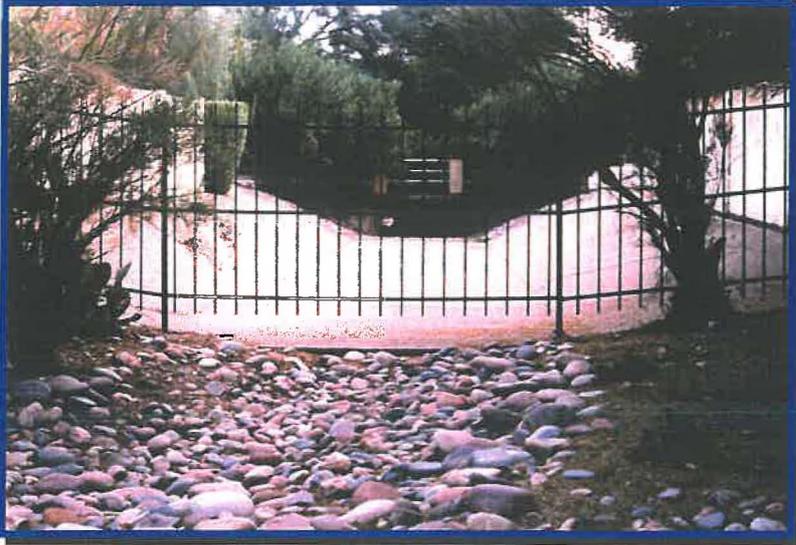
Pic 2B-2.4:

Looking downstream at the concrete lined drainage easement conveying storm flows to Sweetwater Ranch Village and channel shown in Pic 2B-2.3.

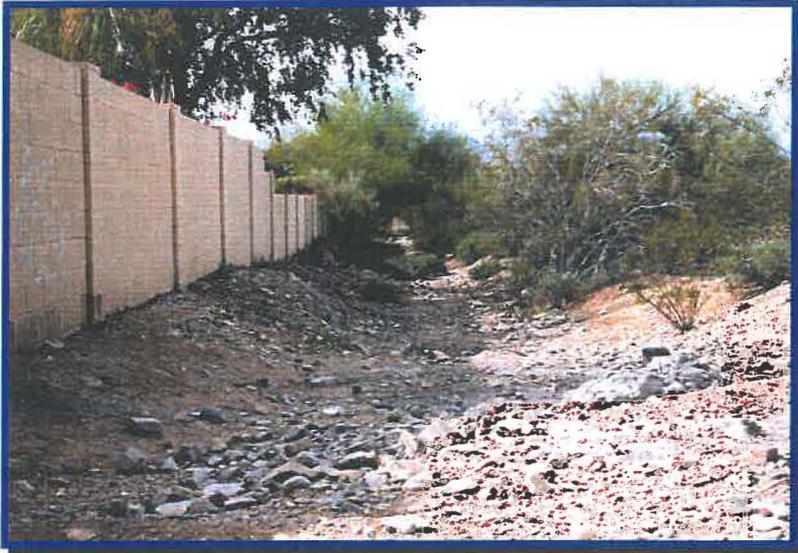
Pic 2B-3.1:

Looking downstream at the unimproved earthen channel (Wash-2B-3) located just north of Sweetwater Ranch Foothills subdivision. The channel is conveying flows west of 96th Street

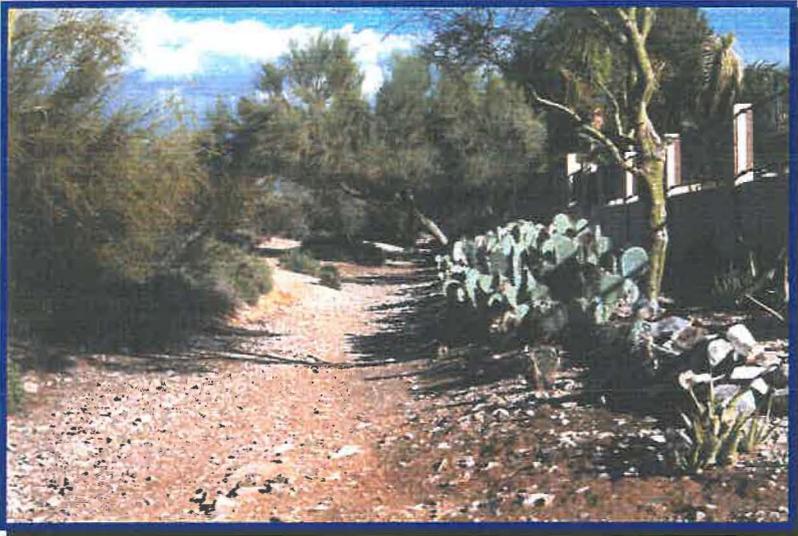
Pic 2B-3.2:

Looking upstream at the channel described in Pic 2B-3.1.

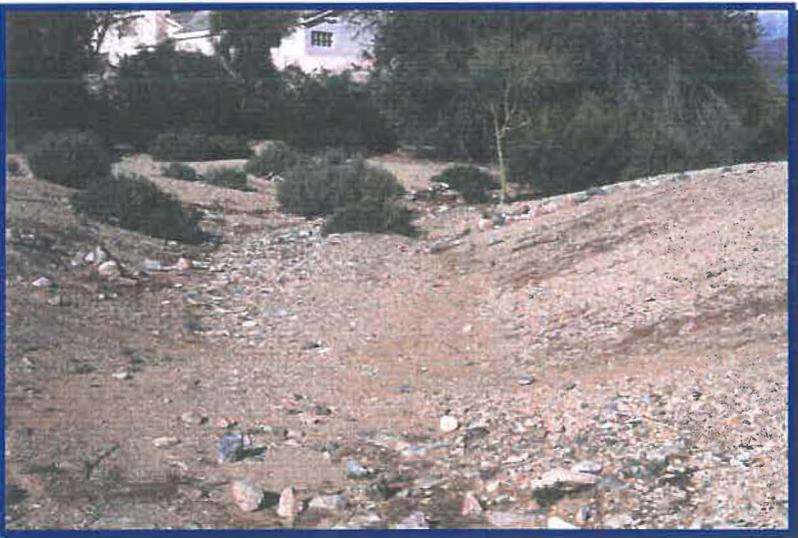
Pic 2B-3.3:

Looking upstream at the graded earthen channel described in Pic 2B-3.1 turning east.

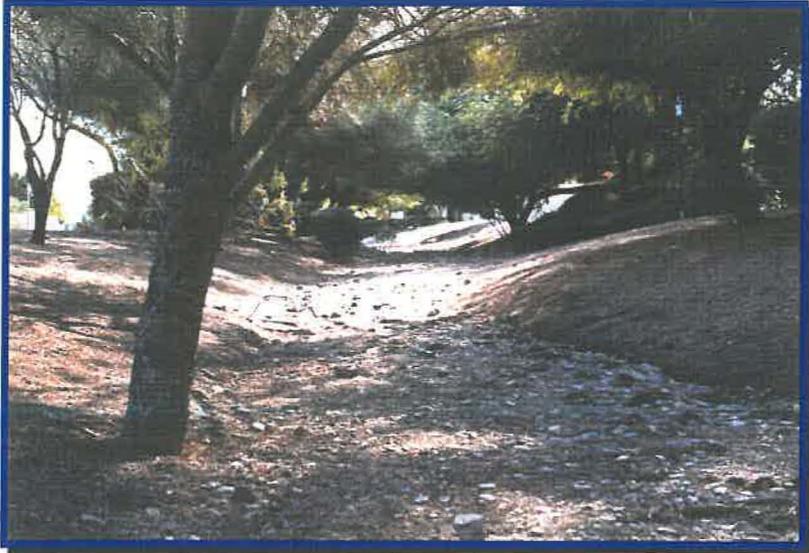
Pic 2B-3.4:

Looking downstream at the improved earthen channel located west of 97th Street.

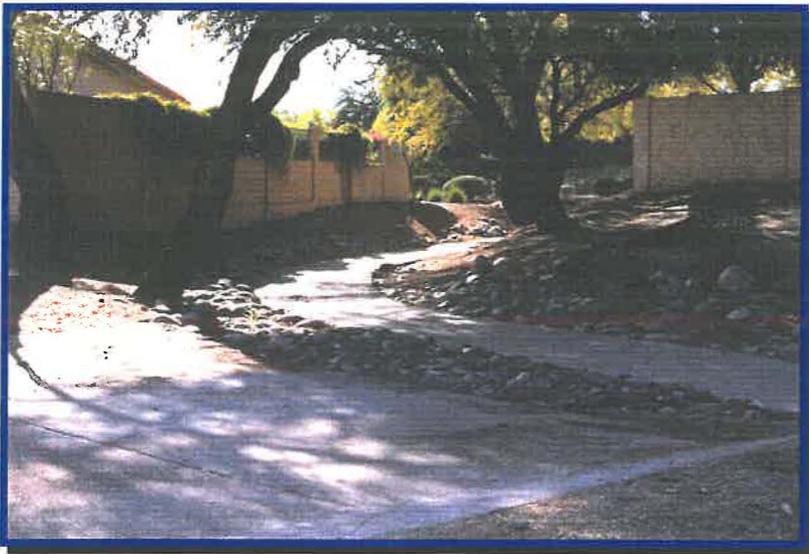
Pic 2B-3.5:

Looking downstream at the improved earthen channel with a concrete lined walk-way located west of 97th Street turning west within the Sweetwater Ranch Village subdivision and ultimately discharging flows to Wash-2B.

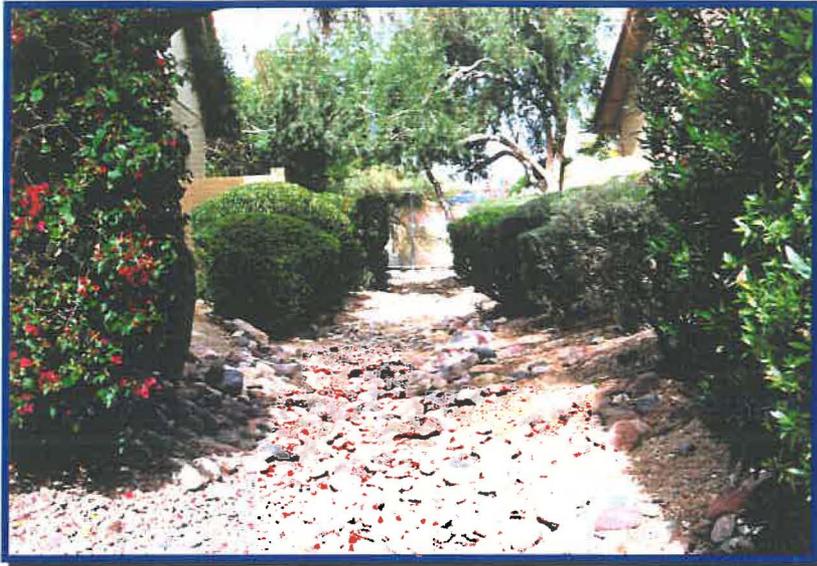
Pic 2C-1.1:

Looking upstream at the improved earthen channel north of Sutton Drive (Wash-2C-1) west of 100th Street conveying off-site flows from the school property located just north.

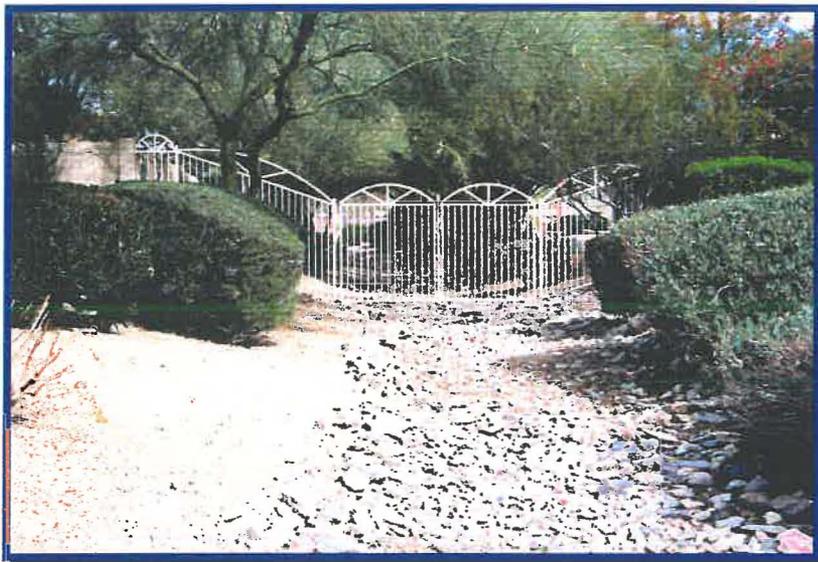
Pic 2C-2.1:

Looking upstream at the improved earthen channel north of Sutton Drive and approximately 400-feet east of Pic 2C-1.1 (Wash-2C-2) west of 100th Street conveying off-site flows from the school property located just north.

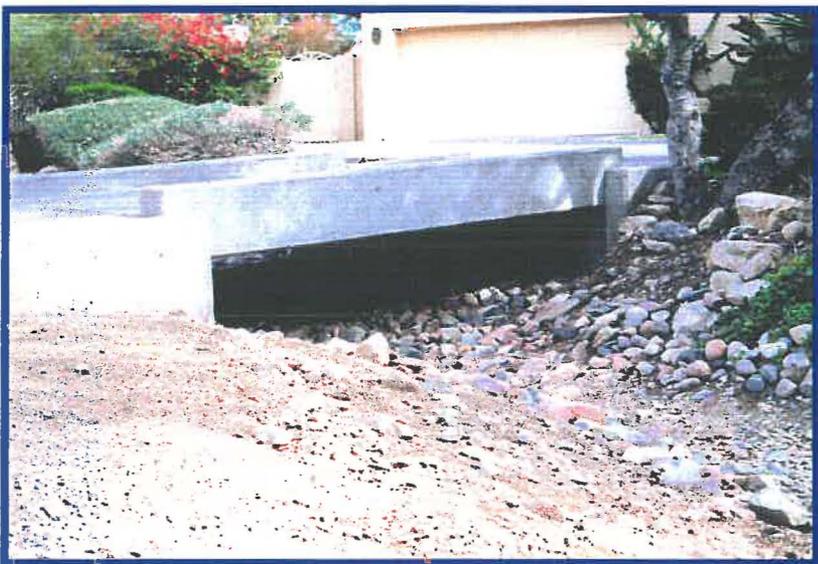
Pic 2C-2.2:

Looking upstream at the box culvert crossing the end of the cul-de-sac on Sutton Drive.

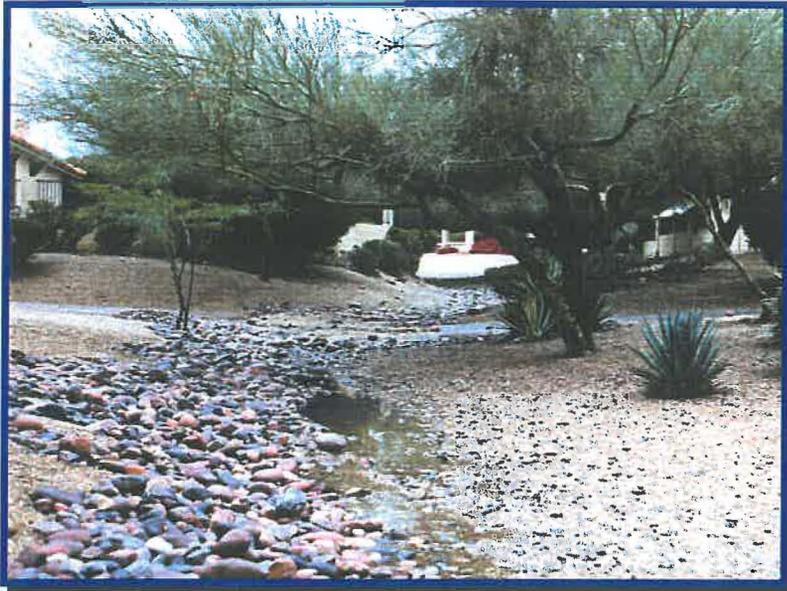
Pic 2C.1:

Looking upstream at the improved earthen channel located north of Dreyfus Avenue and west of 96th Street within the Sweetwater Ranch Foothills Subdivision.

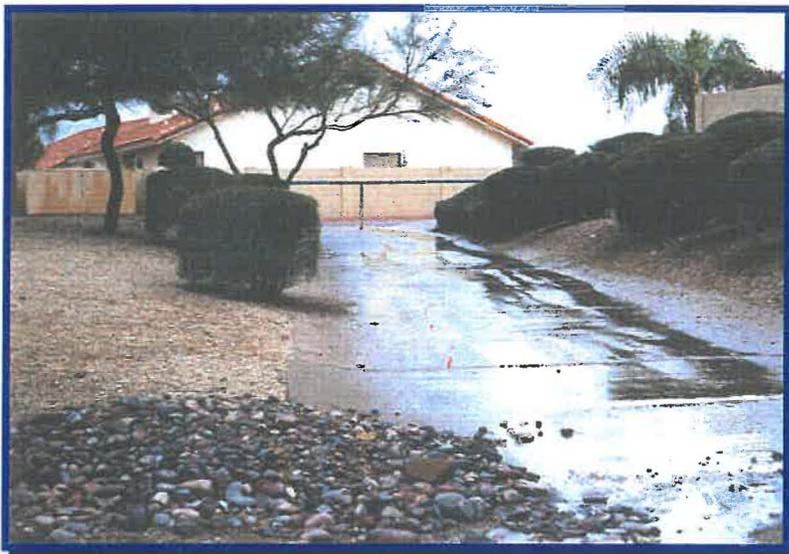
Pic 2C.2:

Concrete Valley approximately 30-foot wide conveying flows from 98th Place (west half of Sweetwater Ranch Foothills Subdivision) into Wash-2C.

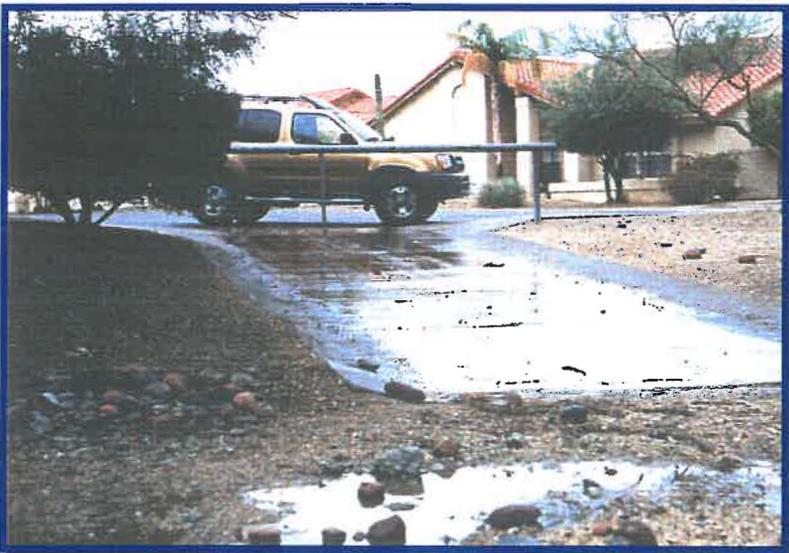
Pic 2C.3:

Concrete Valley approximately 30-foot wide conveying flows from Dreyfus Avenue (east half of Sweetwater Ranch Foothills Subdivision) into Wash-2C.

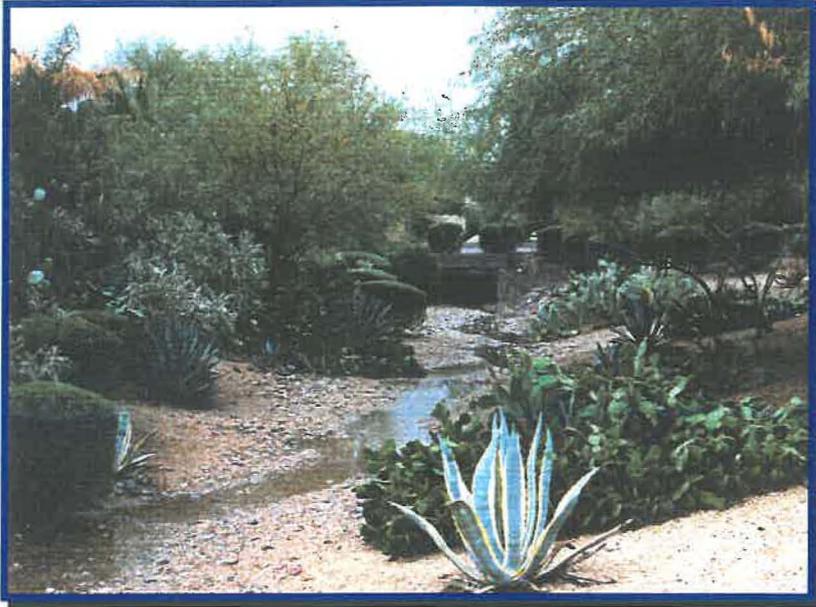
Pic 2C.4:

Looking downstream at the box culvert crossing Sweetwater Avenue.

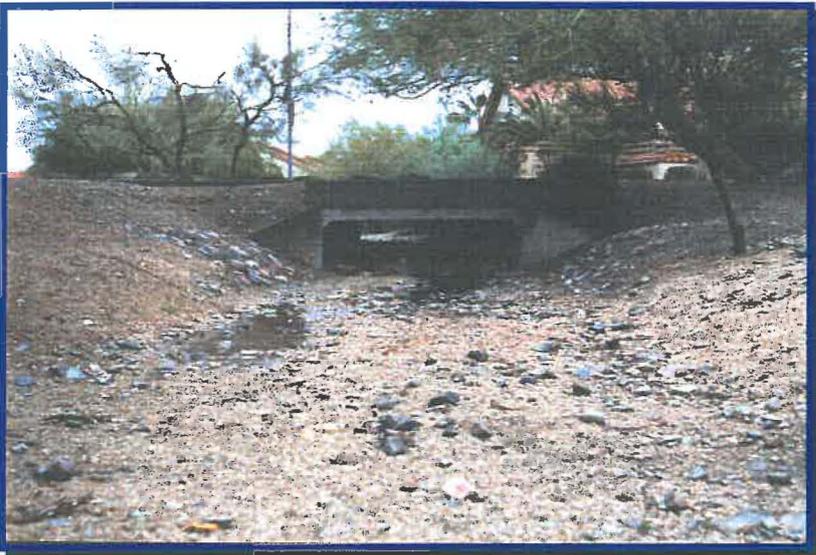
Pic 2C.5:

Looking upstream at the box culvert crossing Sweetwater Avenue (downstream of Pic 2C.4).

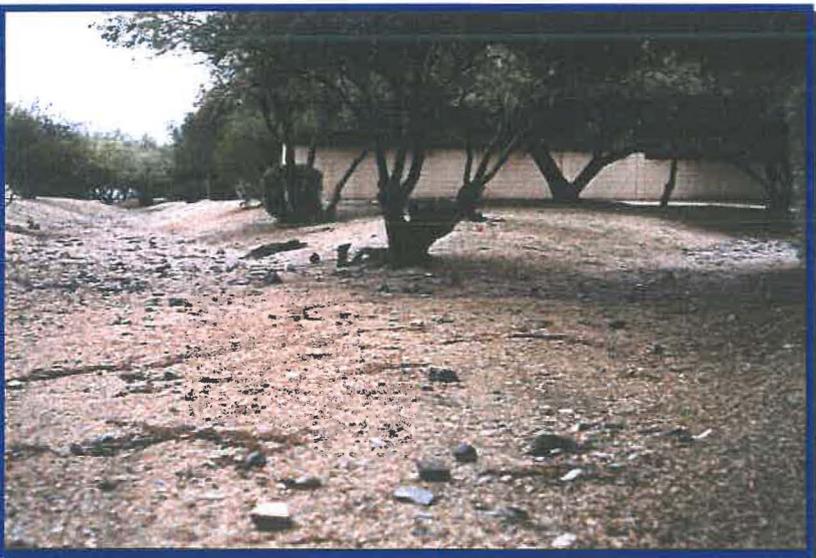
Pic 2C.6:

Looking downstream at Wash-2C diverge into a east & west branch.

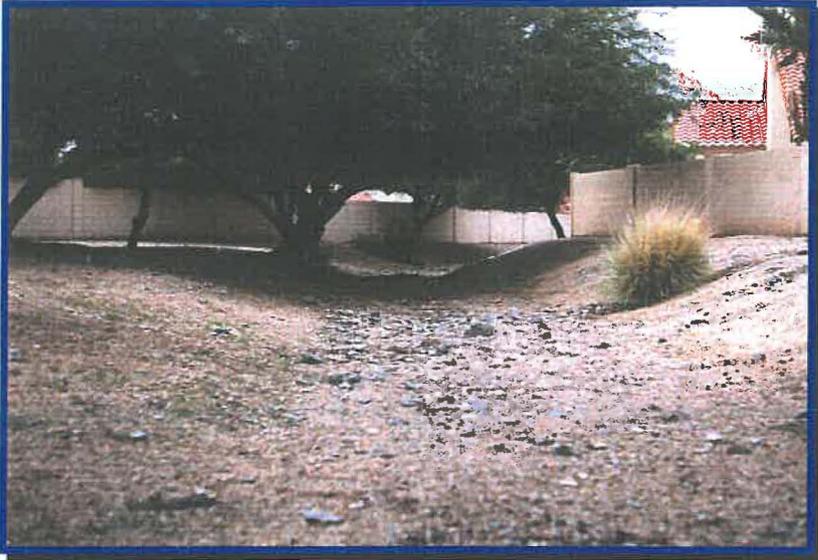
Pic 2C.7:

Looking downstream of Wash-2C after divergence as shown in Pic 2C.6.

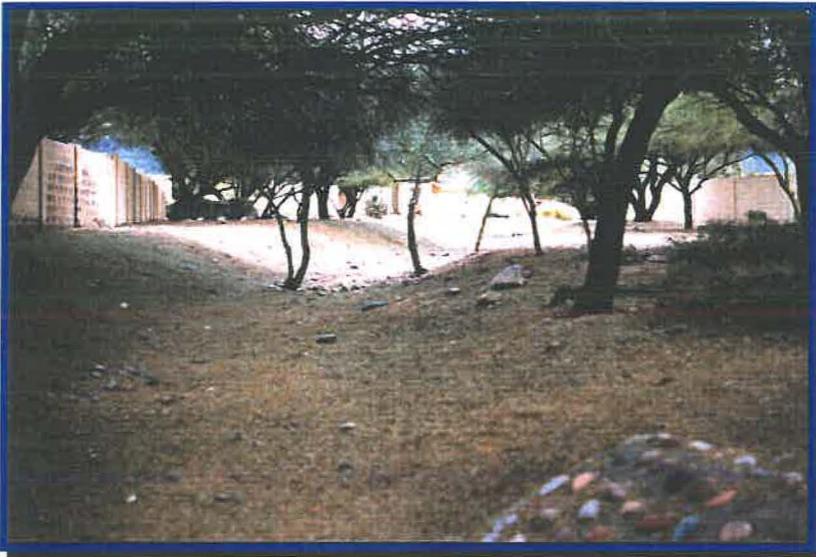
Pic 2C.8:

Looking upstream of Wash-2C north of Windrose Drive.

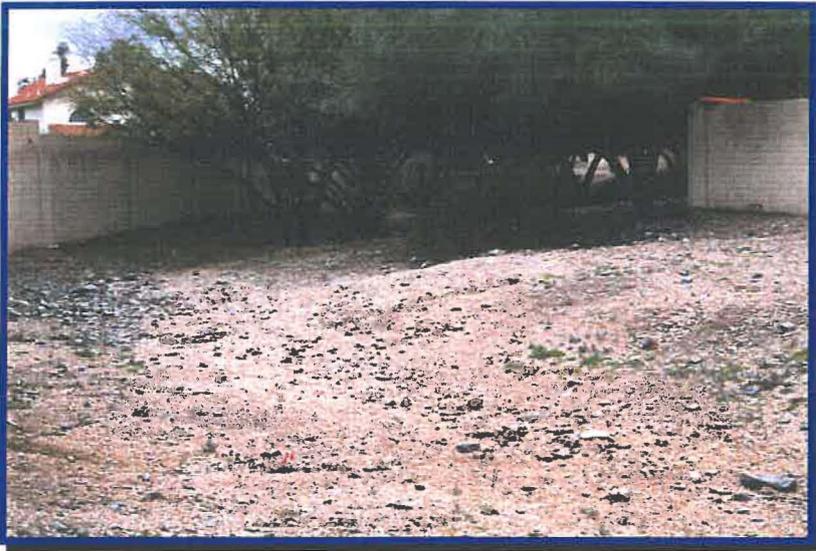
Pic 2C.11:

Looking downstream at Wash-2C turning west.

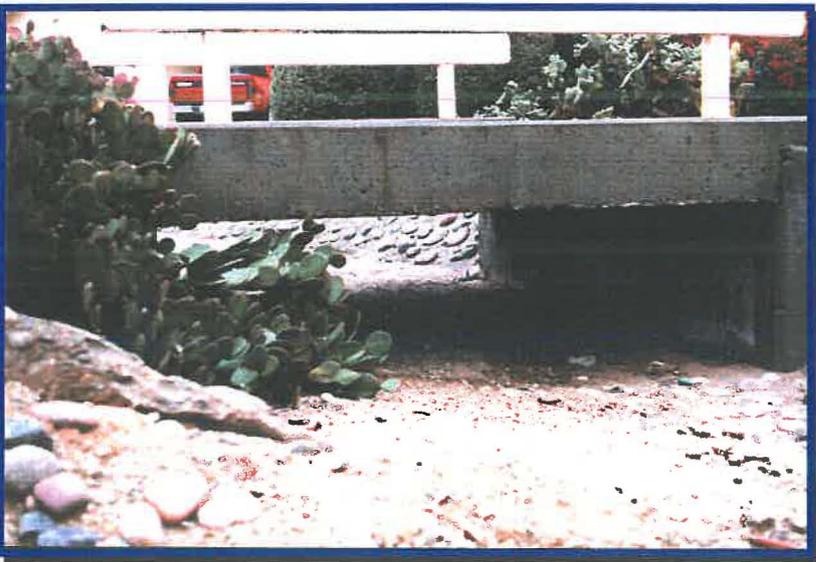
Pic 2C.12:

Looking upstream at the box culvert crossing the cul-de-sac on Desert Terrace east of 98th Street.

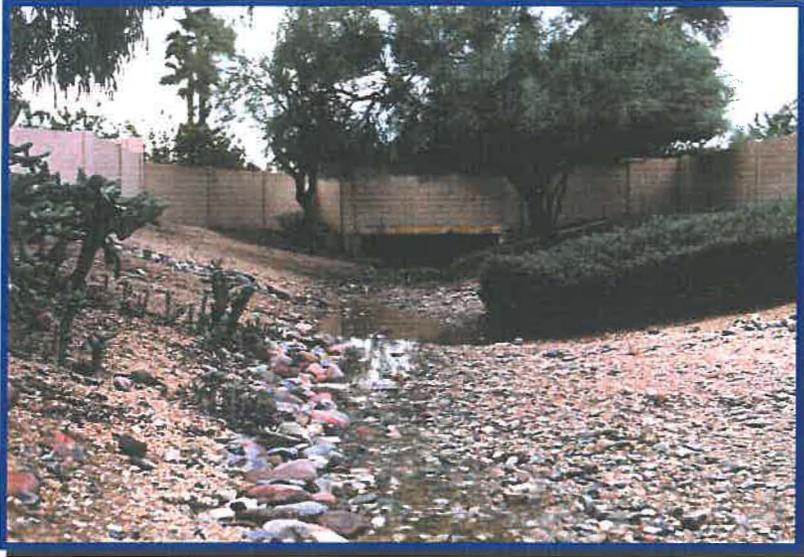
Pic 2C.13:

Looking downstream at Wash-2C and the block wall opening conveying flows to Sweetwater Estates Subdivision and ultimately discharging to the storm drain system within Larkspur Drive.
