Report of the Flooding in Laveen Storm of July 28, 1999

Afshin Ahouraiyan, Flood Control District of Maricopa County

Report on the flooding in Laveen
Storm of July 28, 1999
Afshin Ahouraiyan, Engineering Division

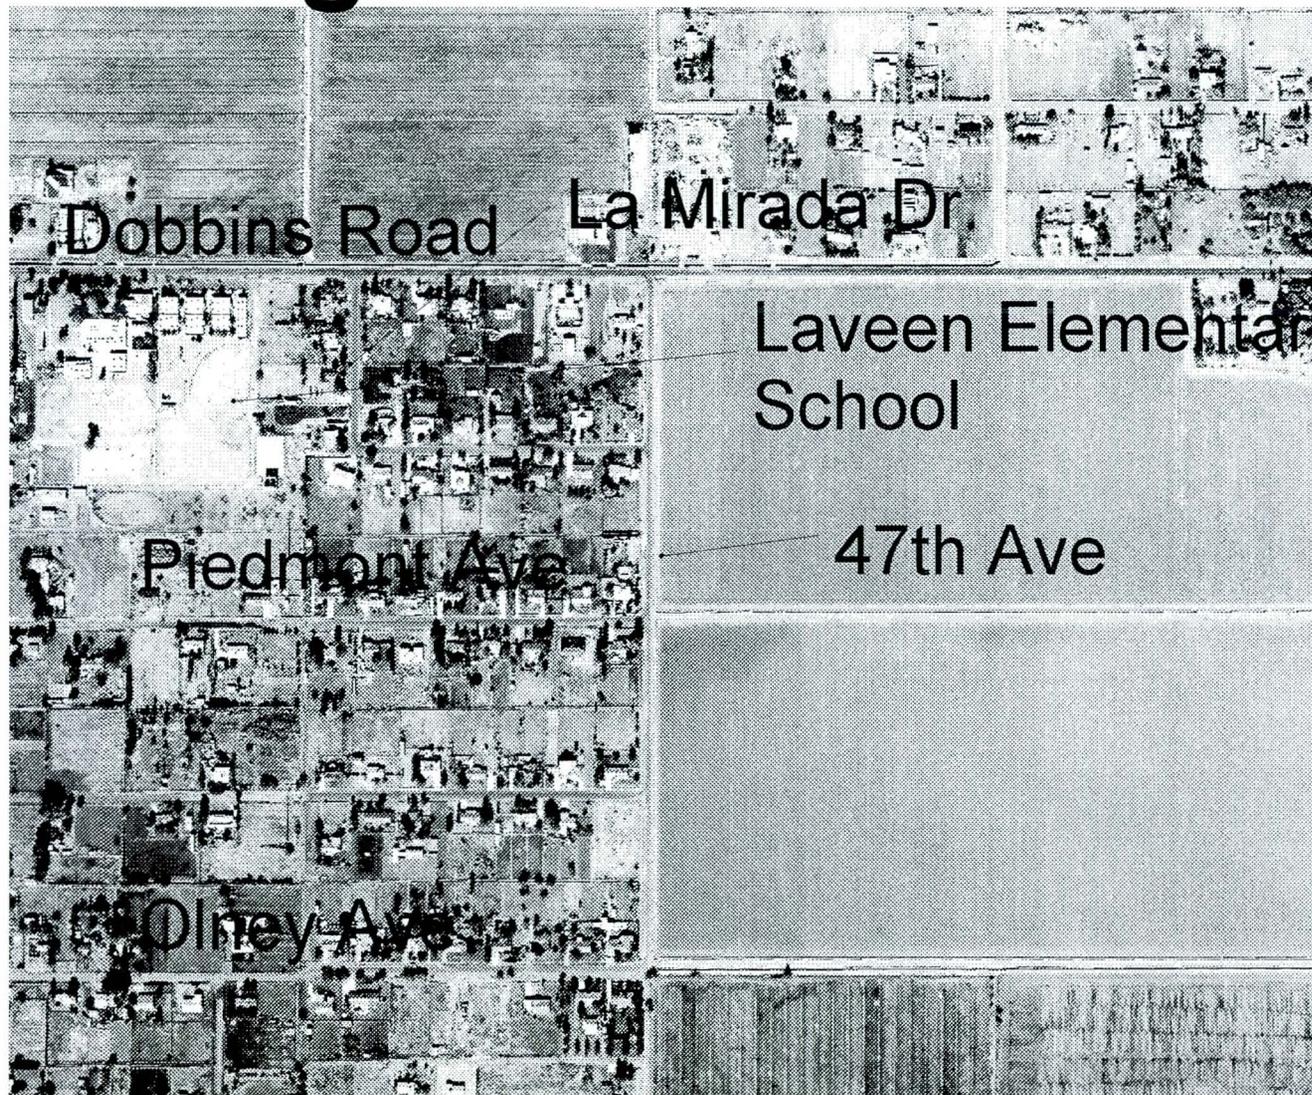
Figure 1

At about 3:00 p.m. in the afternoon, Ben Gregg of the Flood Control District's Regulatory Division had called in to the District that the Laveen area (Figure 1) had been hit quite hard because of the day's storm. The Laveen Elementary School had major flooding and the neighborhood to the east of the school was also inundated with floodwaters. The following is a collection of the comments received from the residents in the area regarding the flooding (Figure 2). The residents had concerns as to when the problem is going to be resolved. Included with this report are photos that show the inundated areas.
