# Bridge Evaluation Study Ash Avenue Bridge (Salt River Crossing)

**City of Tempe**  
**Project 876191B**  
**Maricopa County, Arizona**

BRIDGE EVALUATION STUDY

May 4, 1990

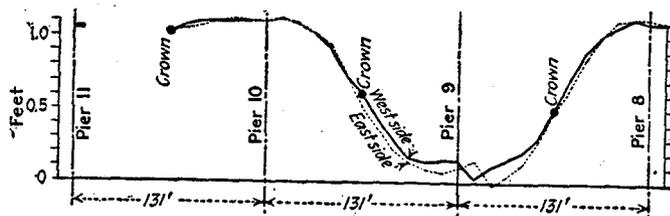
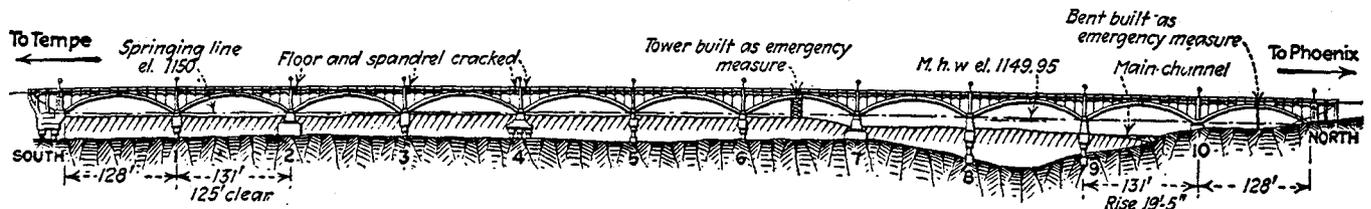
FIG. 1. GENERAL ELEVATION OF TEMPE BRIDGE, AND PROFILE OF ROADWAY IN SPANS ADJACENT TO THE SETTLED PIER NO. 9

A profile of the bridge roadway between piers 8 and 10 is shown by a small sketch in Fig. 1, drawn to an exaggerated vertical scale. The sag was strikingly noticeable in looking along the pavement, as in the view, Fig. 2. Evidently the structure adapted itself to the 1-ft. settlement of pier 9 in fairly flexible manner. No evidence of any crack in the floor was found in the region of settlement, although the hand rail was

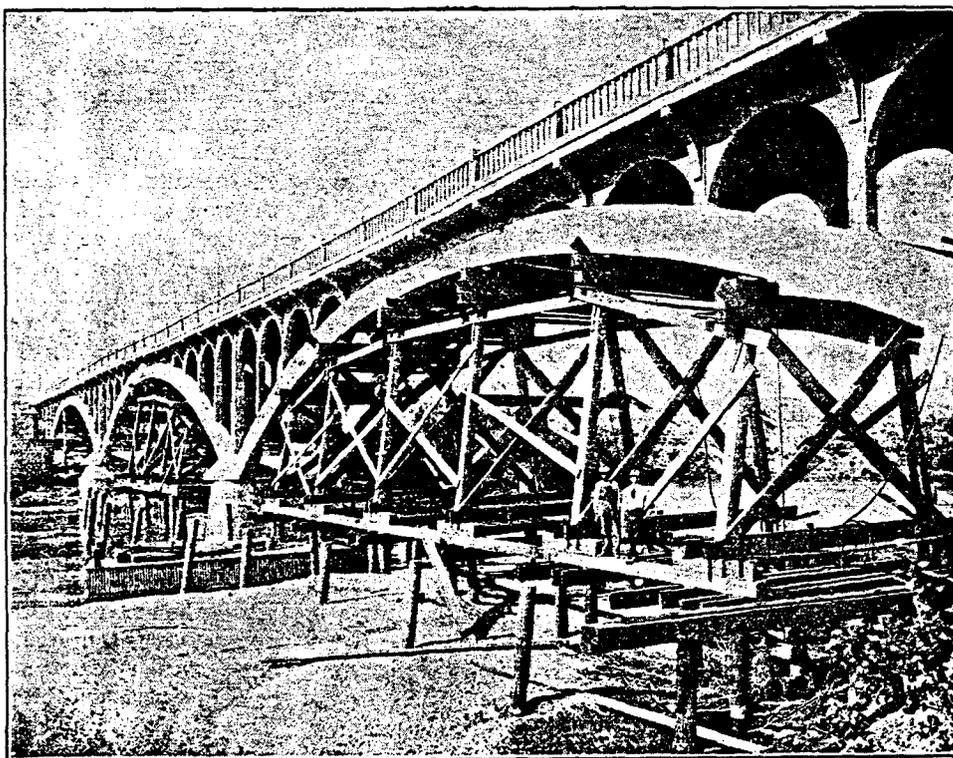
FIG. 3. FALSEWORK ON BOTH SIDES OF PIER 9

Later in the month, in preparation for the underpinning work on pier 9, falsework piles were driven in spans 8-9 and 9-10. These had to be placed outside the side lines of the bridge because the driver leads reached above the deck. Framed bents were erected on these piles, and their caps wedged against the intrados of the arch ribs by oak wedges (Fig. 3); a man inspected these wedges every second day, to make sure that none worked loose under the action of traffic.
