Erosion Hazard Study

Skunk Tank Wash

October 2000

DATE: October 31, 2000
TO: Joe Tram, P.E./ FCDMC
FROM: Jon Fuller, P.E.
RE: FCD #2000CO13 – Assignment #1
Skunk Tank Wash Erosion Hazard Study
CC: Dave Johnson, P.E./ FCDMC

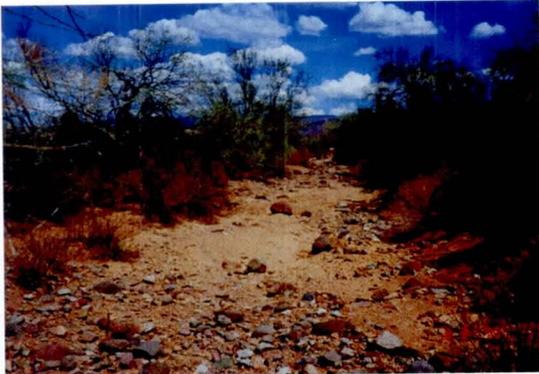
- **Typical Cross Section.** The typical cross section for Skunk Tank Wash varies significantly within the study reach, as illustrated in Figures 2 to 4. Channel width and depth in Reach 1 (Figure 2) generally increase in the downstream direction, but average about 15 feet and two feet, respectively. In Reach 2 (Figure 3), the channel becomes shallower and narrower in the downstream direction, and is less well defined. In Reach 3 (Figure 4), the channel width again increases in

Figure 2. Reach 1, looking upstream.

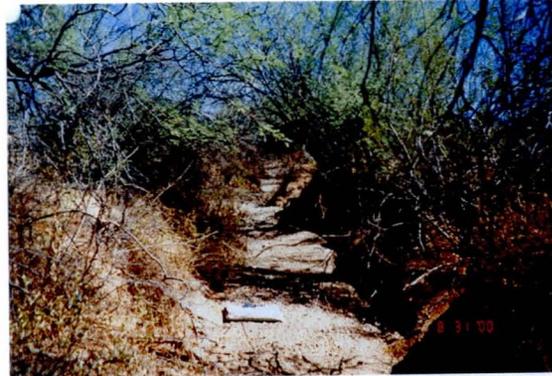
Figure 3. Reach 2, looking upstream.

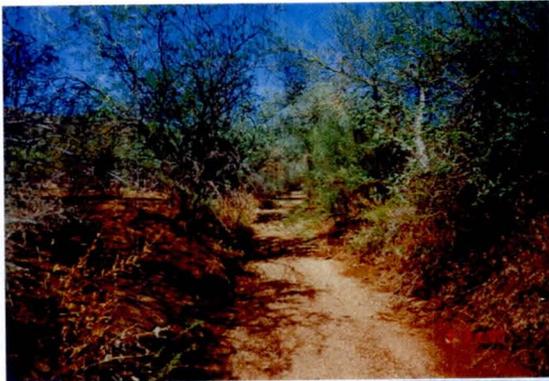
the downstream direction, with an average width of about six feet, and a depth of about 3 feet

Figure 4. Reach 3, looking downstream.

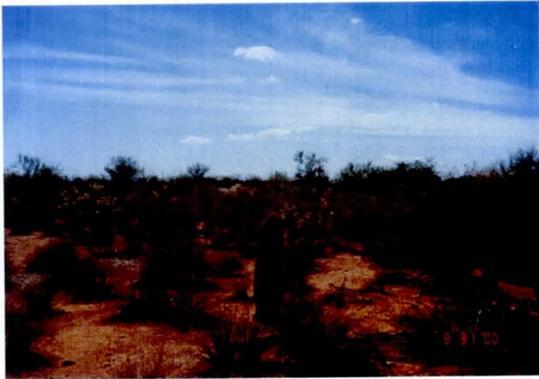
- Floodplain Dimensions. A natural floodplain (Figure 5) is present adjacent to the main channel throughout the study area. The floodplain generally widens in the downstream direction, especially in Reach 2, where it takes the shape of an alluvial fan. The height of the floodplain relative to the main channel is lowest in Reach 2, and is most variable in Reach 1. As the height of this natural floodplain above the main channel increases, the frequency of flow on the floodplain decreases, and the erosion potential of the main channel bank increases due to the relatively higher flow depths and velocities along the main channel bank, as illustrated in Figure 6. Where field evidence suggests more frequent overbank flow on the floodplain, the potential for avulsive channel change increases.

Figure 5. Floodplain terrace in Reach 1.

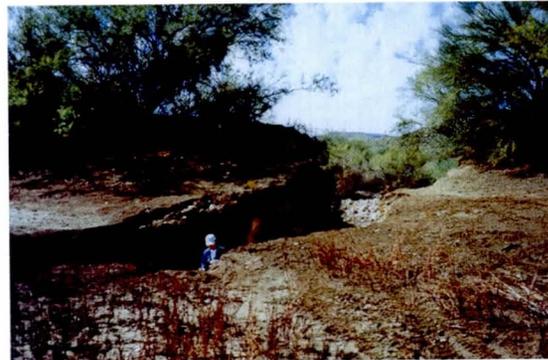
After the photograph in Figure 11a was taken, a small flood occurred on Skunk Tank Wash on October 22, 2000. Figures 11b to 11d show the condition of the breach in the dam on October 26, 2000. Further degradation of the dam and subsequent floods will lead to headcutting through the tank impoundment area and increased lateral erosion in Skunk Creek downstream of the tank.

Figure 11b. Full breach in Skunk Tank after October 22, 2000 flood.

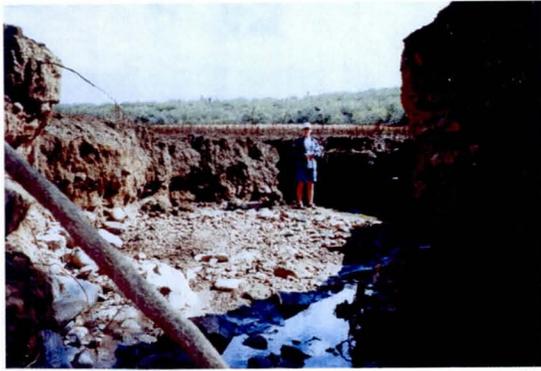
Figure 11c. Looking upstream through breach after October 22, 2000 flood. Bottom of tank at eye level.

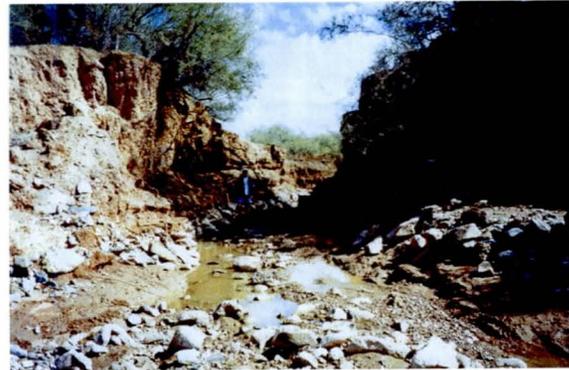
Figure 11d. Looking upstream through breach after October 22, 2000 flood.

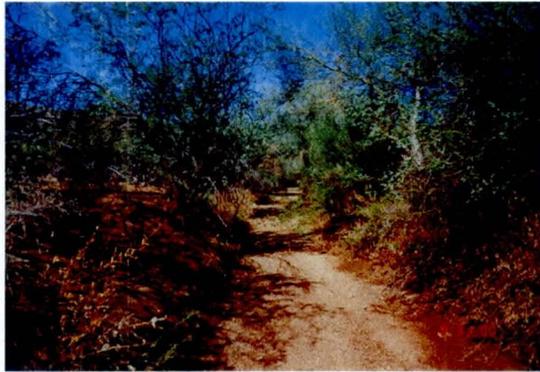
- Bank vegetation. In most locations, the banks are well vegetated with mesquite, palo verde, and dense brush (Figure 20). The bank vegetation generally covers the entire bank slope from toe to top, and includes deep rooting riparian species which enhance bank stability.¹ The following two aspects of the bank vegetation enhance bank stability: (1) roots which holds soil material in place, and (2) branches, leaves, and debris trapped in the vegetation which lower the velocities

at the bank line and prevent high-velocity floodwaters from flowing directly on the soils that comprise the bank. The presence of mature bank vegetation throughout much of the study area indicates that the average rate of lateral erosion has been slow in the past 50 years. That is, the average rate of lateral erosion is less than the average growth rate of the vegetation on the banks.

Figure 20. Dense bank vegetation.

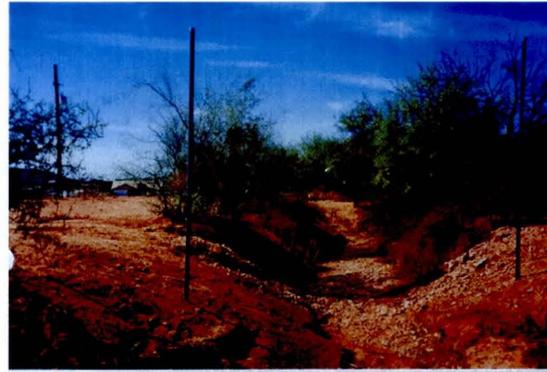
Figure 21. Bank vegetation partially removed by homeowner.

In some cases, bank vegetation has been removed on developed lots. Loss of the bank vegetation will accelerate the risk and rate of lateral erosion (Figure 20).

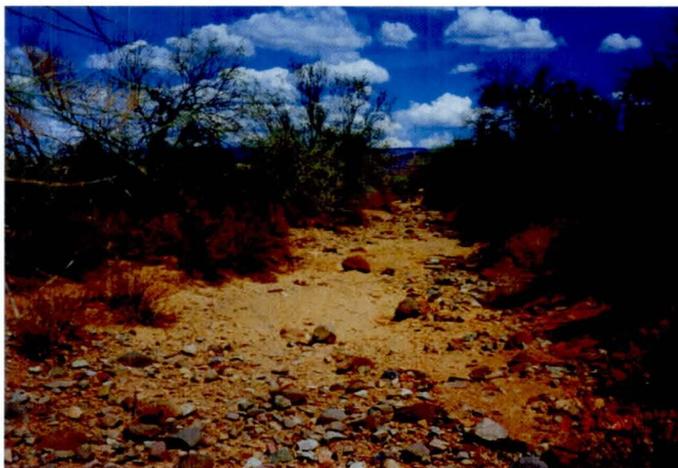
- **Sediment Transport.** The channel beds consist primarily of sand and gravel sized sediment, with some cobbles and small boulders (Figure 22). The floodplain soils typically consist of finer sand and gravel deposits. The difference in composition between the floodplain and channel indicates that fine sediment is transported through the main channels without being deposited. The main channel sediments are moderately well sorted, indicating that they have been transported by recent flows, and are not primarily derived from slope processes acting on the banks and canyon slopes. Fine-grained sediment deposited in Skunk Tank confirms that the streams transport fine-grained material, but that it is normally conveyed through the system without deposition in the main channels.

Figure 22. Coarse bed material in small riffle.

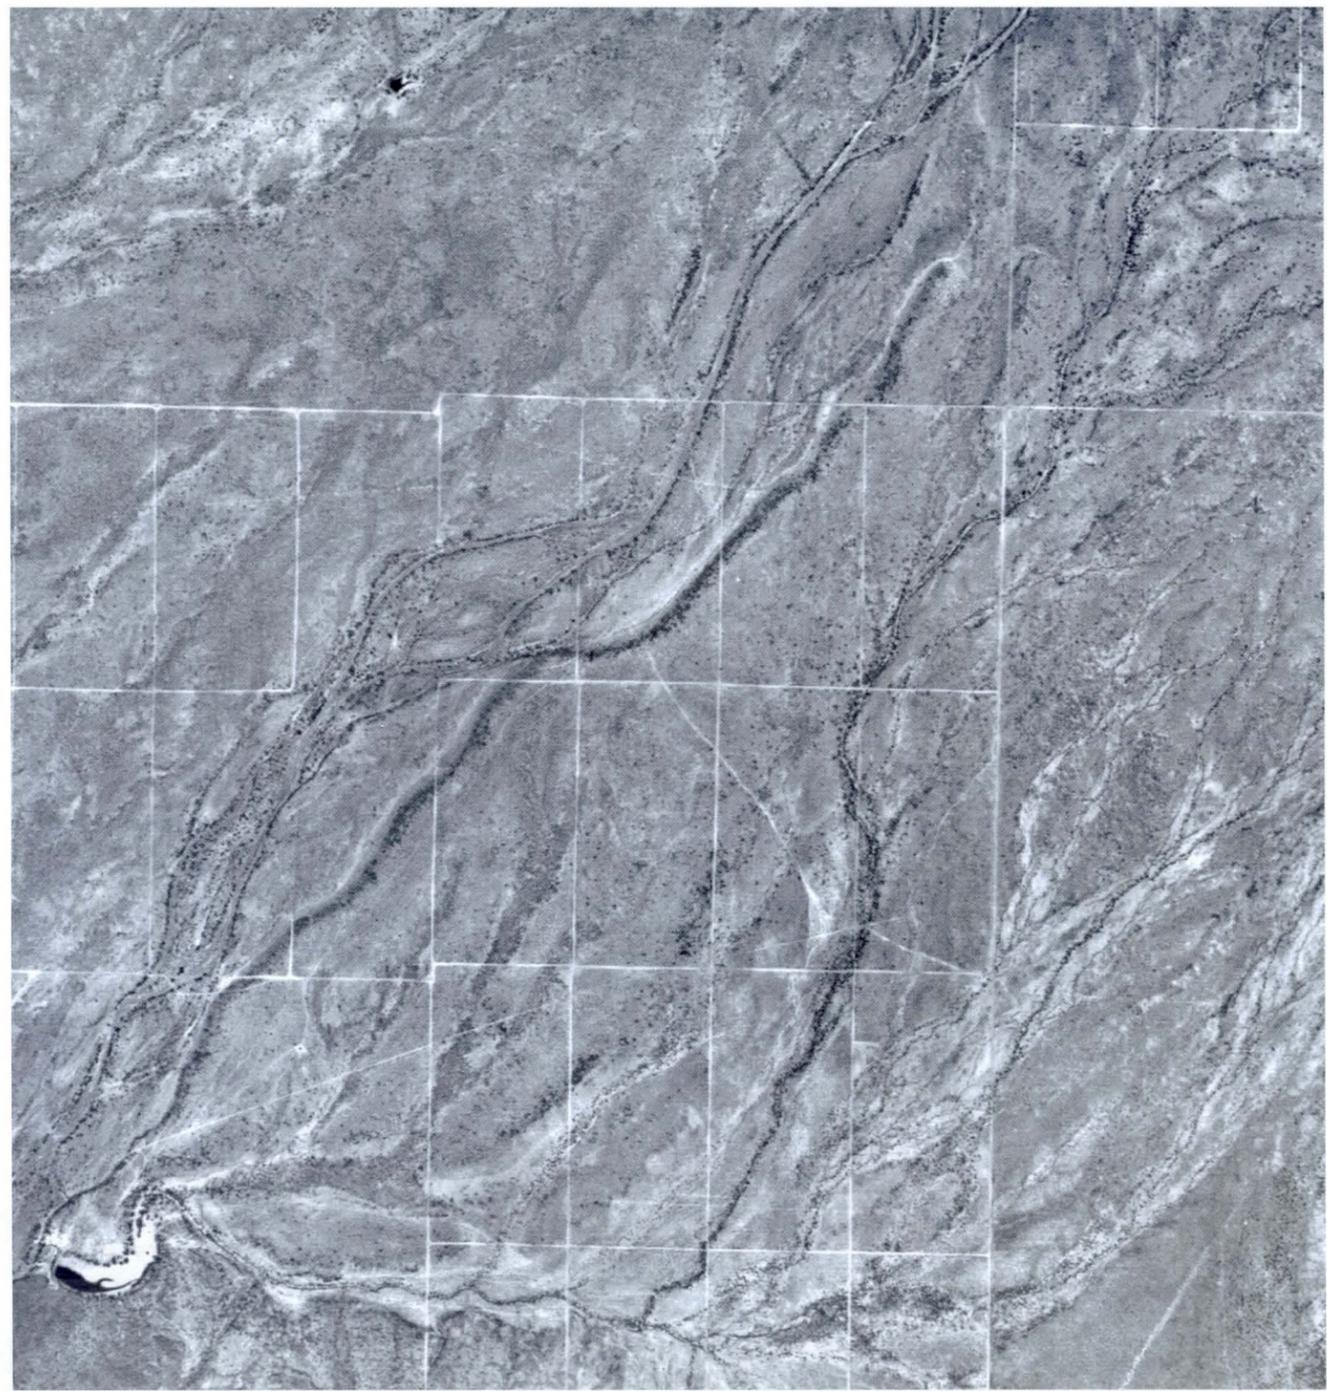
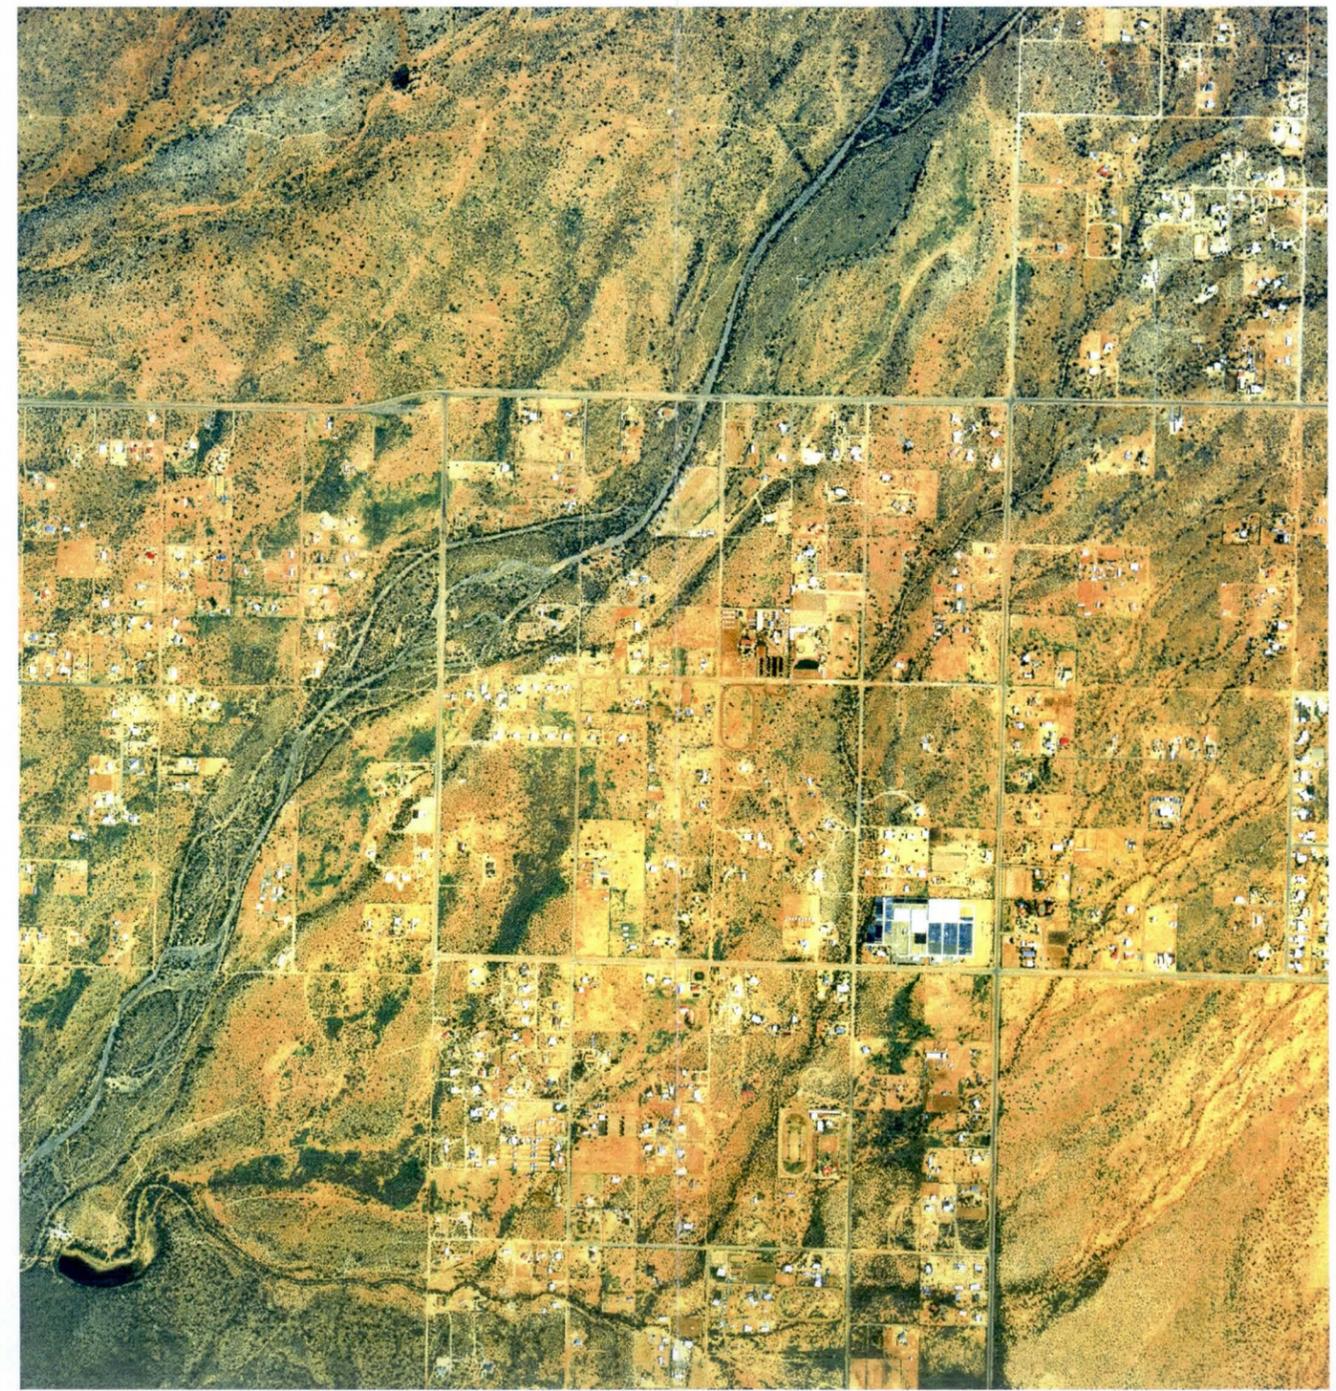
Figure 26. Skunk Tank Wash Photo Comparison

A side-by-side plot of the 1962 and 1999 aerial photographs is provided in Figure 26 to illustrate the degree of urbanization of the floodplain.

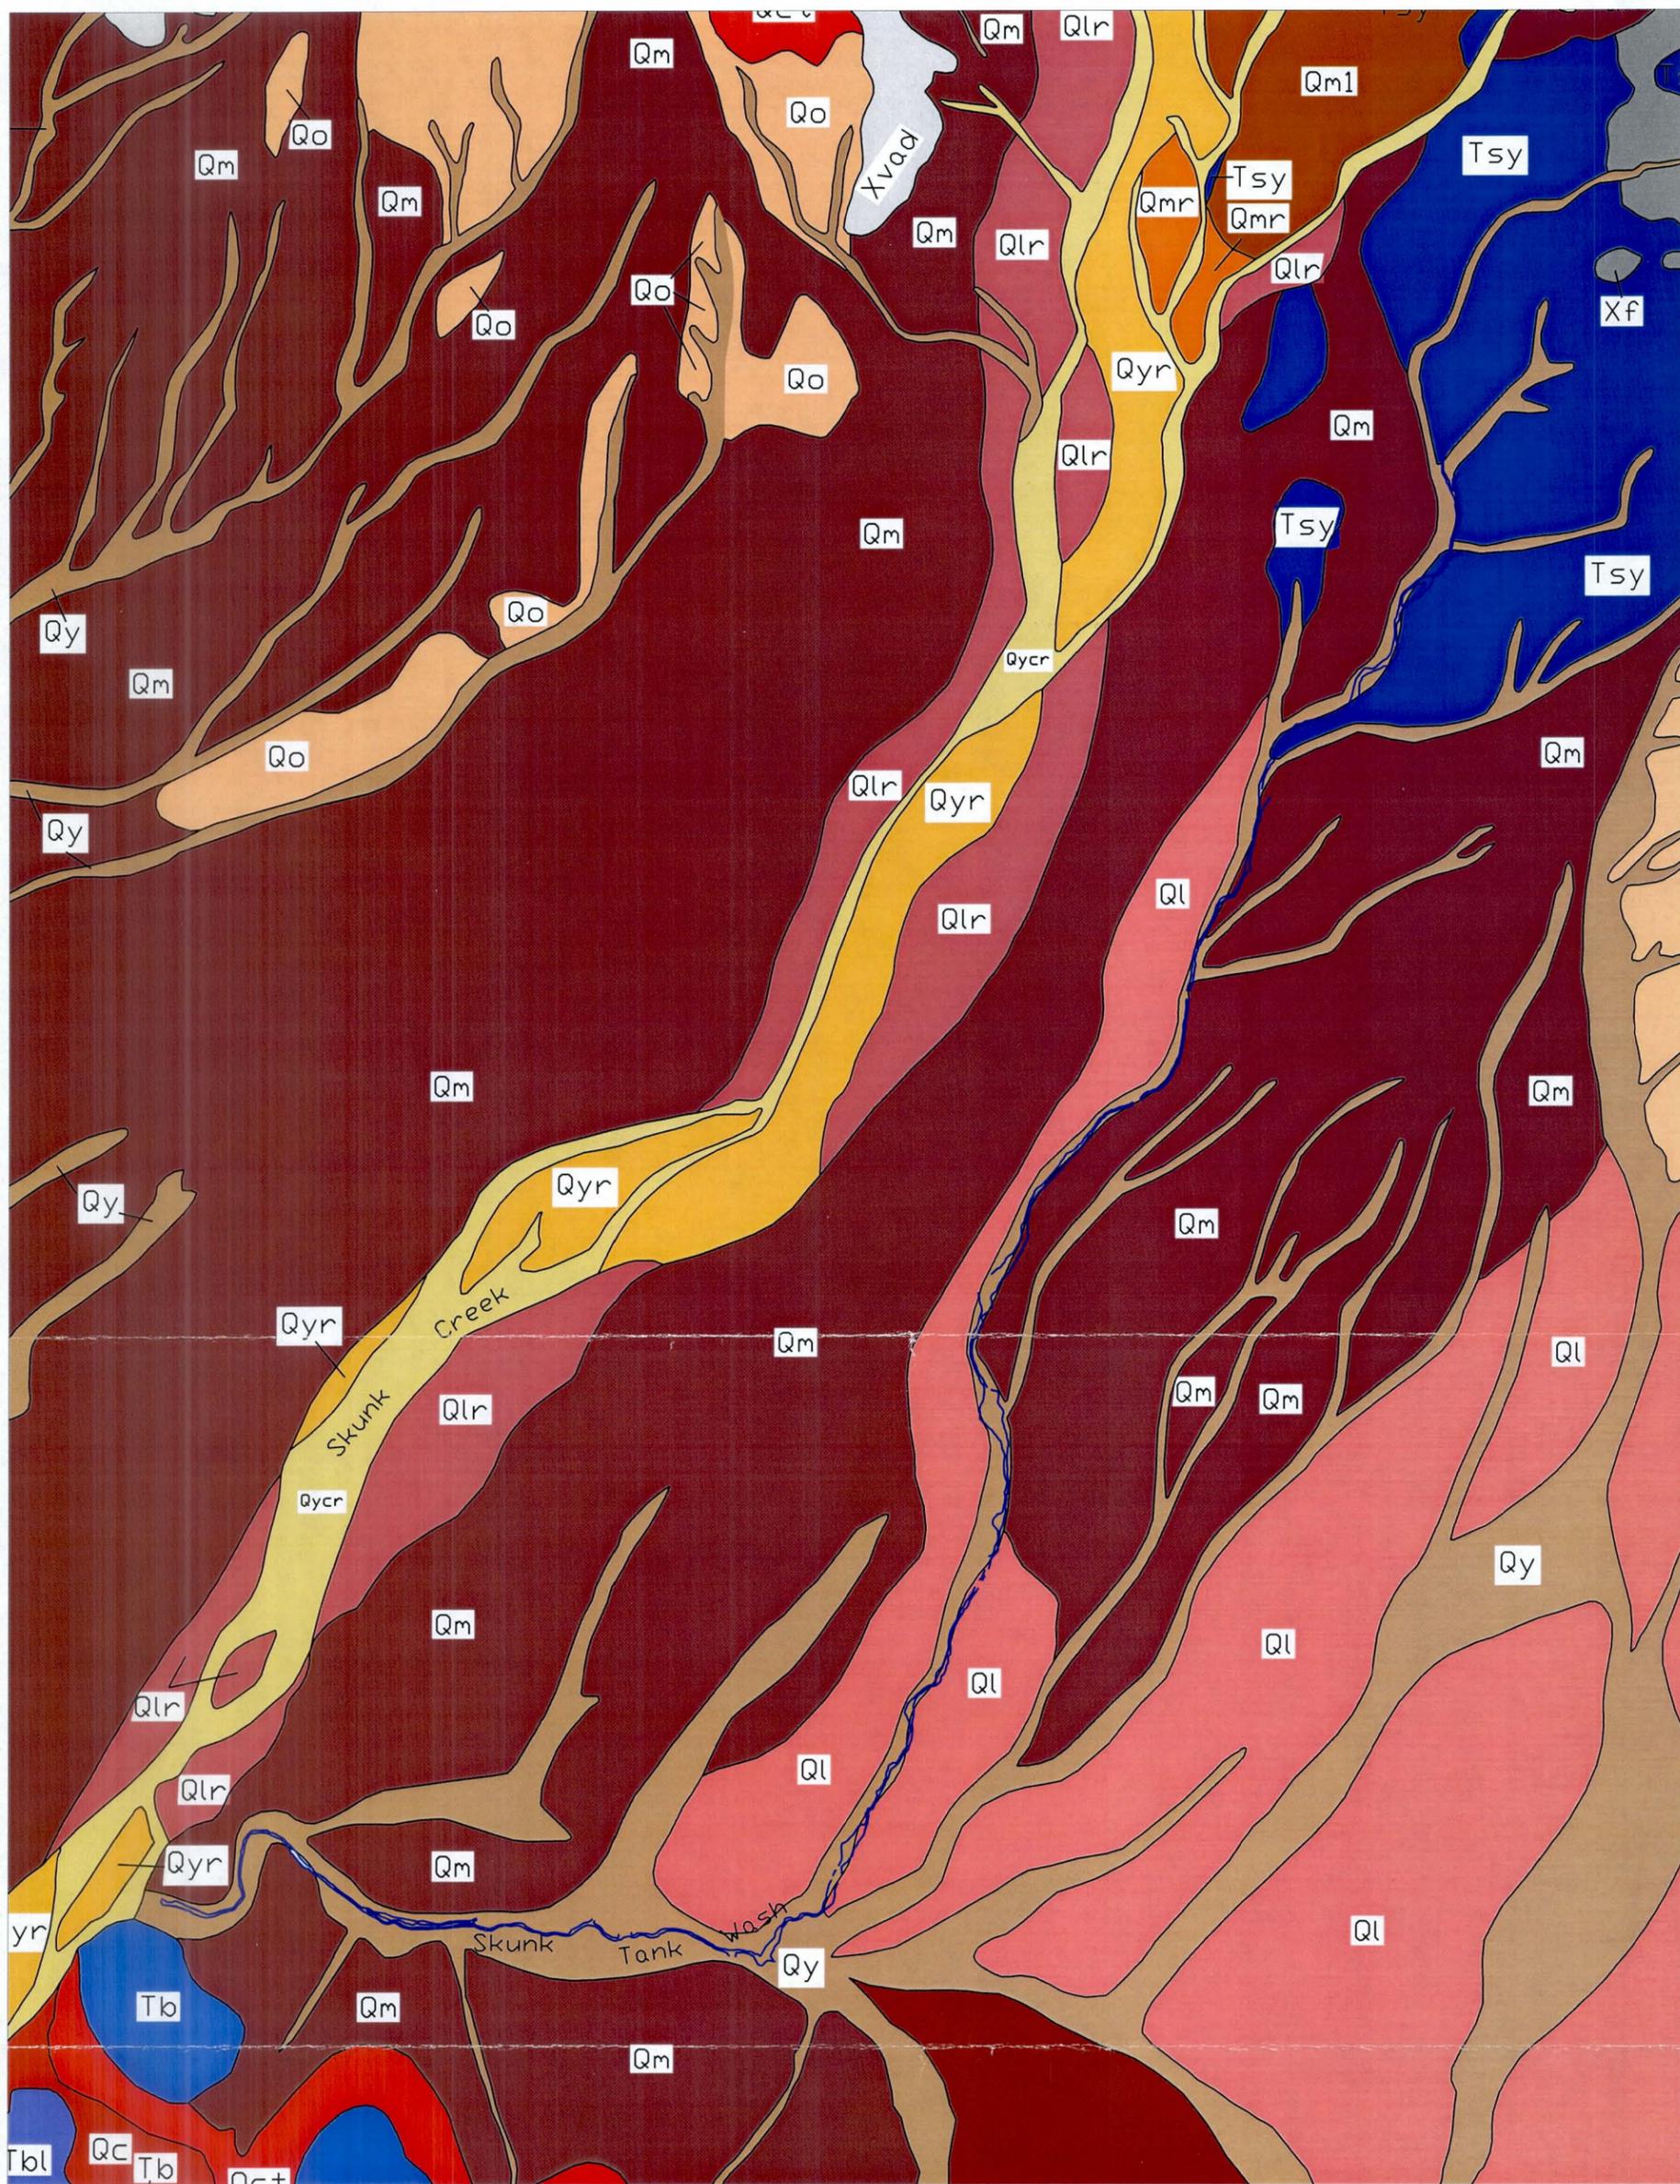
Fig. 28. Surficial Geology of Skunk Tank Wash, AZ

Interpretation of surficial geology maps. The surficial geology of the Skunk Tank Wash watershed was mapped previously by the Arizona Geological Survey (AZGS).¹ A portion of the AZGS surficial mapping near Skunk Tank Wash is provided in Figure 28. The AZGS mapping distinguishes the following three geomorphic surfaces in the vicinity of Skunk Tank Wash.

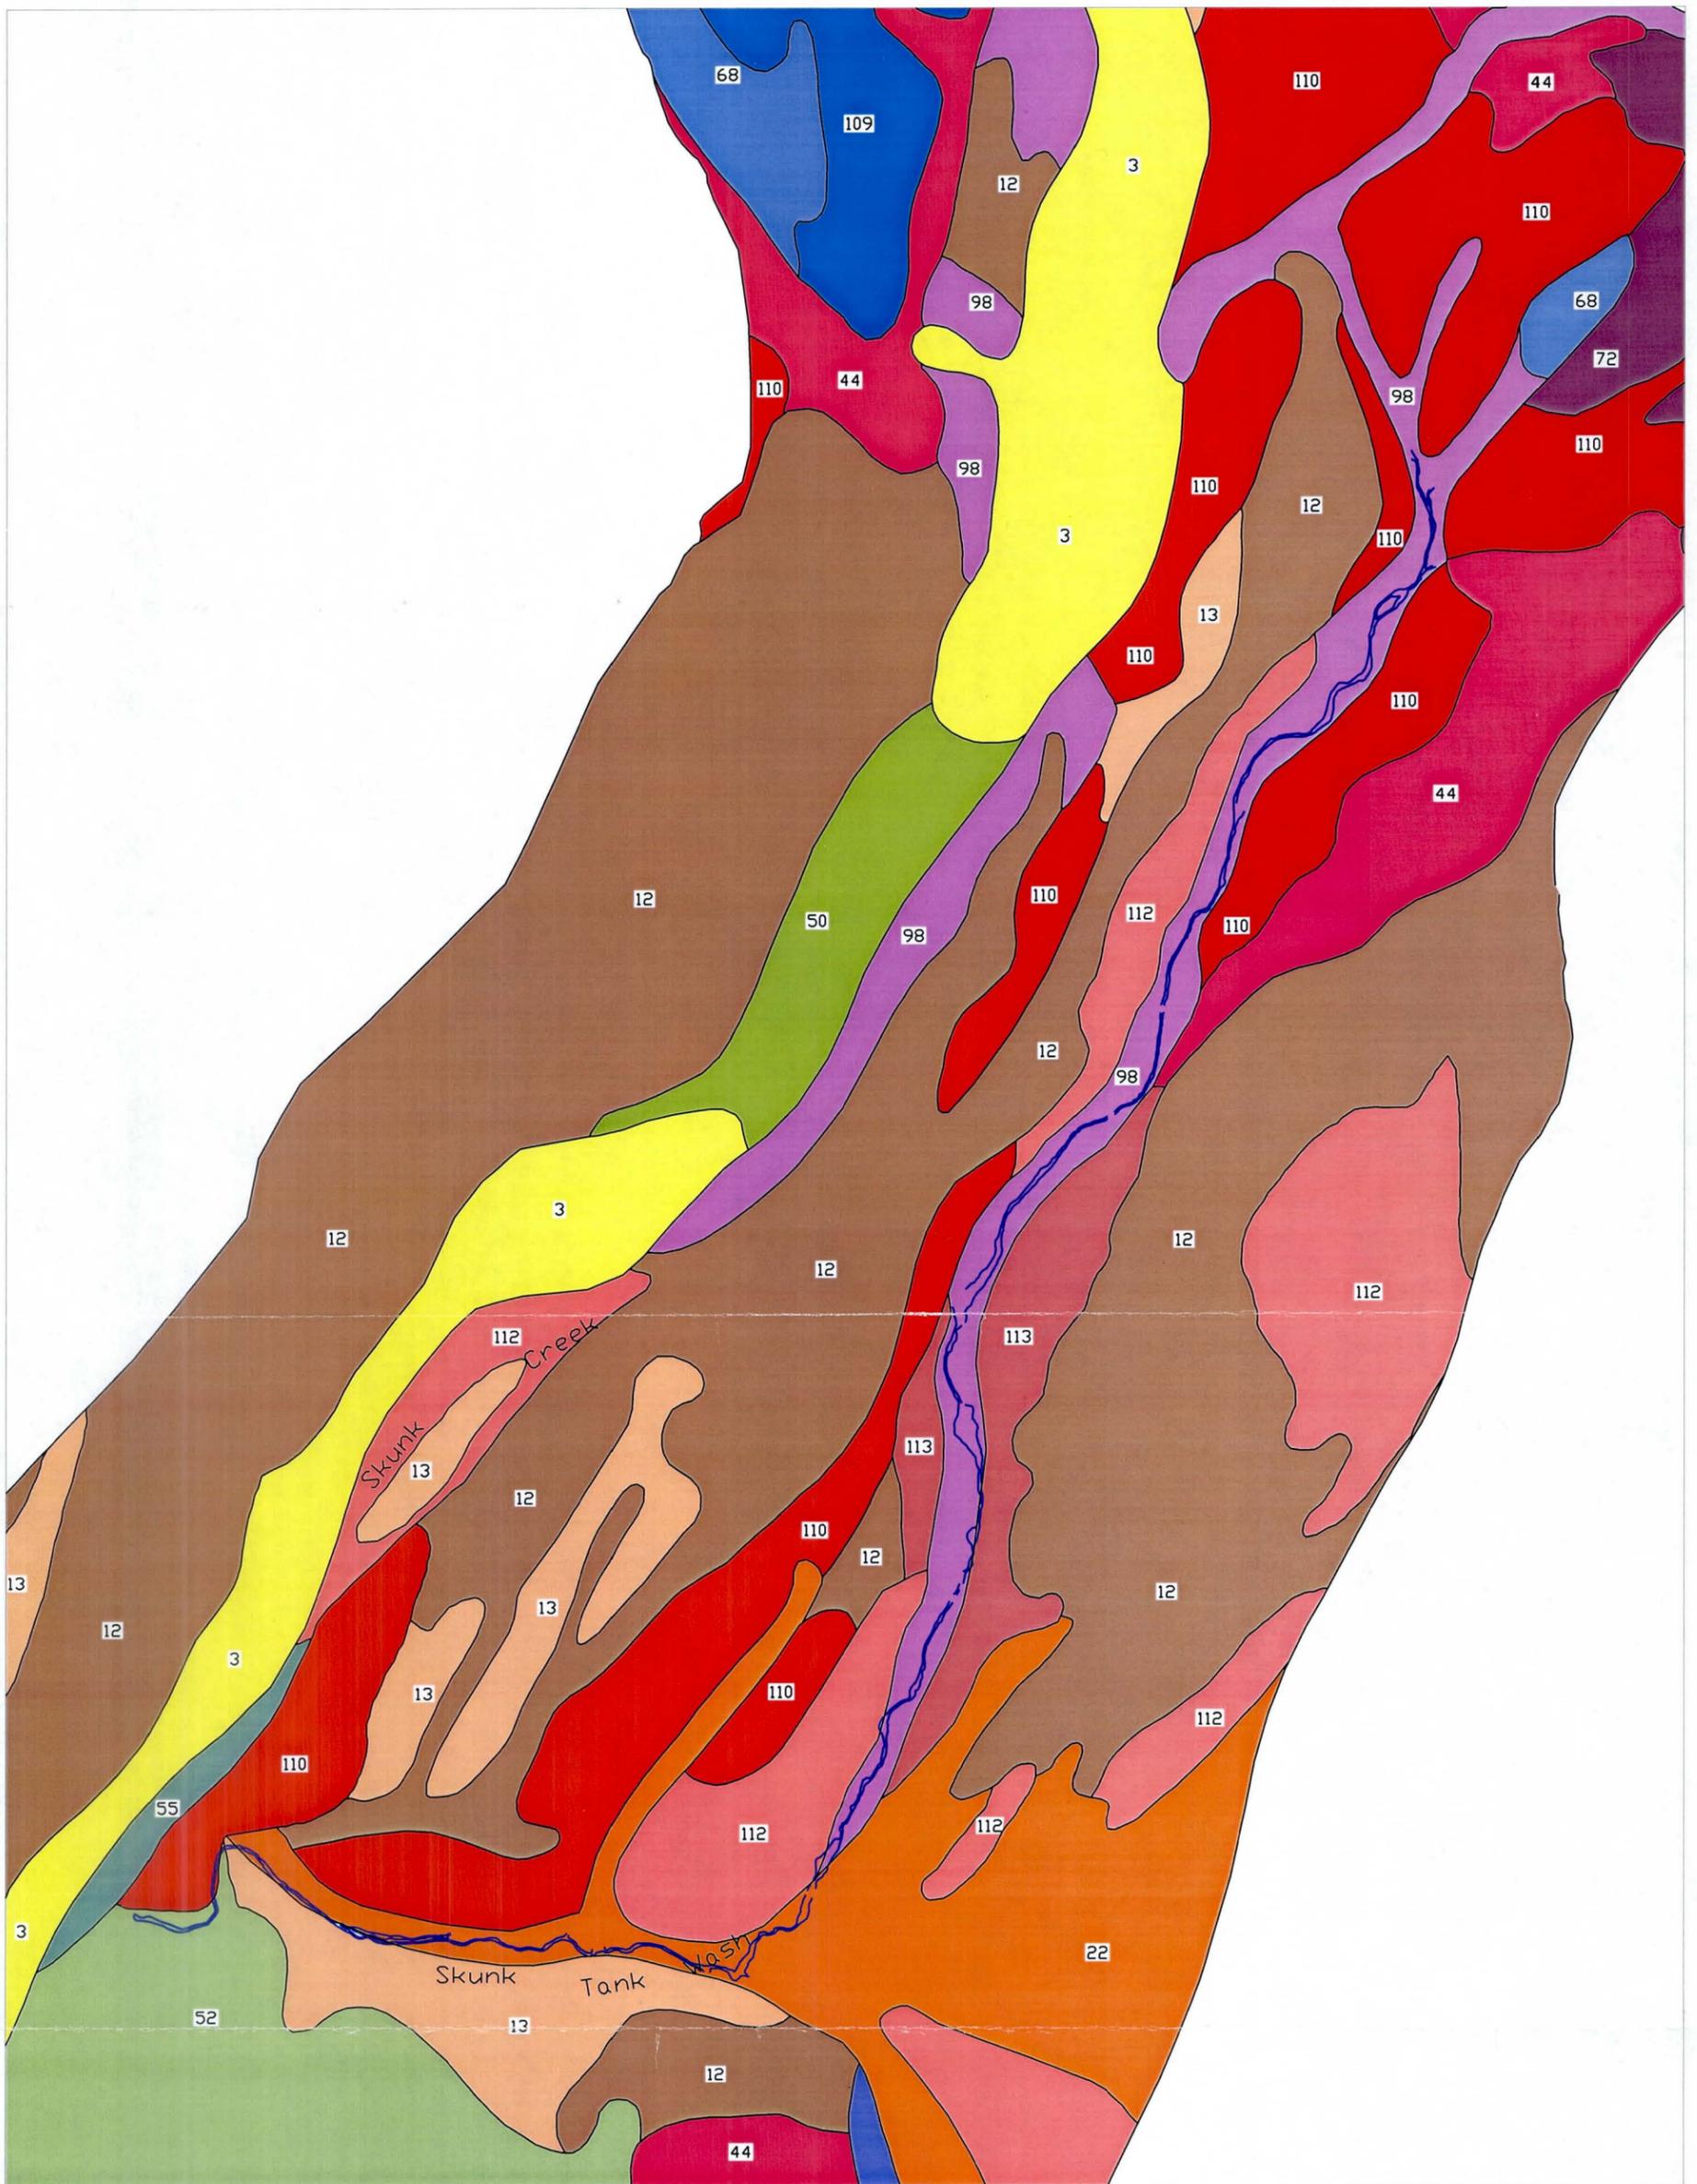
Fig. 27. Soil Distribution Along Skunk Tank Wash, AZ

Interpretation of detailed soils maps. Detailed soils mapping of the study area is available from the Soil Conservation Service (SCS).¹ Brief descriptions of the mapped soil units near Skunk Tank Wash are provided in Tables 3 to 5. Engineering characteristics of the soils are listed in Table 5. Note that all of the soil units in the study area were designated as fan terraces, and none were considered representative of drainageways or floodplains. In addition, as shown in Table 4, the soil classes for the units near Skunk Tank Wash are typically associated with surfaces of early Holocene age (7-11 ka²). The relationship of surface age with soil class is supported by the presence of clay and caliche in the soil profiles as noted in Table 4. The portion of the SCS soils map near Skunk Tank Wash is reproduced in Figure 27.
