# Harquahala Flood Retarding Structure Individual Structure Assessment Report

Prepared for  
Flood Control District of Maricopa County  
On-Call Phase I Assessment  
FGD 2003C015  
PCN 050.03.01  
October 2005

**KIMLEY-HORN AND ASSOCIATES, INC.  
7878 NORTH 16<sup>TH</sup> STREET, SUITE 300  
PHOENIX, ARIZONA 85020  
(602) 944-5500**

**OCTOBER 2005**

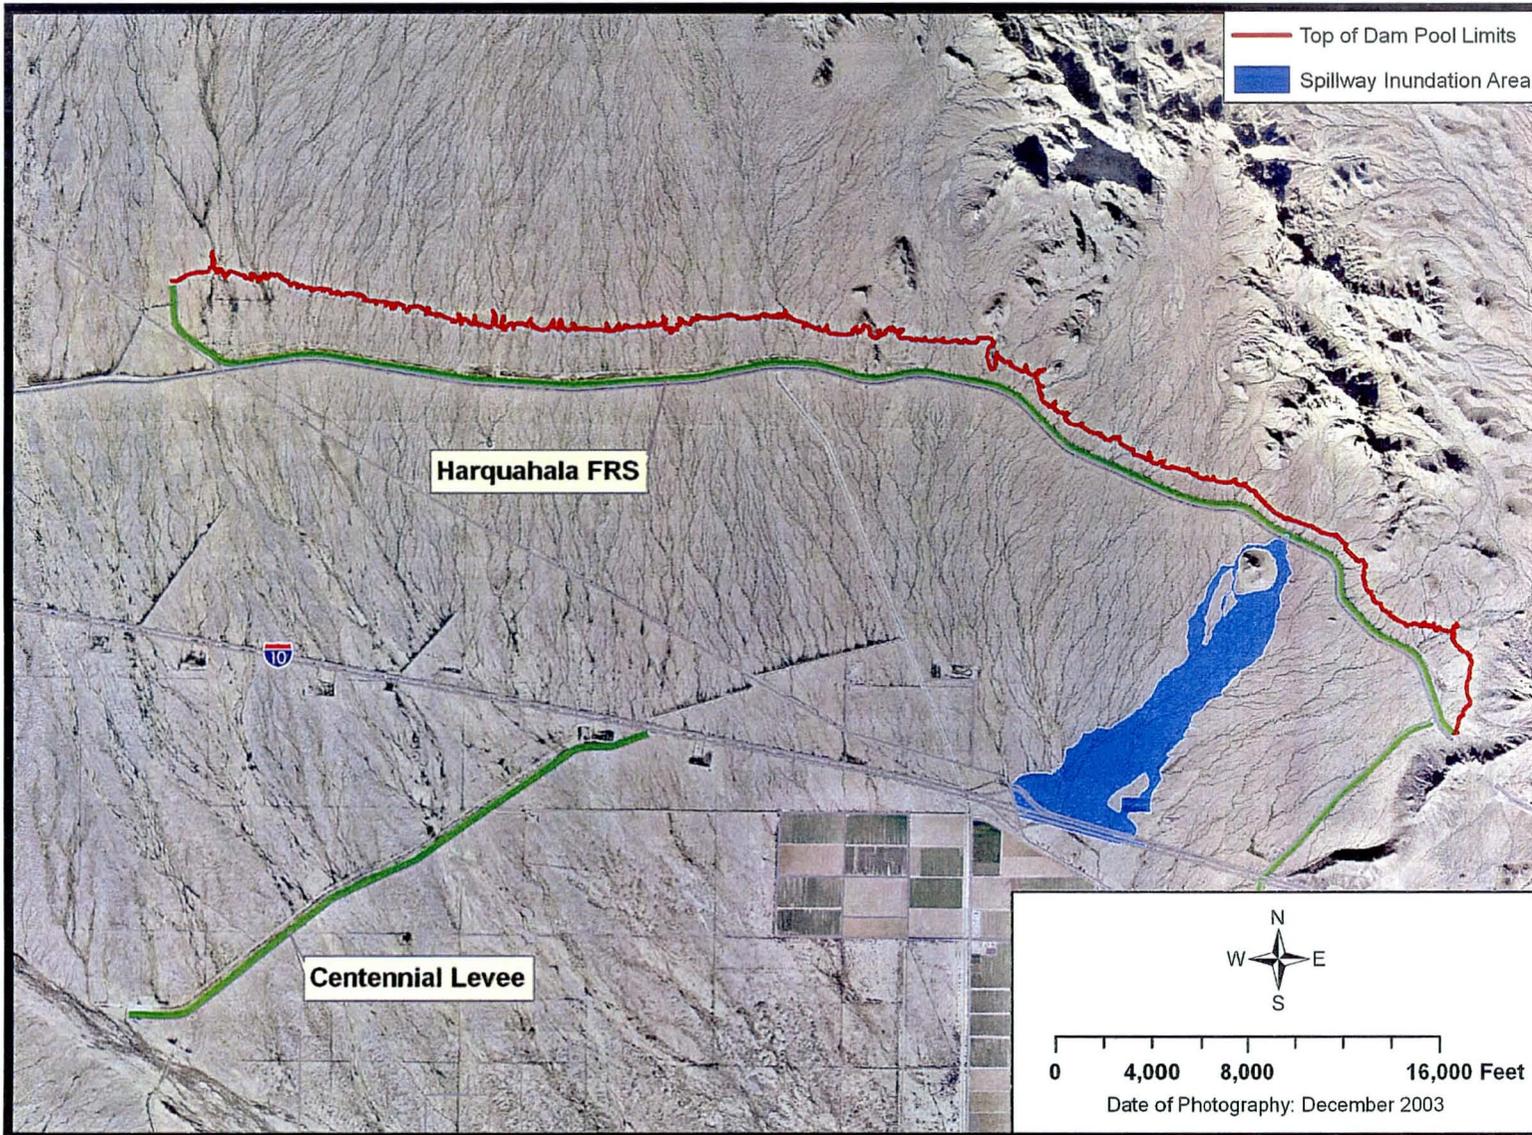
Figure 2. Harquahala FRS Spillway Inundation Map.  
KHA Project No. 091131010

**3.3.2. Spillway Inundation Study.** An emergency spillway delineation study was completed for the Harquahala FRS in June 1998 by Dibble and Associates (Dibble, 1998). Spillway inundation routing is provided for the PMF discharge through the emergency spillway of 15,000 cfs, the 2/3 PMF of 10,000 cfs, and 1/3 PMF of 5,000 cfs. The study extends from the emergency spillway to Interstate-10, which is approximately 2.8 miles downstream of the emergency spillway structure. The discharges, mapping, and a Digital Terrain Model used to develop the hydraulic and topographic information for the water-surface profile models were provided to Dibble by the District. The study was completed using the Corps of Engineers HEC-RAS steady-state one-dimensional analysis program. **Figure 2 (Figures Appendix)** illustrates the emergency spillway inundation limits from the Harquahala FRS to I-10.

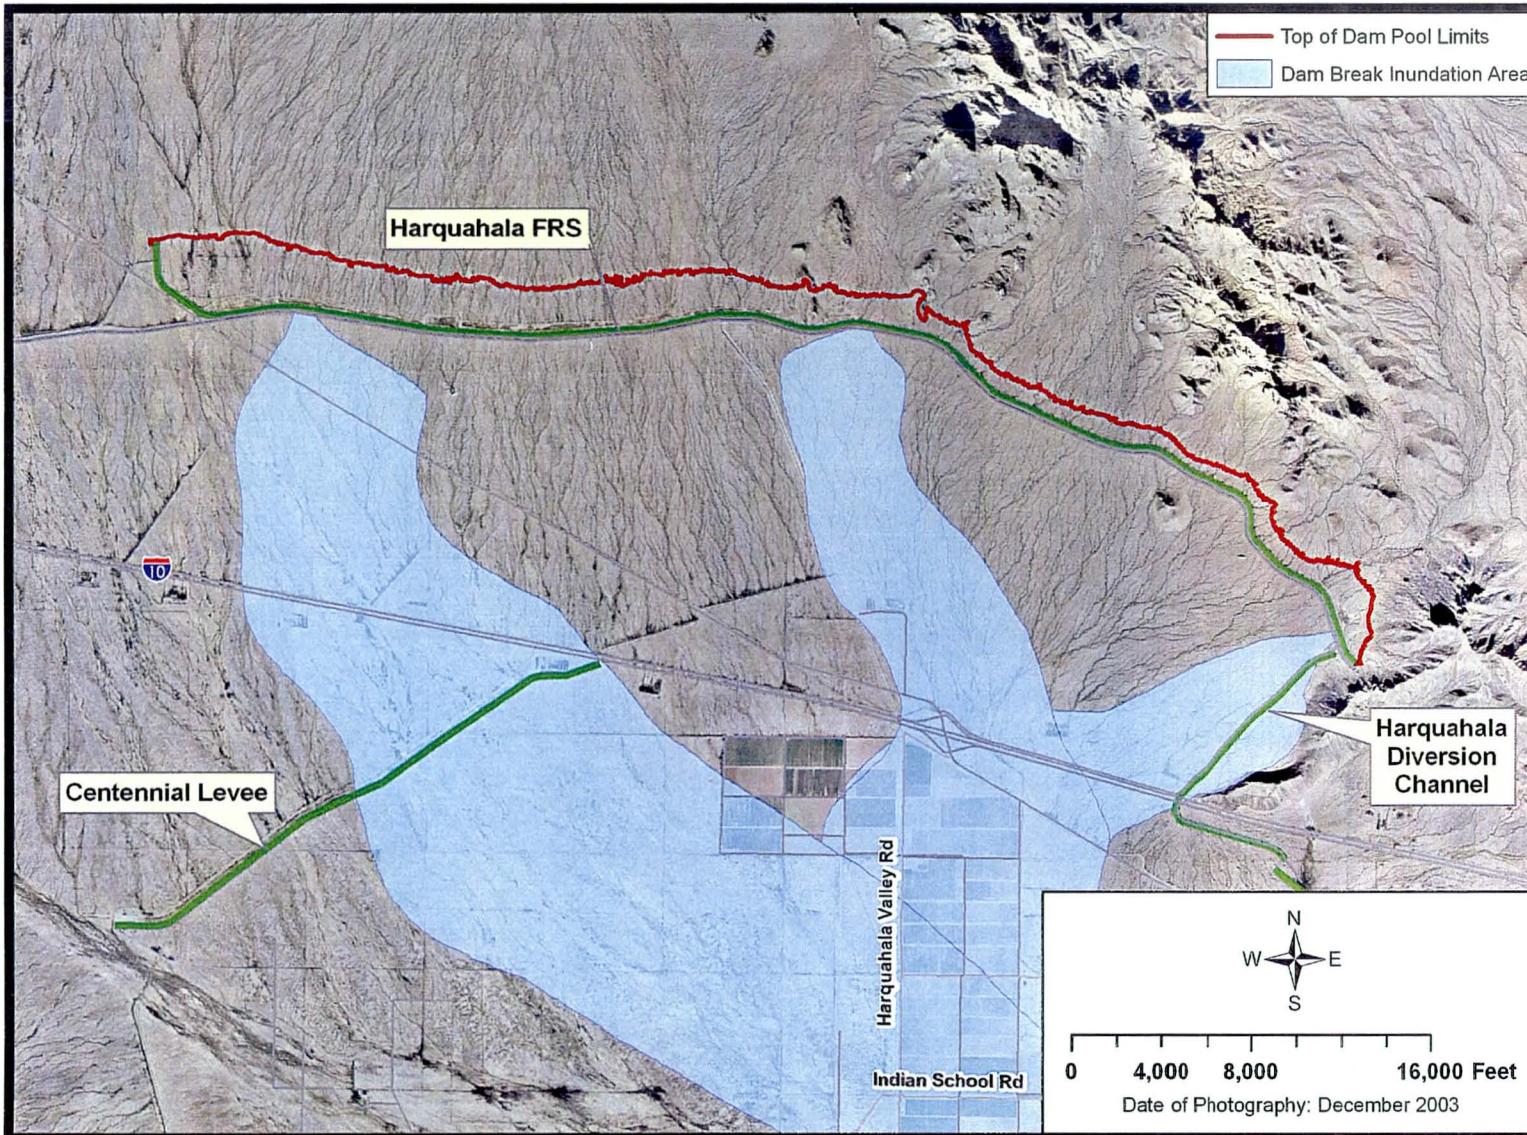
Figure 3. Harquahala FRS Dambreak Inundation Zone Inundation Area Map.  
KHA Project No. 091131010

The emergency spillway and dambreak inundation mapping for Harquahala FRS is provided in **Figure 2** and **Figure 3** in **Appendix Figures**, respectively. Note that the dambreak mapping does not have shading (that indicates areas of potential inundation) in between the west, middle, and east dambreak locations. Since a dambreak could potentially occur anywhere along Harquahala FRS, Kimley-Horn recommends that the inundation map be revised to reflect this possibility.

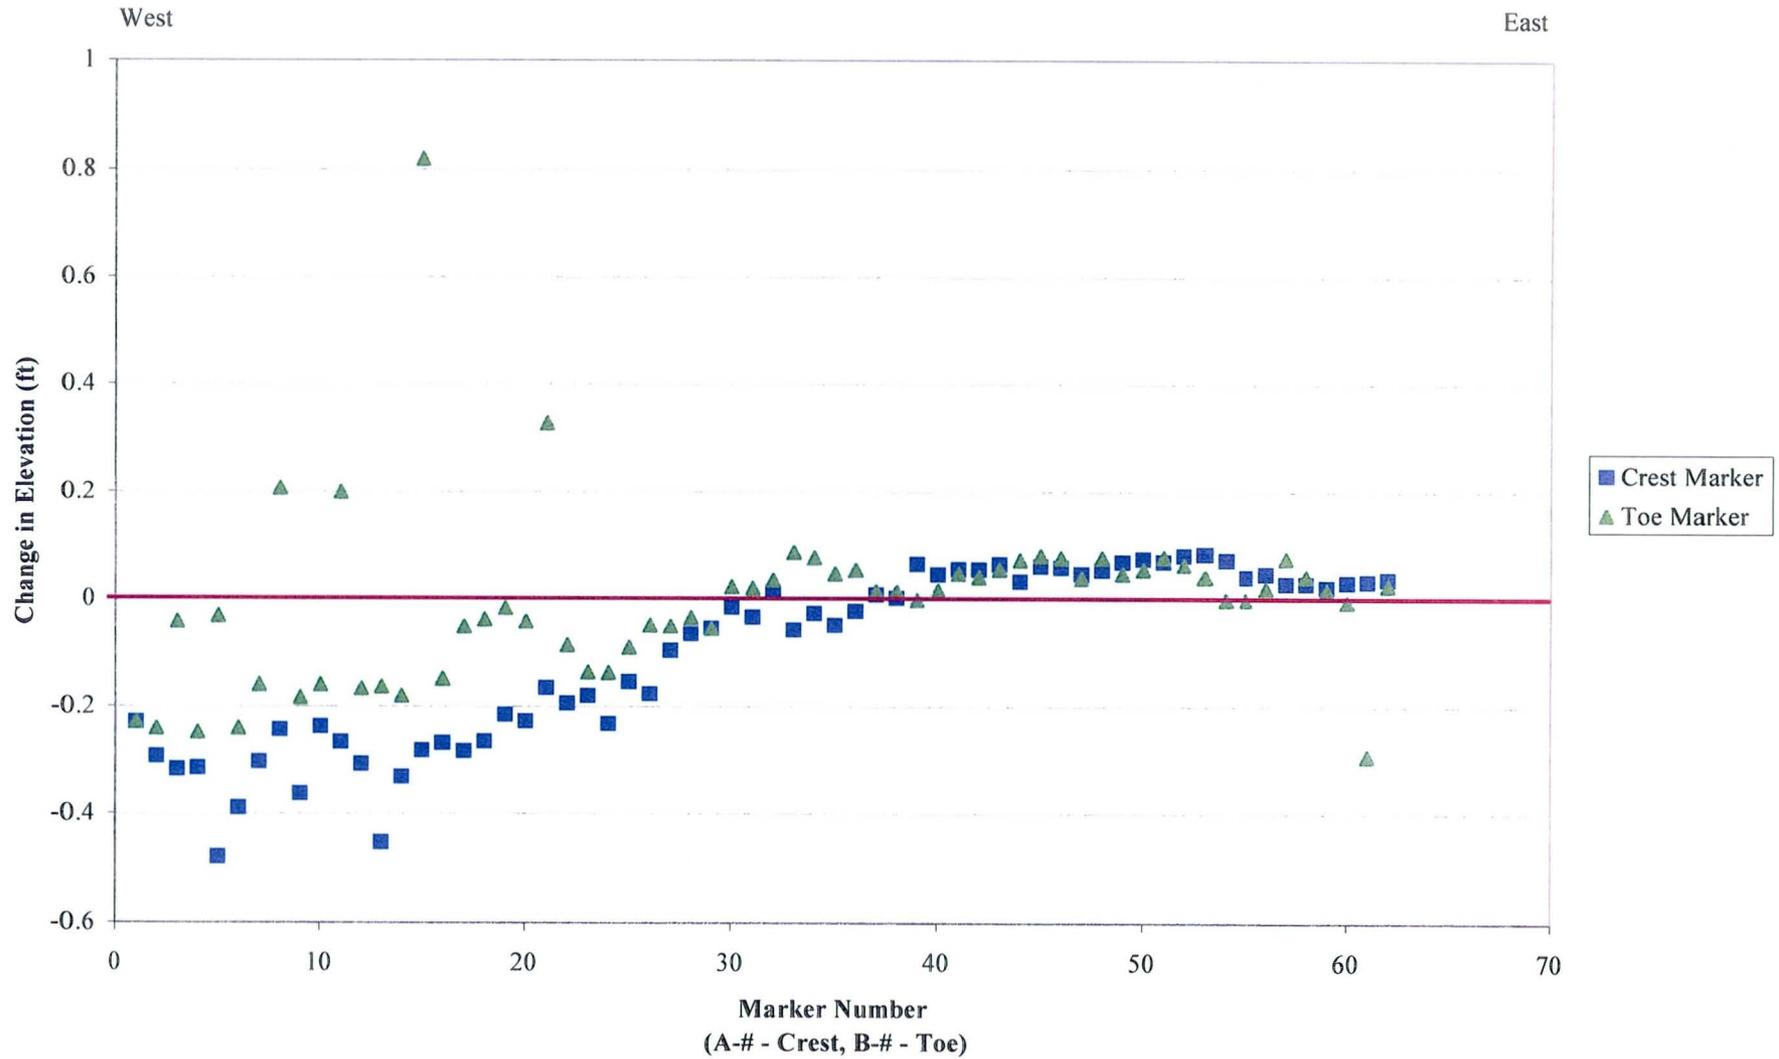
Harquahala F.R.S.  
Geological Consultants Project No. 2003-161  
Figure 6

Historic National Geodetic Survey (NGS) level line data is not available in the vicinity of the Harquahala FRS. However, recent historic subsidence-settlement is available from the Flood Control District of Maricopa County using crest and toe monument elevations recorded between 1984 and 2003. A summary of the settlement that has occurred along the dam is shown in **Table 1 (Appendix A)** (FCDMC, 2004). The data that are plotted in **Figure 6 (Appendix A)** may be used as an indicator of the relative recent land subsidence that may have occurred or is occurring in the project area. As can be seen in **Figure 6 (Appendix A)**, the change in elevation is greatest along Reach 2 of the Harquahala FRS where there is an apparent thickening of the basin fill sediments beyond the area where the buried bedrock surface drops-off from the edge of the pediment (Figure 8).

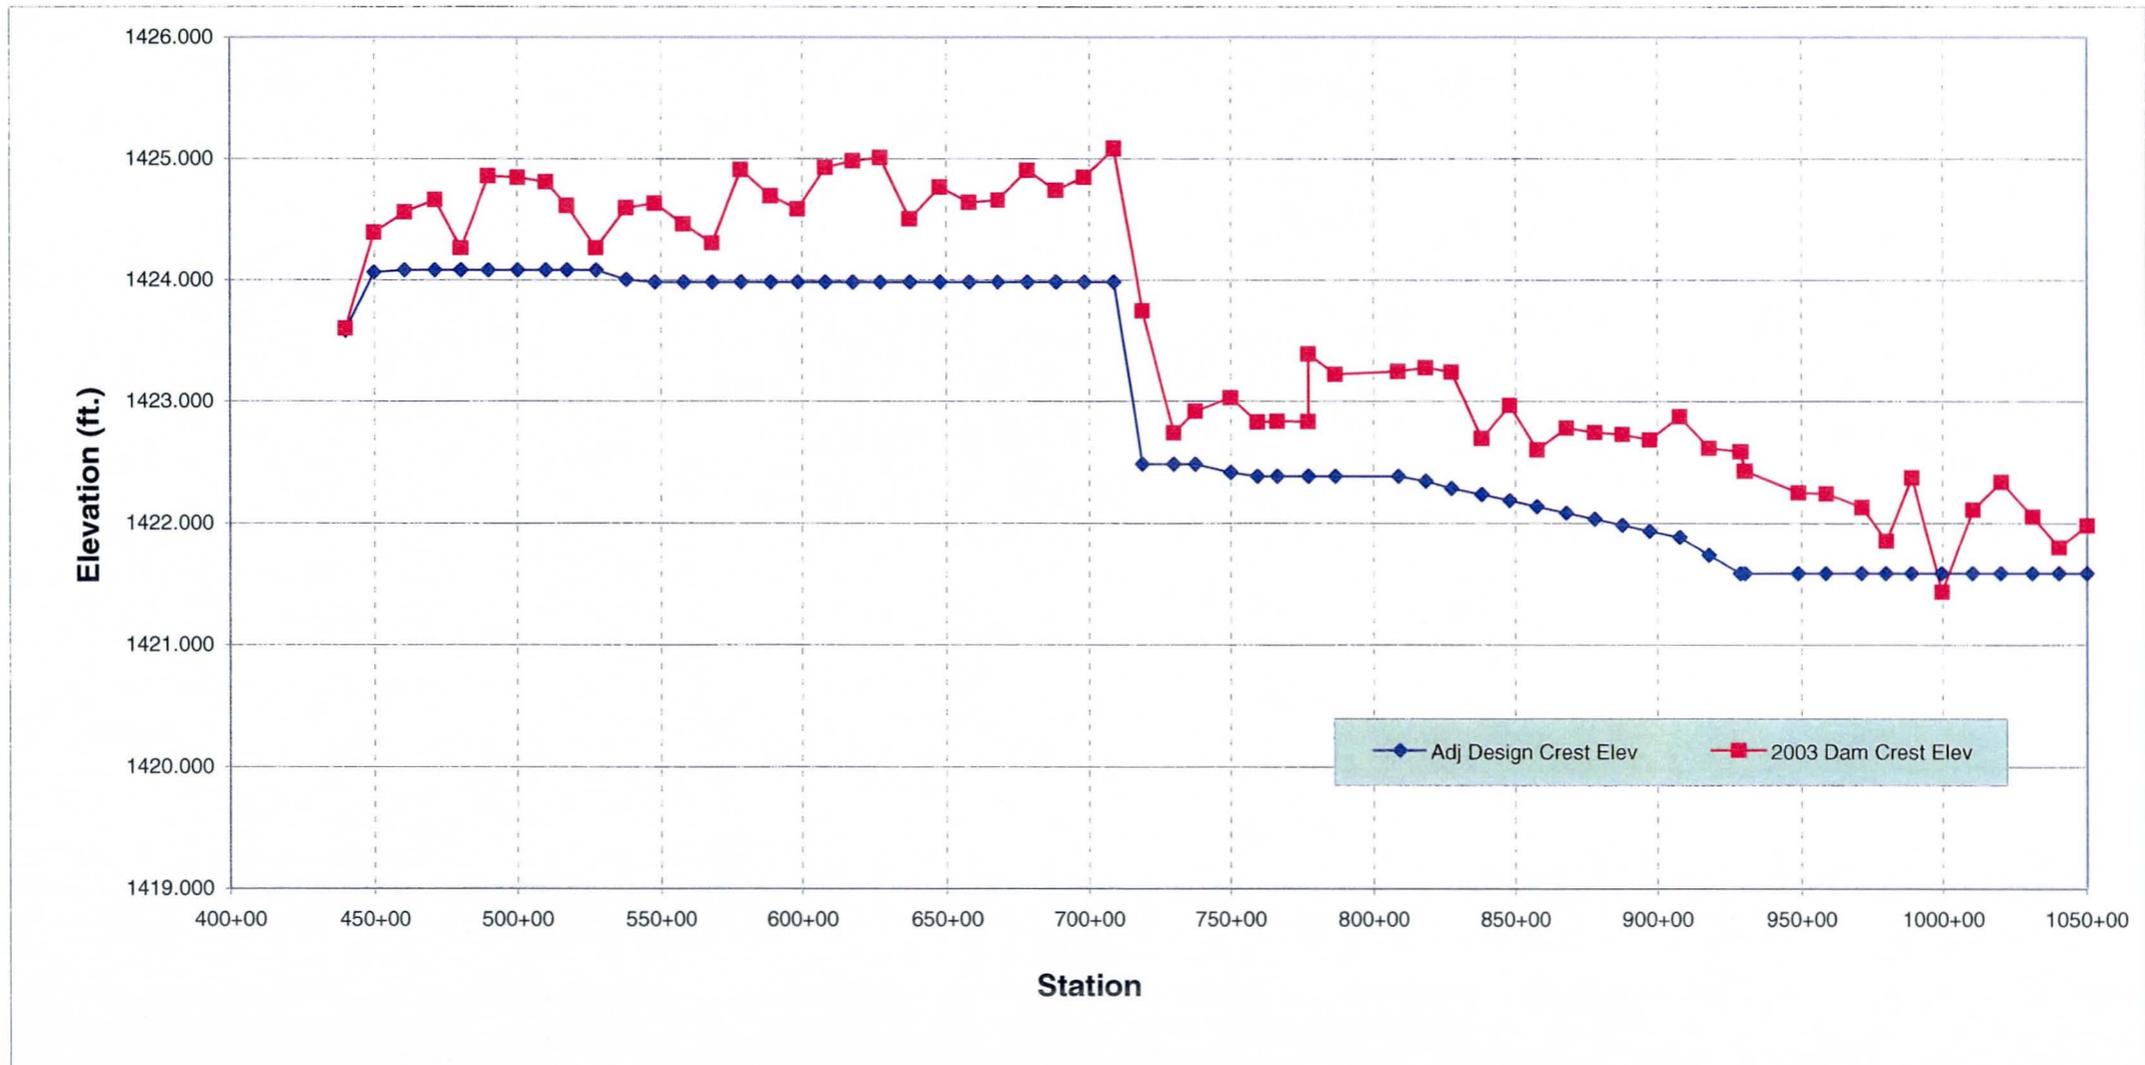
Figure 1-1  
Dam Crest Elevation Comparison Chart

**Figure 1-1** compares the Adjusted Design Crest Elevation and the year-2003 survey data listed in **Table 1**.

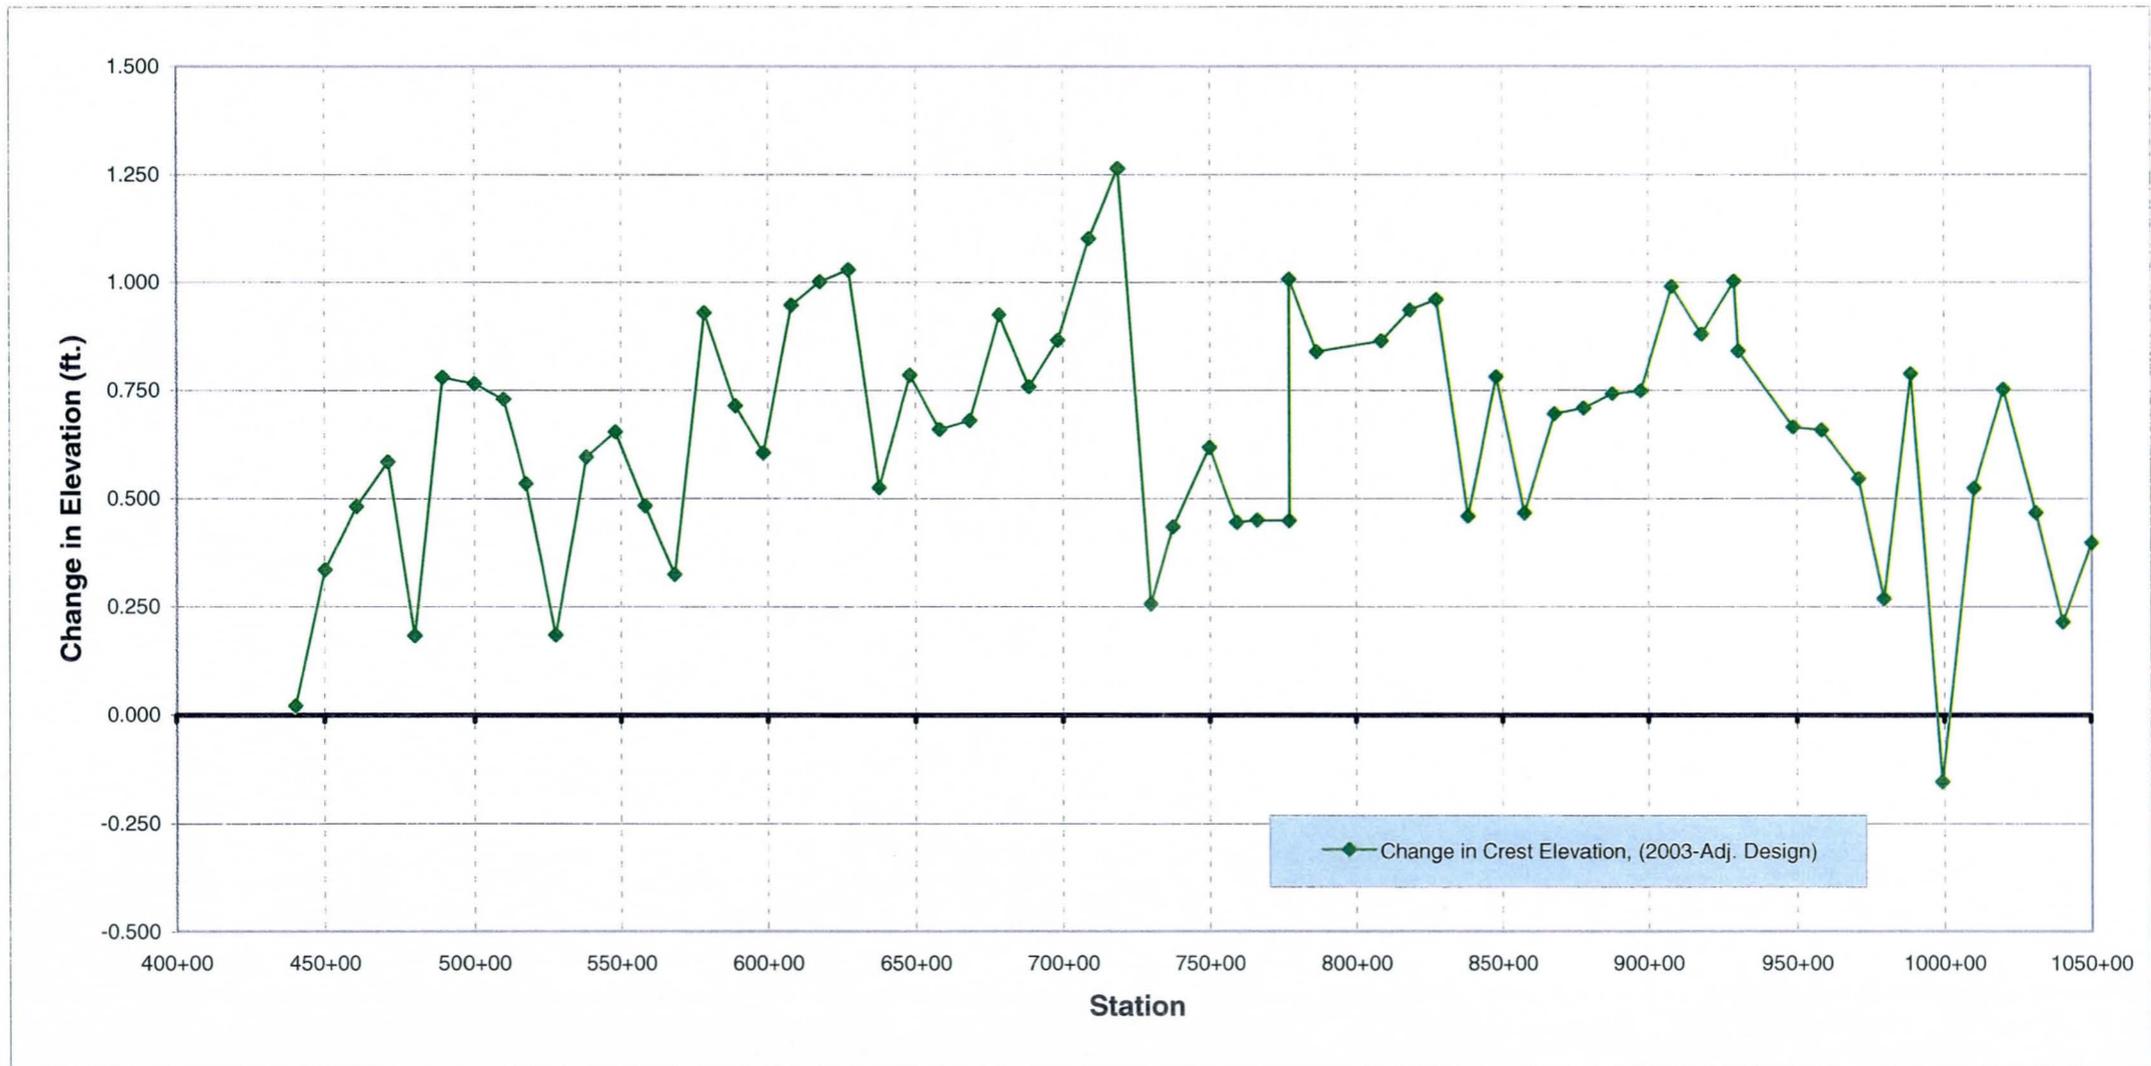
Figure 1-2  
Change in Dam Crest Elevation Chart

**Figure 1-2** displays the relative change in Crest Elevation between the Adjusted Design Crest Elevation and the year-2003 survey crest elevations listed in **Table 1**.

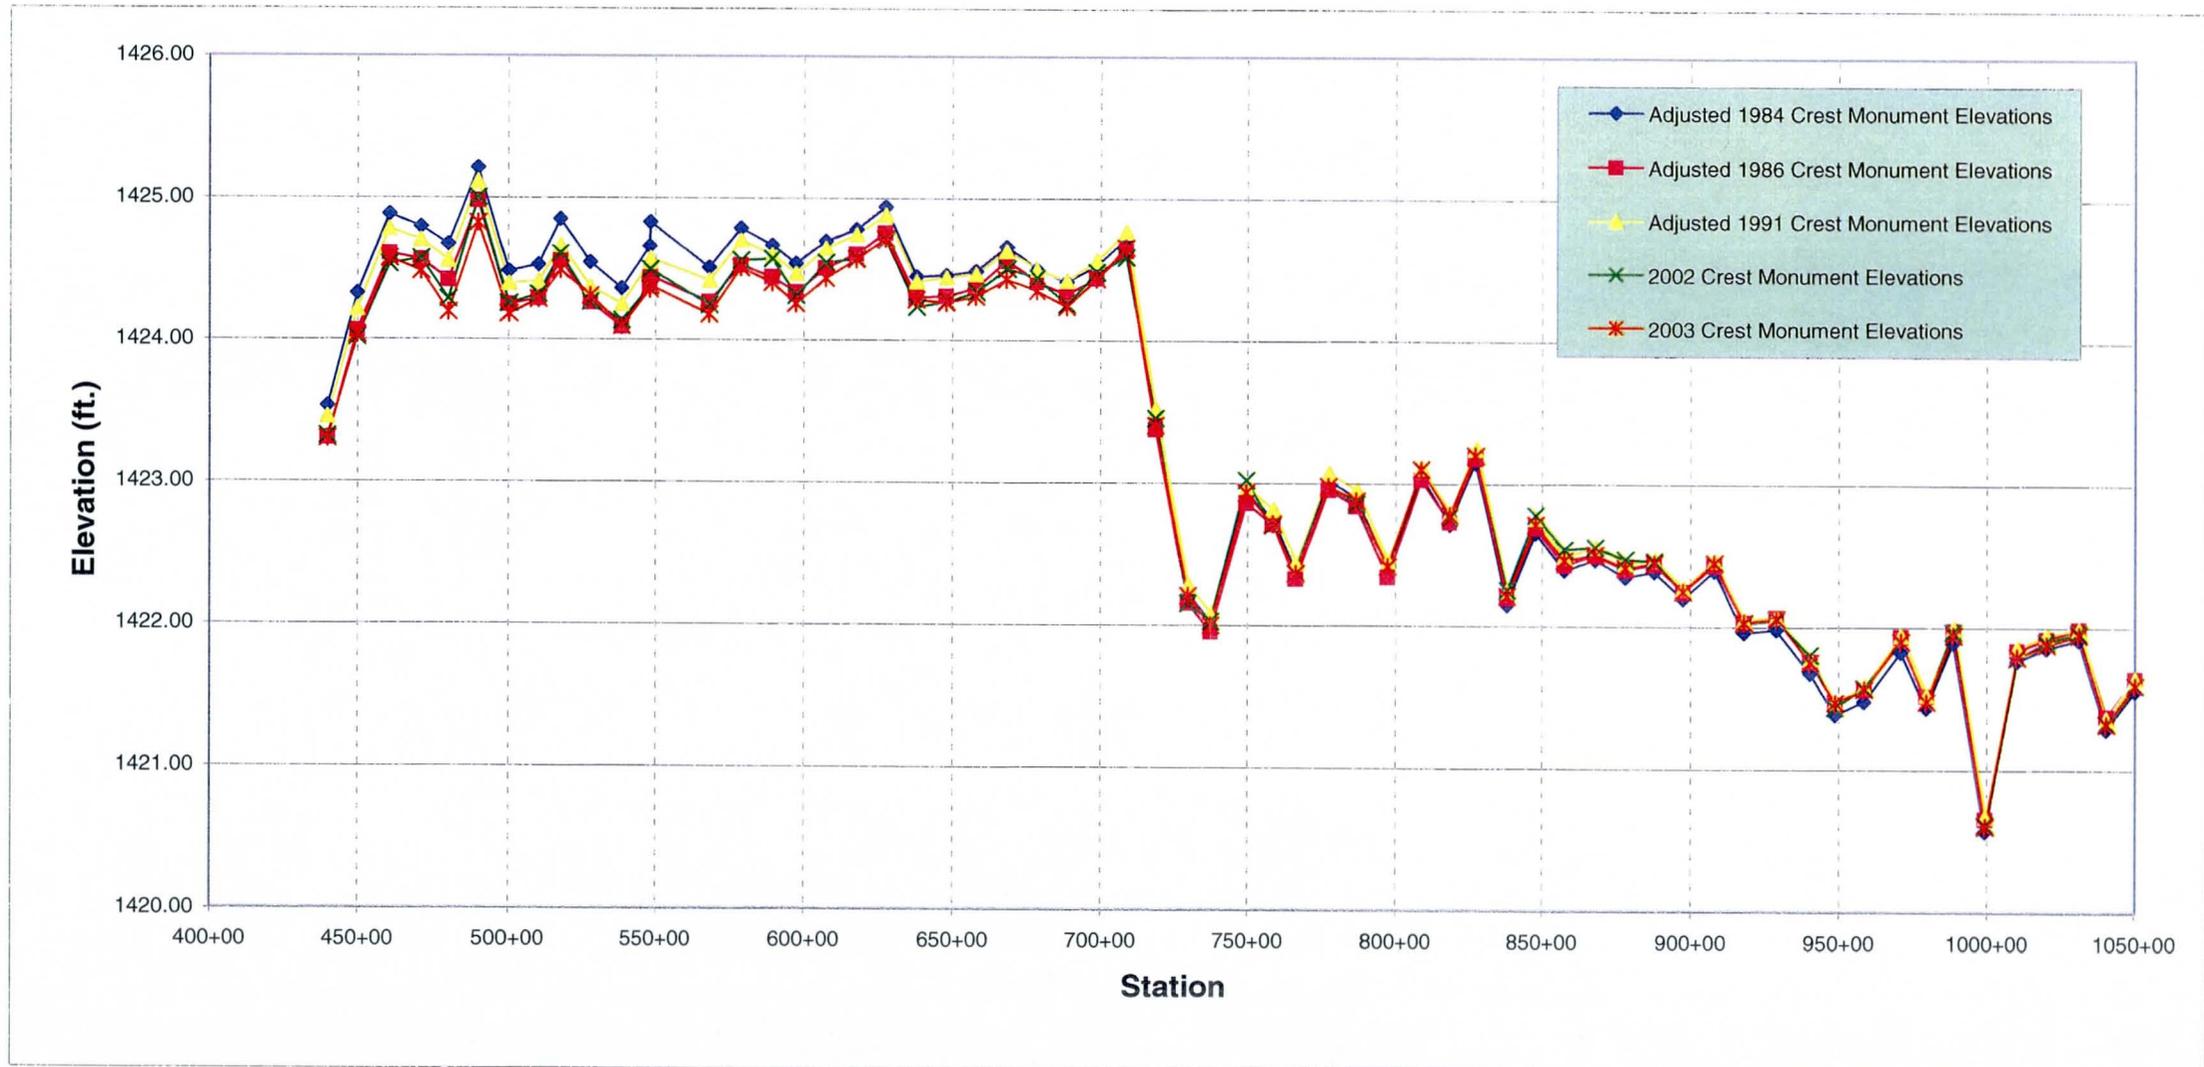
Figure 2-1  
Crest Settlement Monuments' Elevation Chart

**Figure 2-1** compares Crest Settlement Monument Elevations for years 1984, 1986, 1991, 2002, and 2003. Elevations for surveys prior to year-2002 are adjusted as noted.

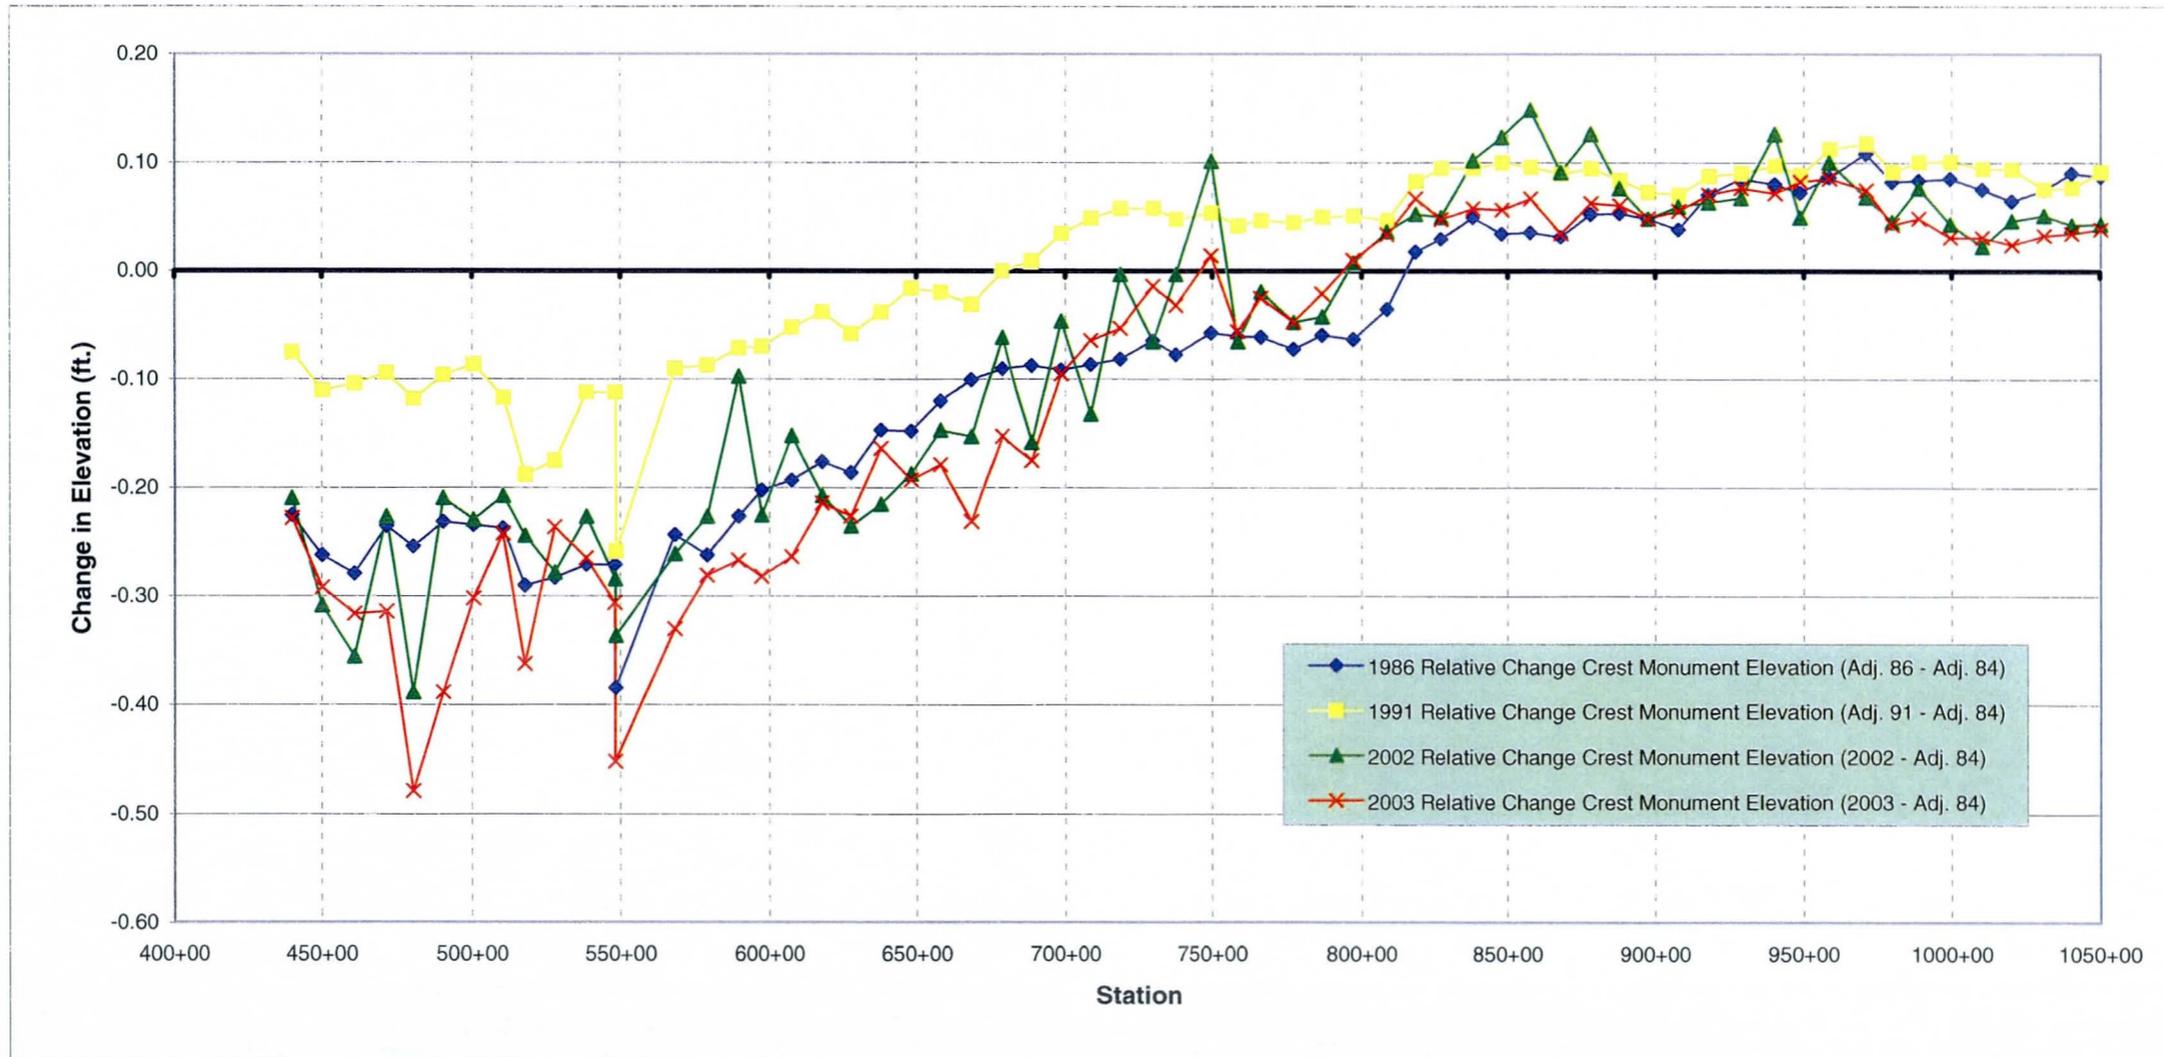
Figure 3-1  
Relative Change in Crest Monument Elevation Chart, 1984 Survey Data Baseline Elevation Reference

Figure 3-1 illustrates the relative change in Settlement monuments as calculated in Table 3.

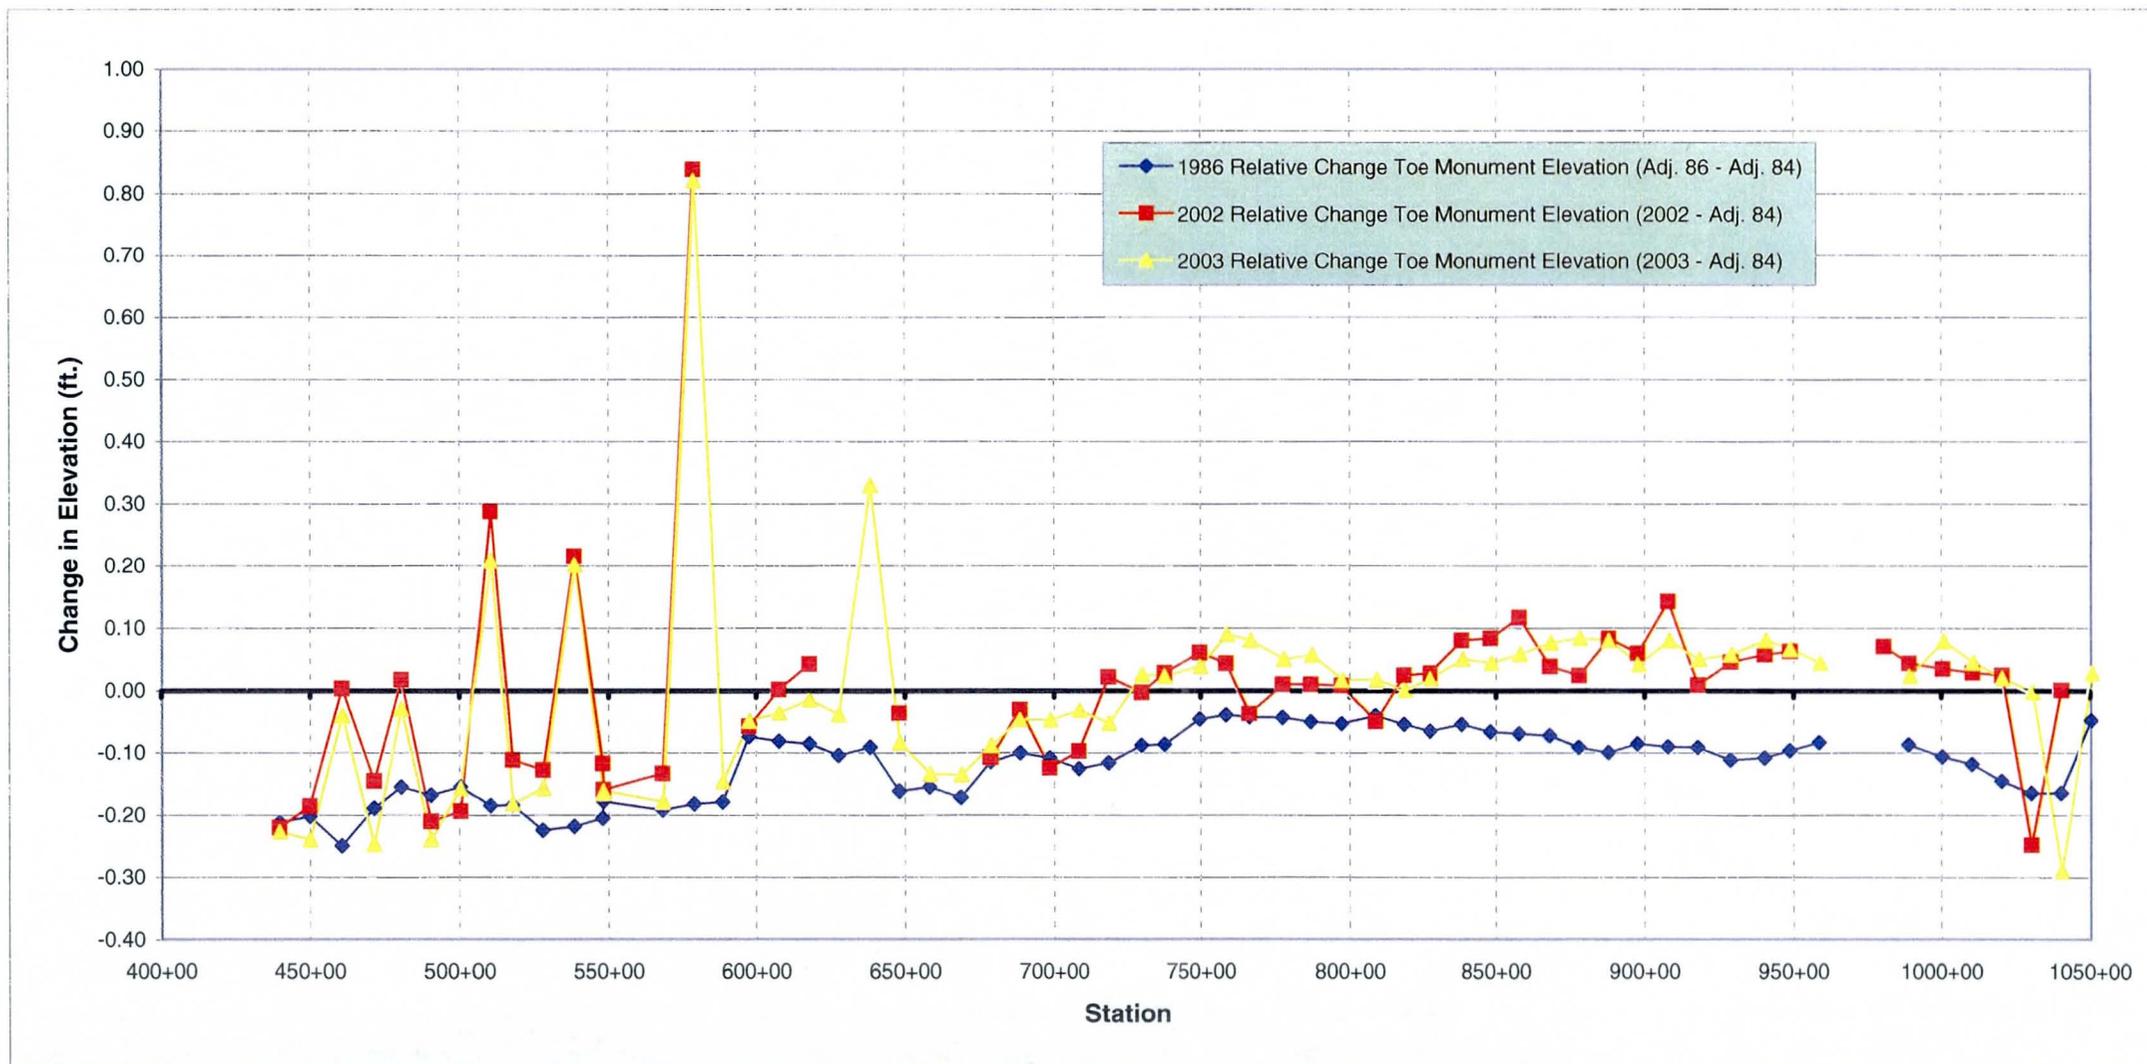
Figure 4-1  
Relative Change in Toe Monument Elevation Chart, 1984 Survey Data Baseline Elevation Reference

**Figure 4-1** illustrates the relative change in Settlement monuments as calculated in **Table 4**.

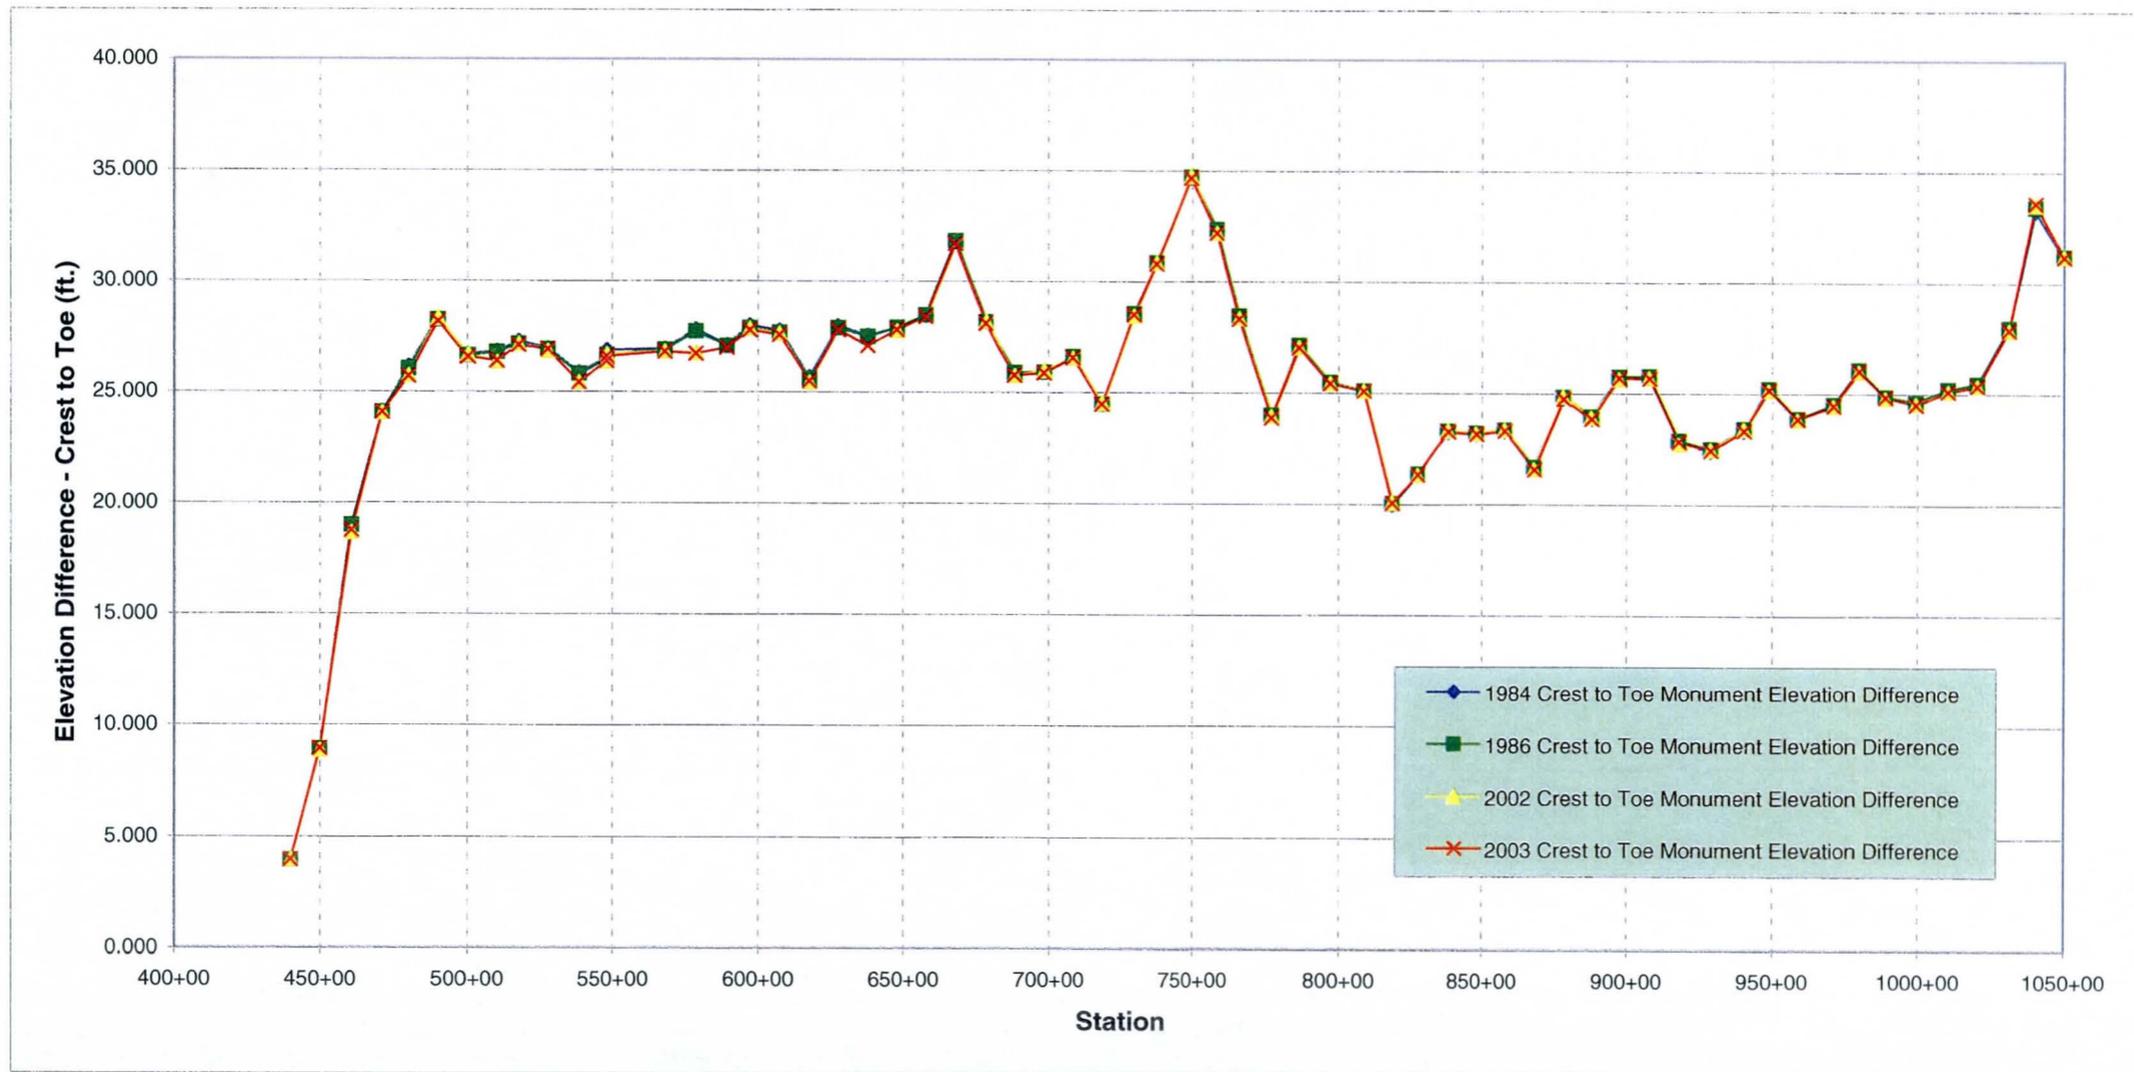
Figure 5-1  
Elevation Difference Between Crest Settlement Monument and Corresponding Toe Settlement Monument

Figure 5-1 plots the elevation difference between crest and corresponding toe monuments at each station.

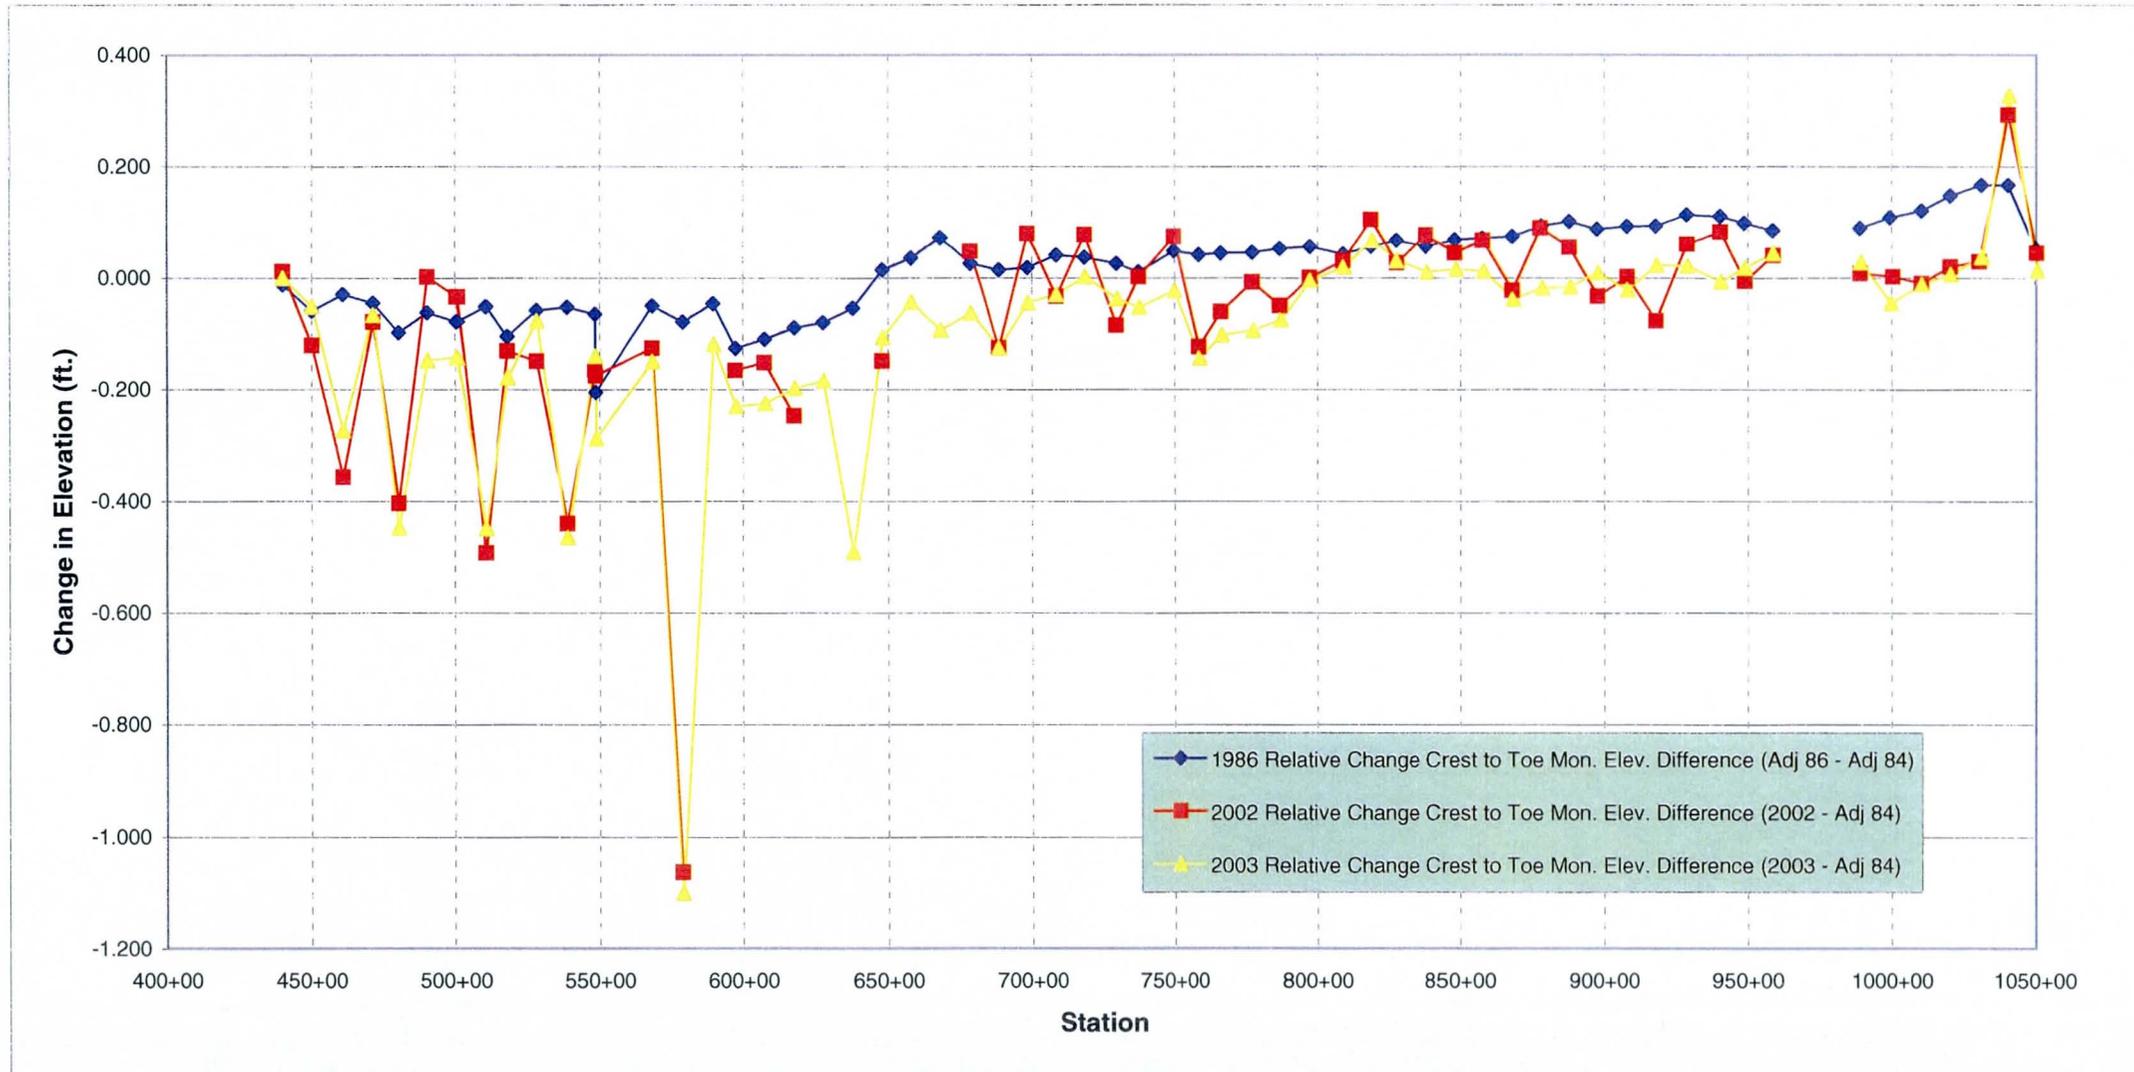
Figure 6-1  
Relative Change in Elevation Difference Between Associated Crest and Toe Settlement Monument Pairs

**Figure 6-1** plots the relative change in differential elevation with the 1984 survey data used as a baseline.
