# Harquahala Flood Retarding Structure Individual Structure Assessment Report

Prepared for  
Flood Control District of Maricopa County  
On-Call Phase I Assessment  
FGD 2003C015  
PCN 050.03.01  
October 2005

**KIMLEY-HORN AND ASSOCIATES, INC.  
7878 NORTH 16<sup>TH</sup> STREET, SUITE 300  
PHOENIX, ARIZONA 85020  
(602) 944-5500**

**OCTOBER 2005**

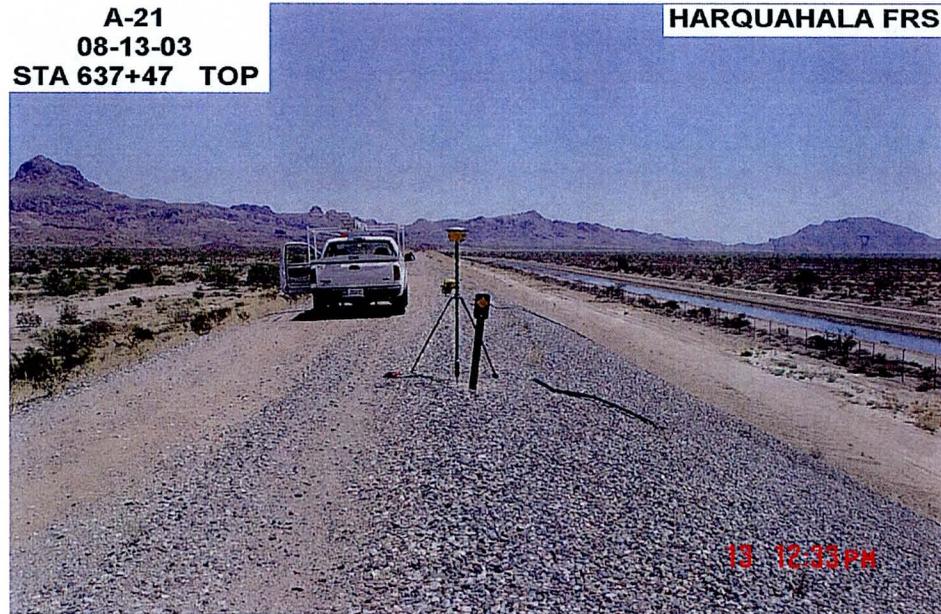
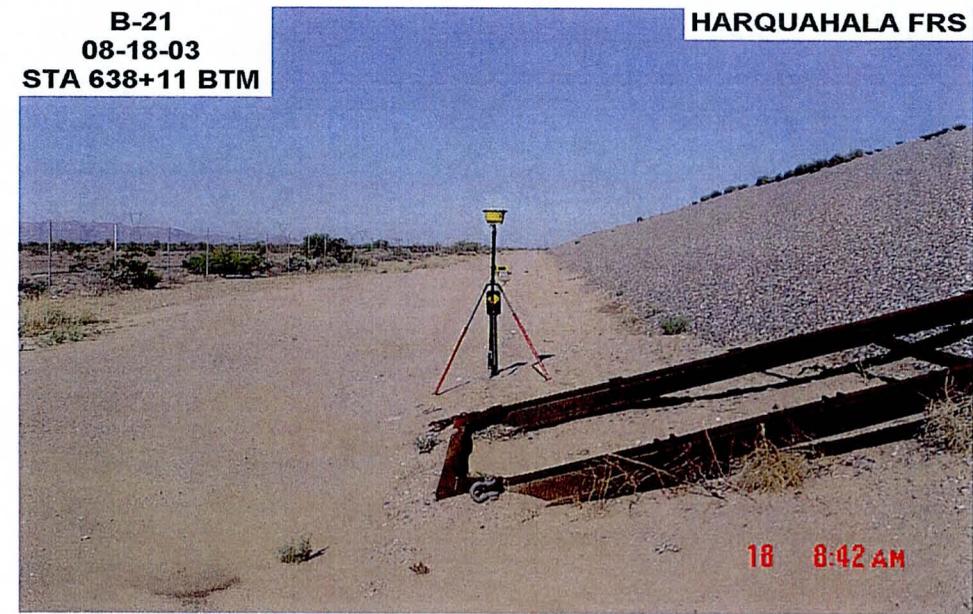
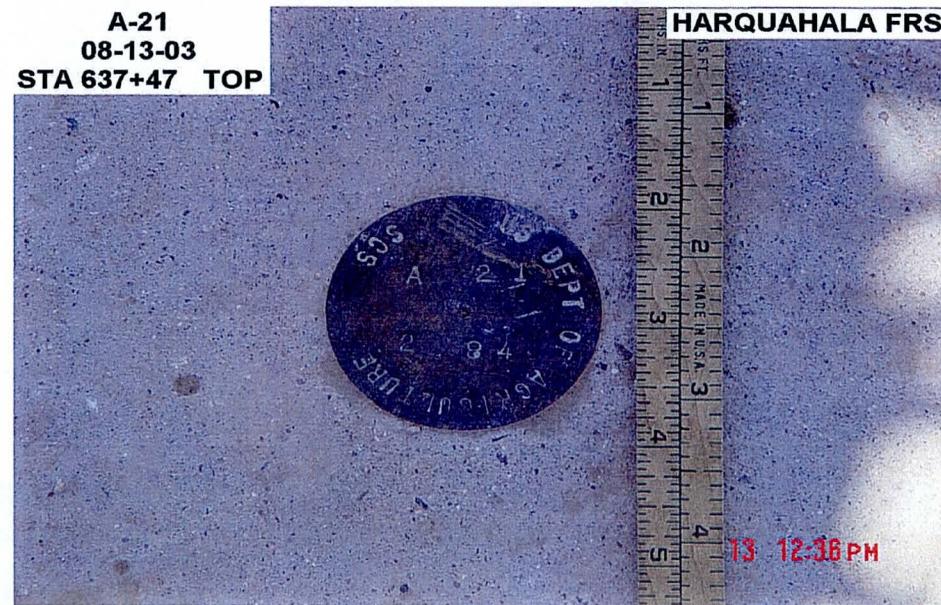
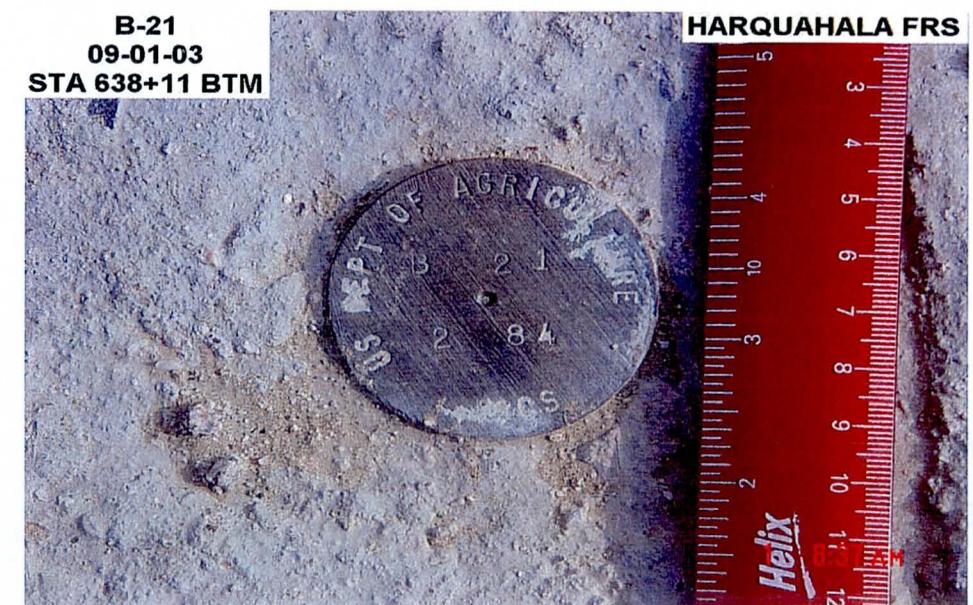
Figure 8-1 - 2003 Photos of Crest A-21 and Toe B-21 Subsidence Caps

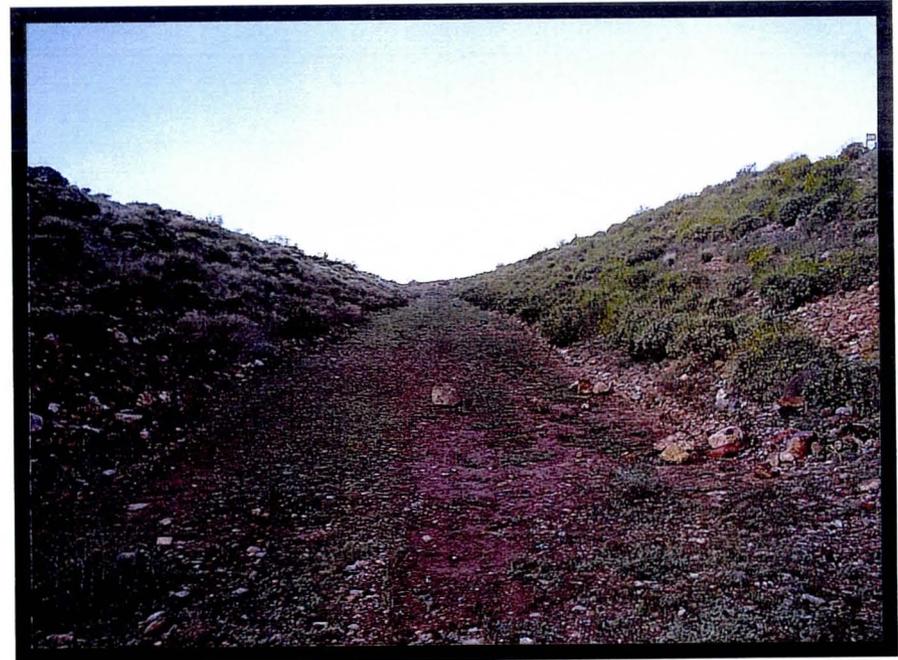
Photo 2 – Harquahala FRS Floodway: At principal outlet structure, looking downstream.

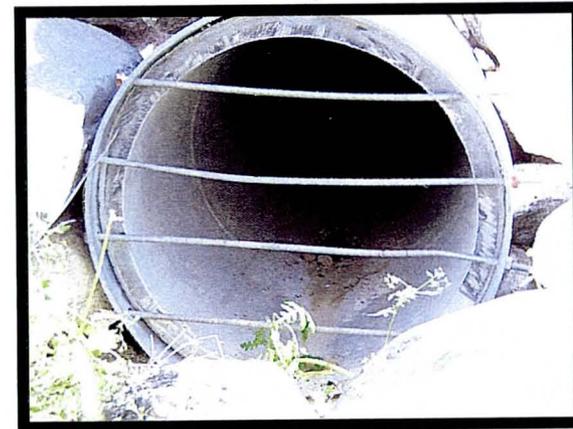
Photo 2a. Toe drain outlet at principal spillway outlet structure.

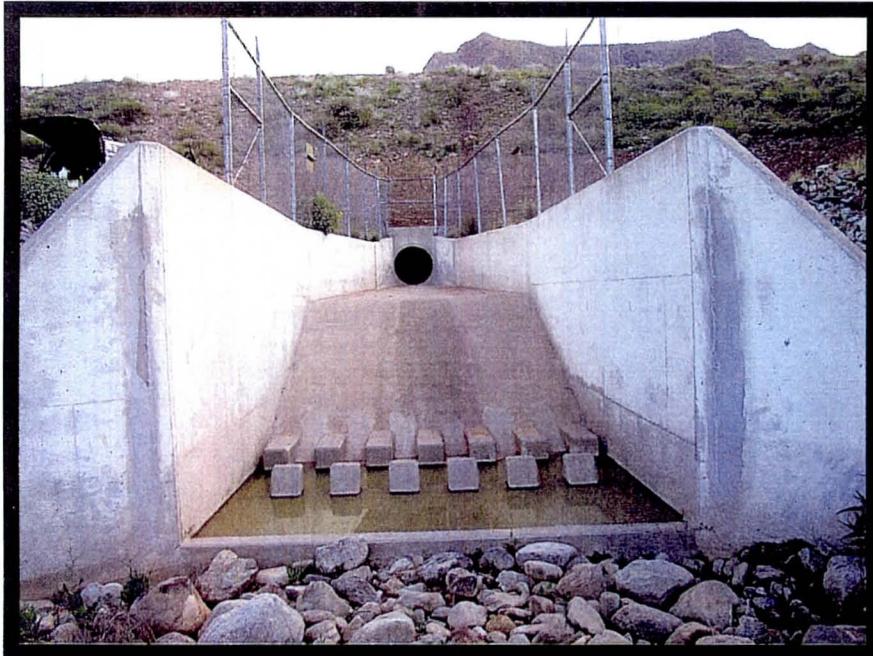
Photo 3 – Principal Outlet Structure and Energy Dissipator.

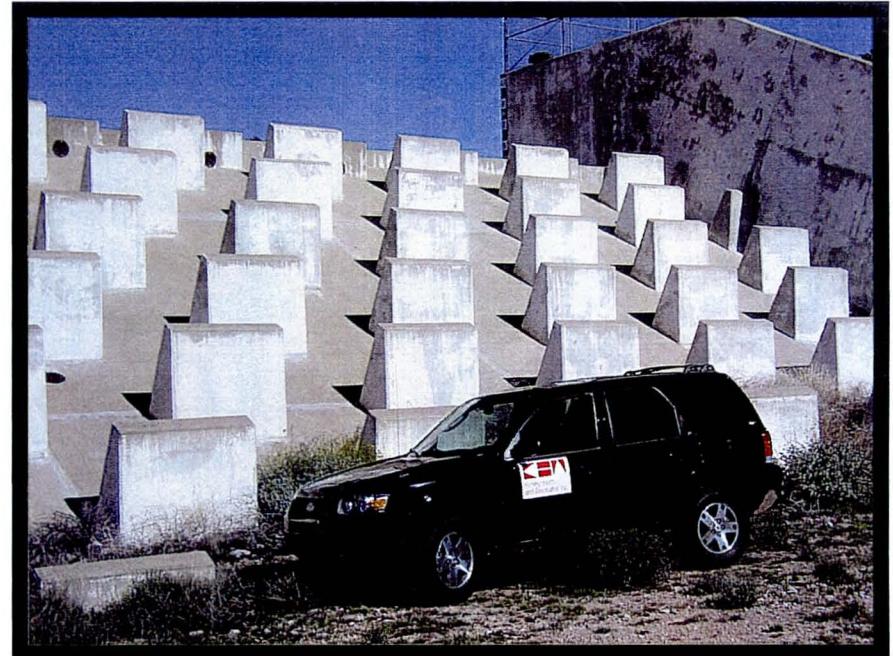
Photo 4 – Emergency Spillway (baffle block chute spillway).

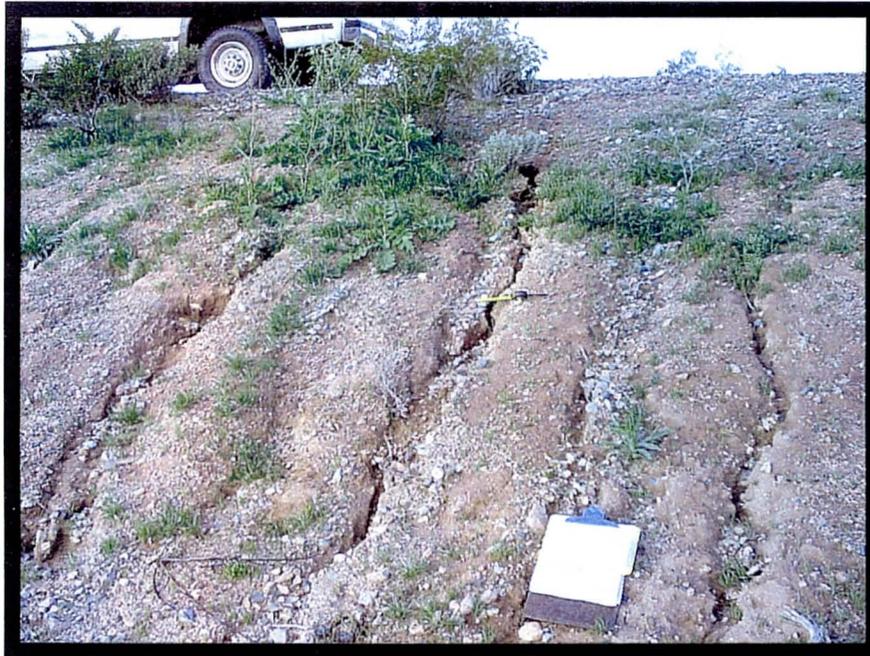
484+85	U/S slope	Slope depression	2005		Slight depression in upstream slope below crest.
486+00	U/S slope	Borrow Area	2005		Head cut erosion channel into borrow excavation (stratifies gravelly silty caliche filaments and fine disseminated caliche).
487+39 to 491+13	Crest	Long.	2002	Change	Longitudinal crack wanders along the crest centerline to +/- 2- to 3-feet from centerline. Crack width in 2002 was hairline and only observed between Sta. 490+58 to 491+13. Few locations in 2003 where probe could be inserted to 30-inch. In Jan. 2004 three 1-inch diameter holes probed 12-inch at Sta. 490+79. In Nov. 2004 more obscure
490+92	Crest	Long	2005		At Station 490+92, two holes along centerline of crest, possible longitudinal crack. (Photo 7)
490+92	U/S slope	Erosion gully	2005		Rill erosion gullies.(Photo 9)

Photo 9 – Upstream Slope, Reach 2: Typical section of erosion gullies ( 2- to 3-inches deep).

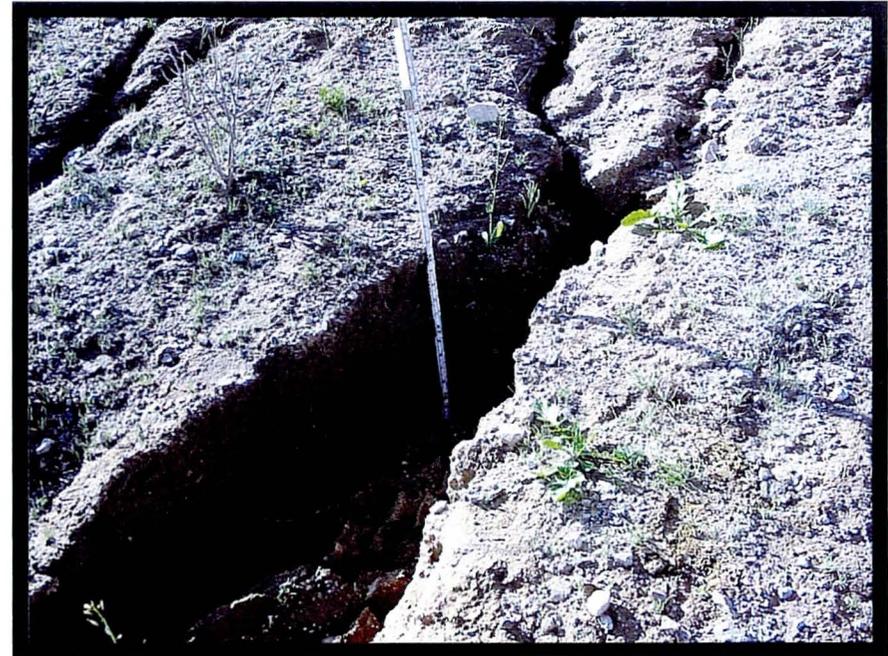
516+50 to 518+00	U/S slope	Erosion gully	2005		Erosion gully, approximately 14-inches deep about 10-feet below upstream crest.						
517+22	U/S slope	Erosion gully	2005		Erosion gully 14-inches deep about 10-feet below upstream crest.						
517+99 to 518+64	Crest	Long.	2002	Did not find	Longitudinal hairline crack wanders along the crest centerline to +/- 2- to 3-feet from centerline. Documented as not found during the 2003 inspection.						
522+89 to 523+03	Crest	Long.	2002	Did not find	Longitudinal hairline crack wanders along the crest centerline to +/- 2- to 3-feet from centerline. Small holes observed at Sta. 522+89, 522+93 and 523+03. Documented as not found during the 2003 inspection.						
526+34	D/S toe	Holes	2005		Large inactive rodent hole located 5-feet above downstream toe.						
527+42	U/S slope	Erosion gully	2005		Erosion gully rill 15- to 20-inches deep; may be related to erosion of gully previously filled by slope repair and seeding. (Photo 10)

Photo 10 – Upstream Slope, Reach 2: Erosion gully 20-inches deep.

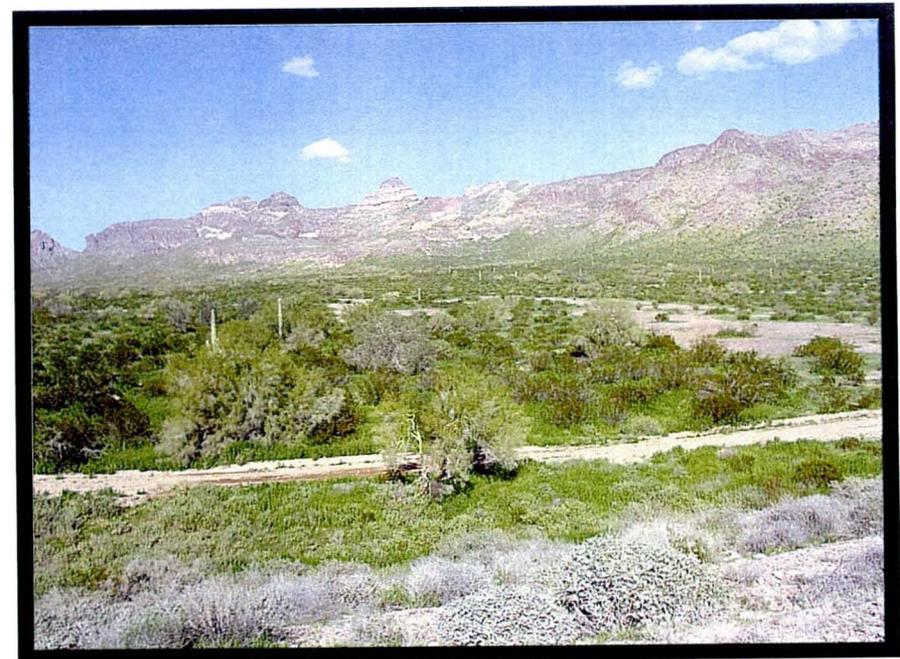
Photo 14 – View from Upstream Slope, Reach 1 (note desert pavement).

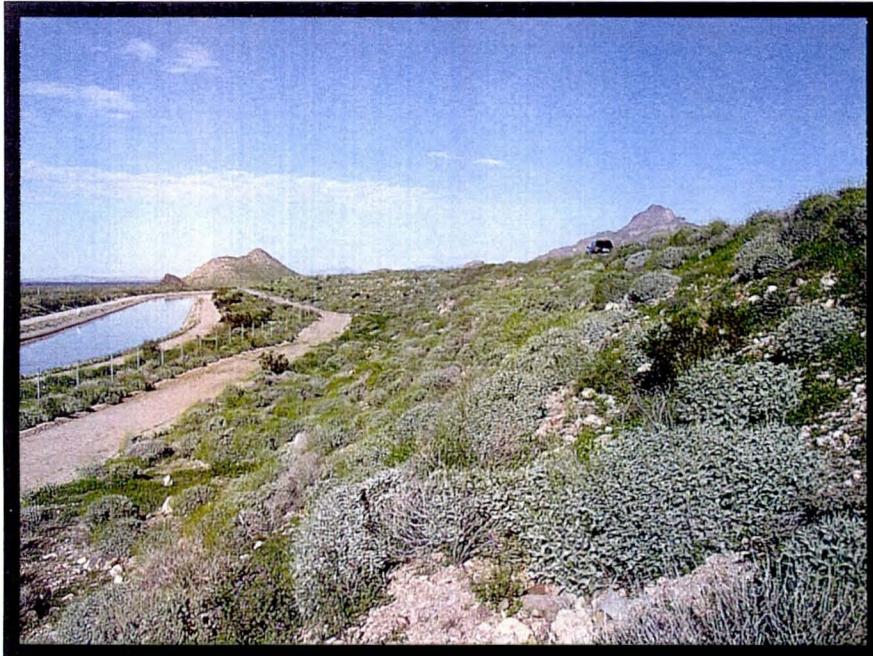
Photo 17 – Downstream Slope, Reach 1.

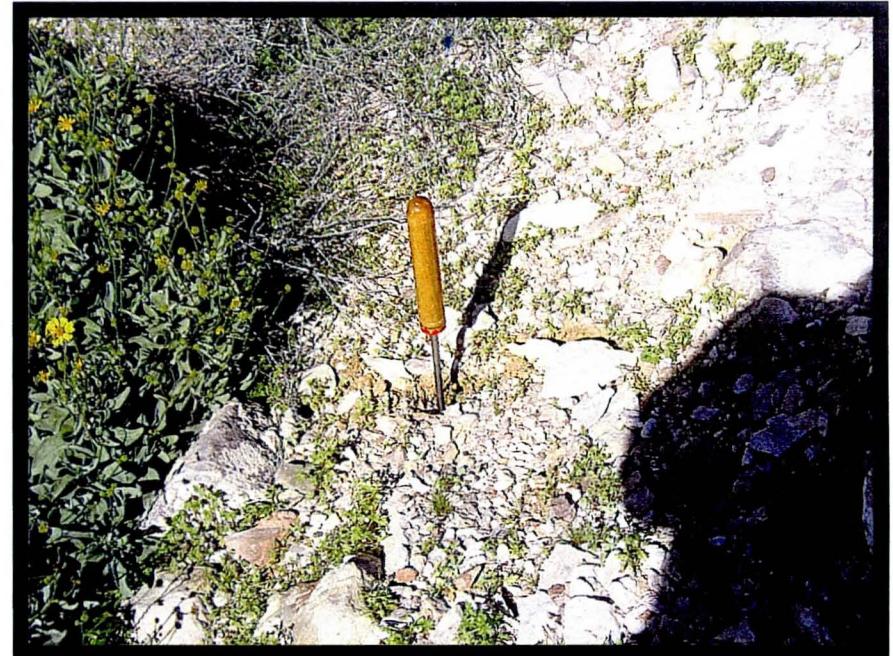
Photo 18 – Downstream Slope, Reach 1, Station 965+00:  
Downstream slope erosion probed 30-inches.
