PROPOSAL FOR REHABILITATION

WHITE TANK MOUNTAINS
FLOOD RETARDING
STRUCTURES #3 AND #4

PILOT WATERSHED PROJECT
MARICOPA COUNTY, ARIZONA

UNITED STATES DEPARTMENT OF AGRICULTURE
SOIL CONSERVATION SERVICE
NOVEMBER 1991

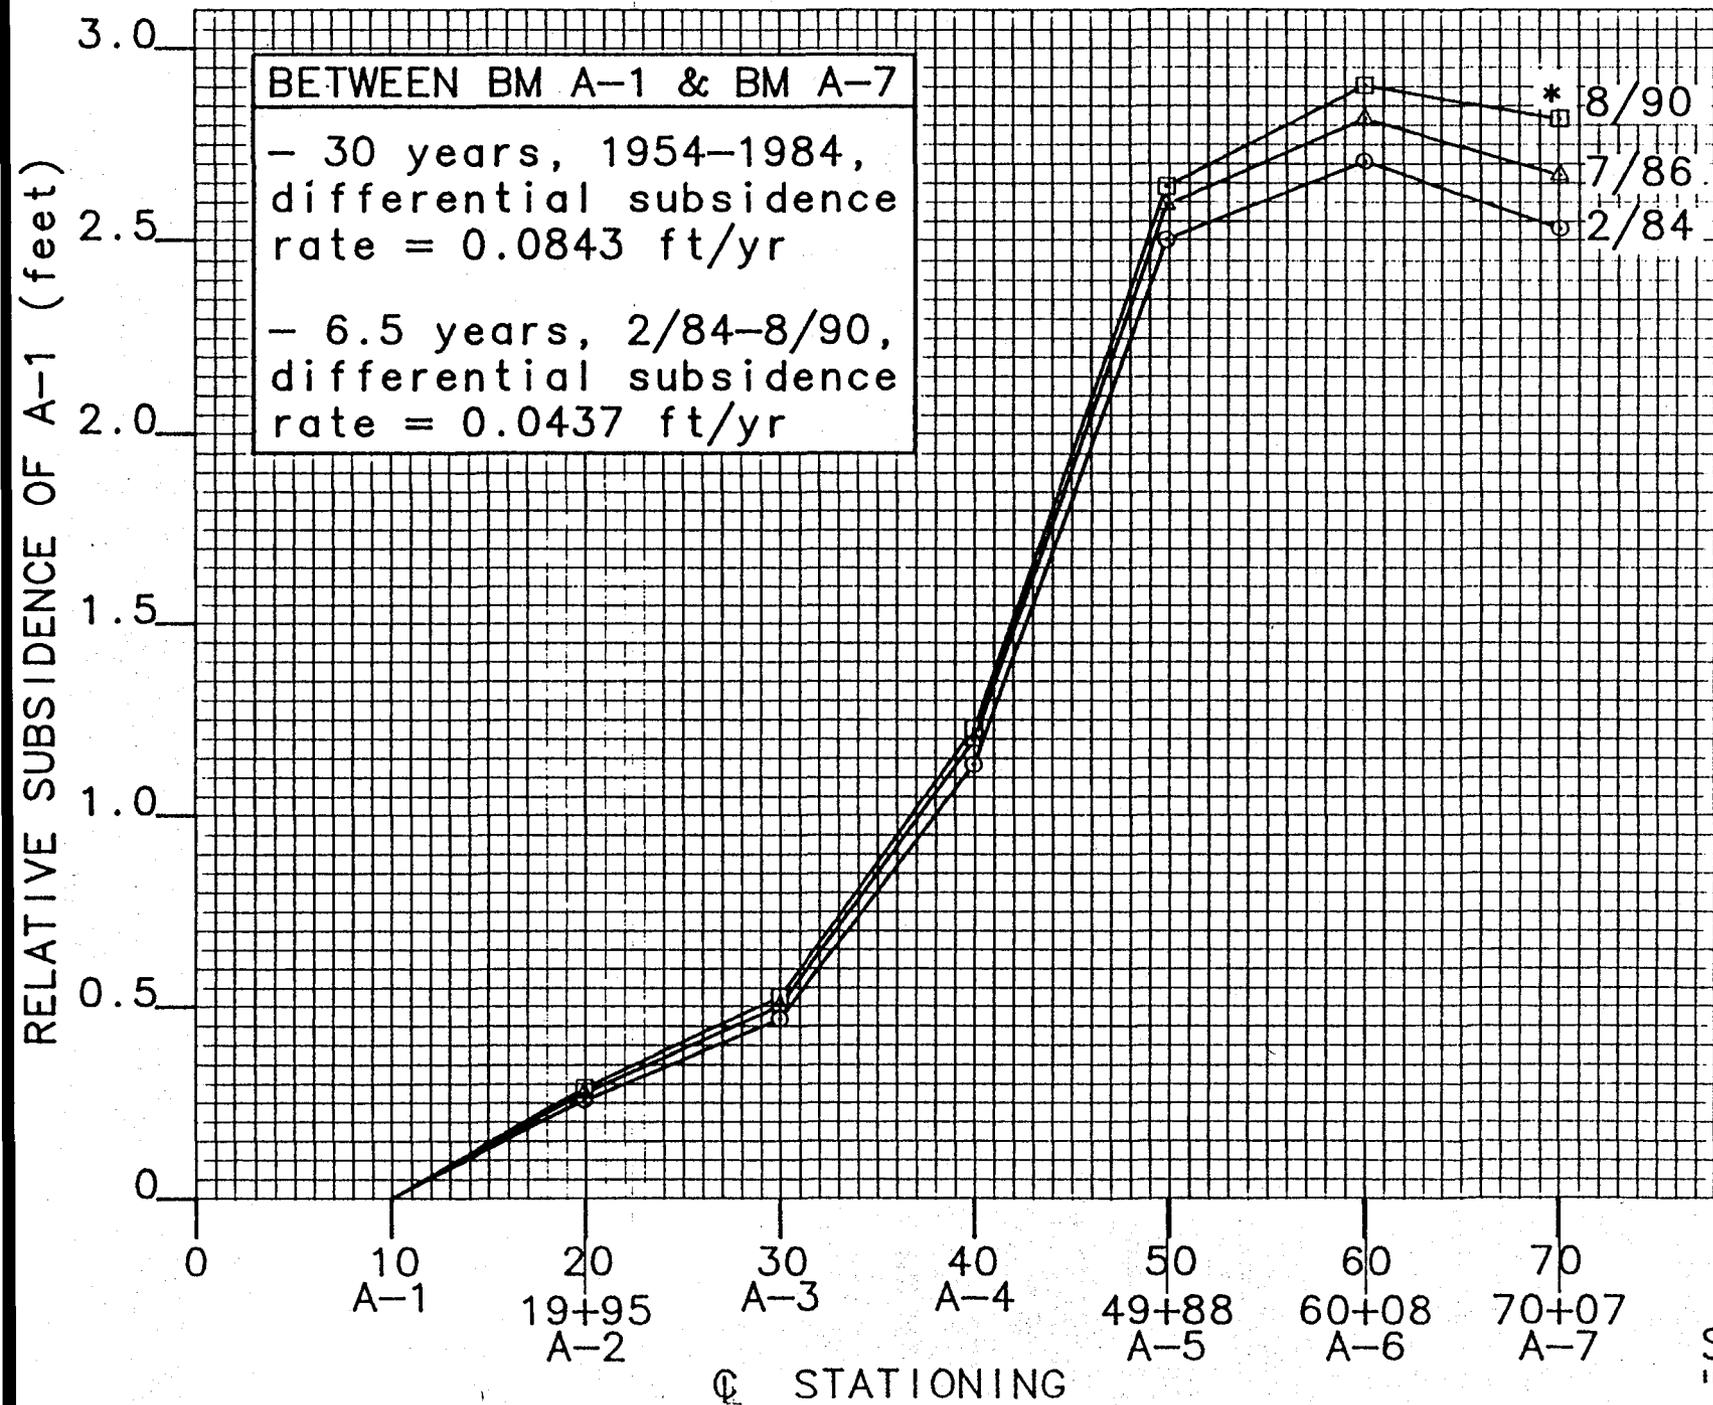
Figure 7 shows a family of plots of differential subsidence for "A" and "B" monuments. These curves clearly show the maximum strain in

DIFFERENTIAL SUBSIDENCE WAS DETERMINED BY SUBTRACTING THE ELEVATION OF A-1 FROM THE ELEVATION OF A-1 THRU A-7.
