CONCRETE QUALITY REPORT

CAVE CREEK DAM
Maricopa County, Arizona

RE: CAVE CREEK DAM

JOB No. 69-36

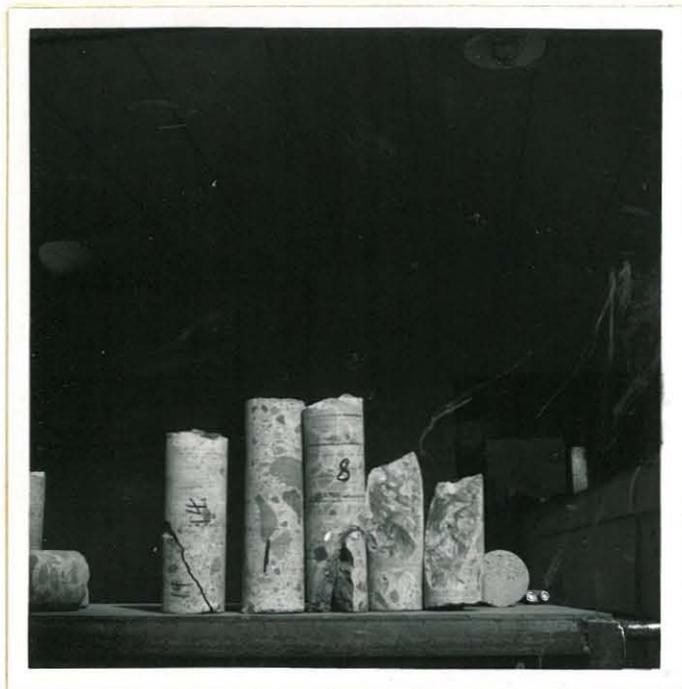
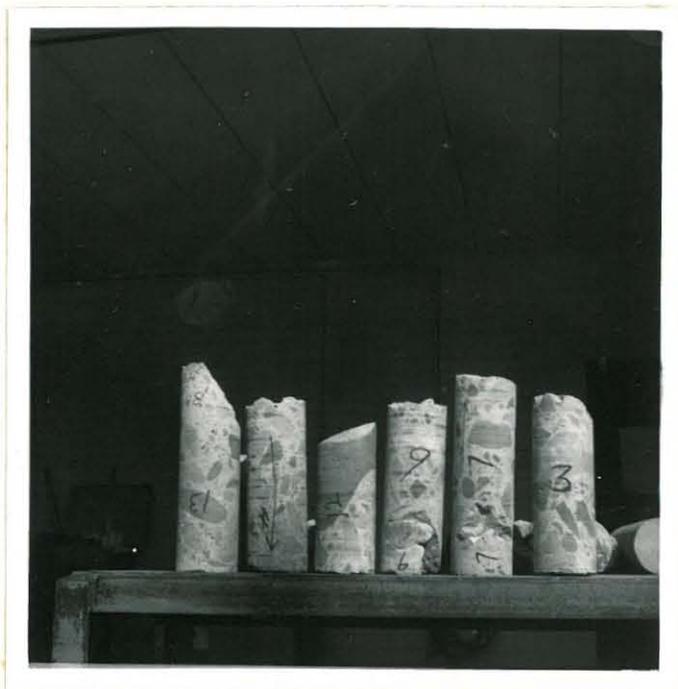
PICTURES OF THE CORES ARE ENCLOSED. ALL DIAGONAL CRACKS ARE DUE TO DRILLING THROUGH THE COLD OR POUR JOINTS. IT WAS DIFFICULT TO FOLLOW THE CRACKS THROUGH THE DAM, SINCE THE DAM FACE IS CURVED, BOTH VERTICALLY AND HORIZONTALLY. THE DRILL WAS FASTENED TO THE DAM FACE, SO THE CORE WAS DRILLED NORMAL TO THE SURFACE, WHILE THE COLD OR POUR JOINT WAS FORMED IN A HORIZONTAL PLANE. BY STARTING THE CORE DRILL BELOW THE CRACK, THE CRACK WAS ENCOUNTERED AT DIFFERENT DISTANCES IN FROM THE DAM FACE AND AS HAS BEEN STATED, SOME OF THE CORES SHOWED THE JOINT COMPLETELY THROUGH THE DAM.

CONCRETE CORES

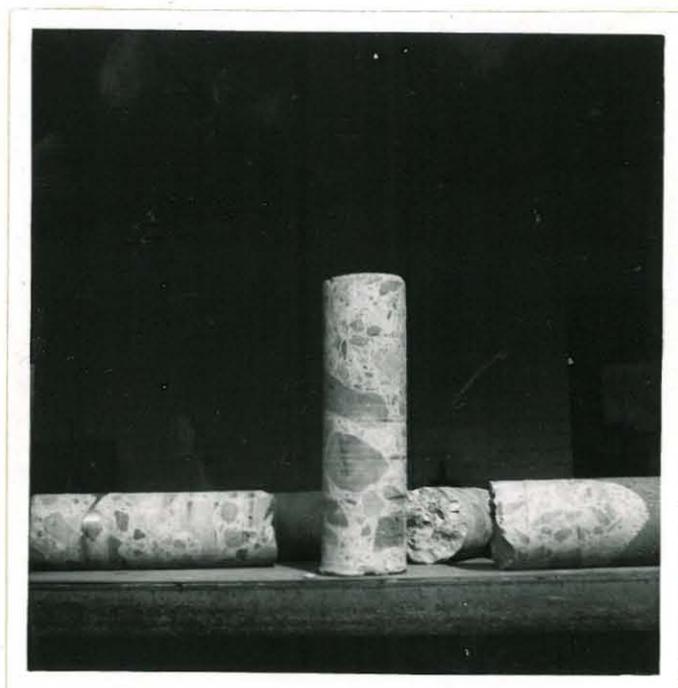
CONCRETE CORES
