GEOTECHNICAL INVESTIGATION

**DURANGO REGIONAL CONVEYANCE
CHANNEL**

**ELWOOD STREET ALIGNMENT BETWEEN 75TH AVENUE AND
107TH AVENUE**

PHOENIX, ARIZONA

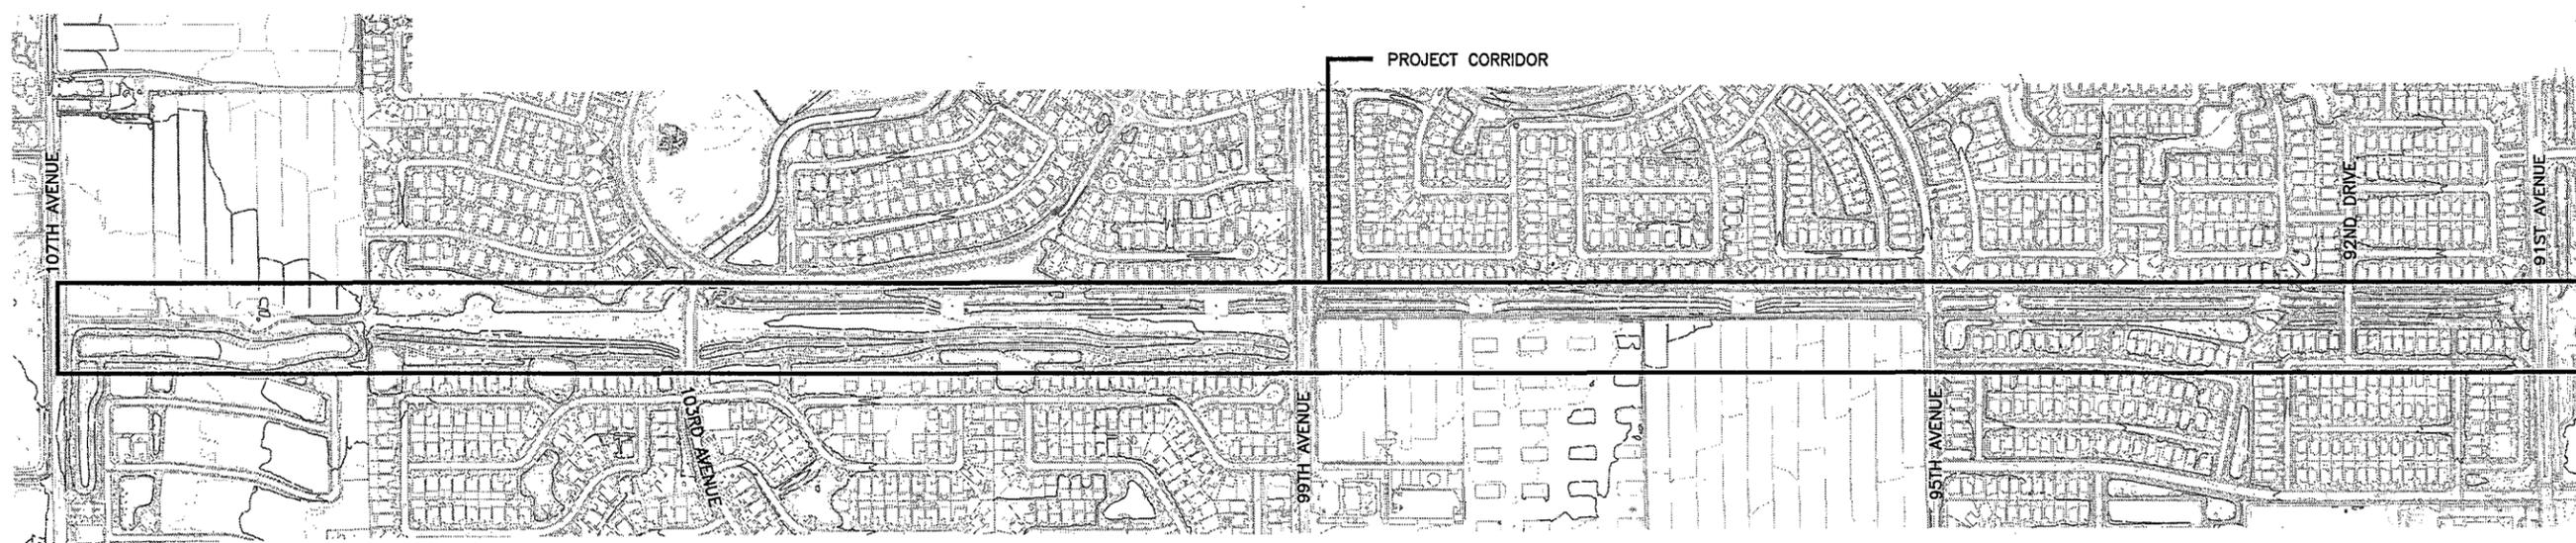
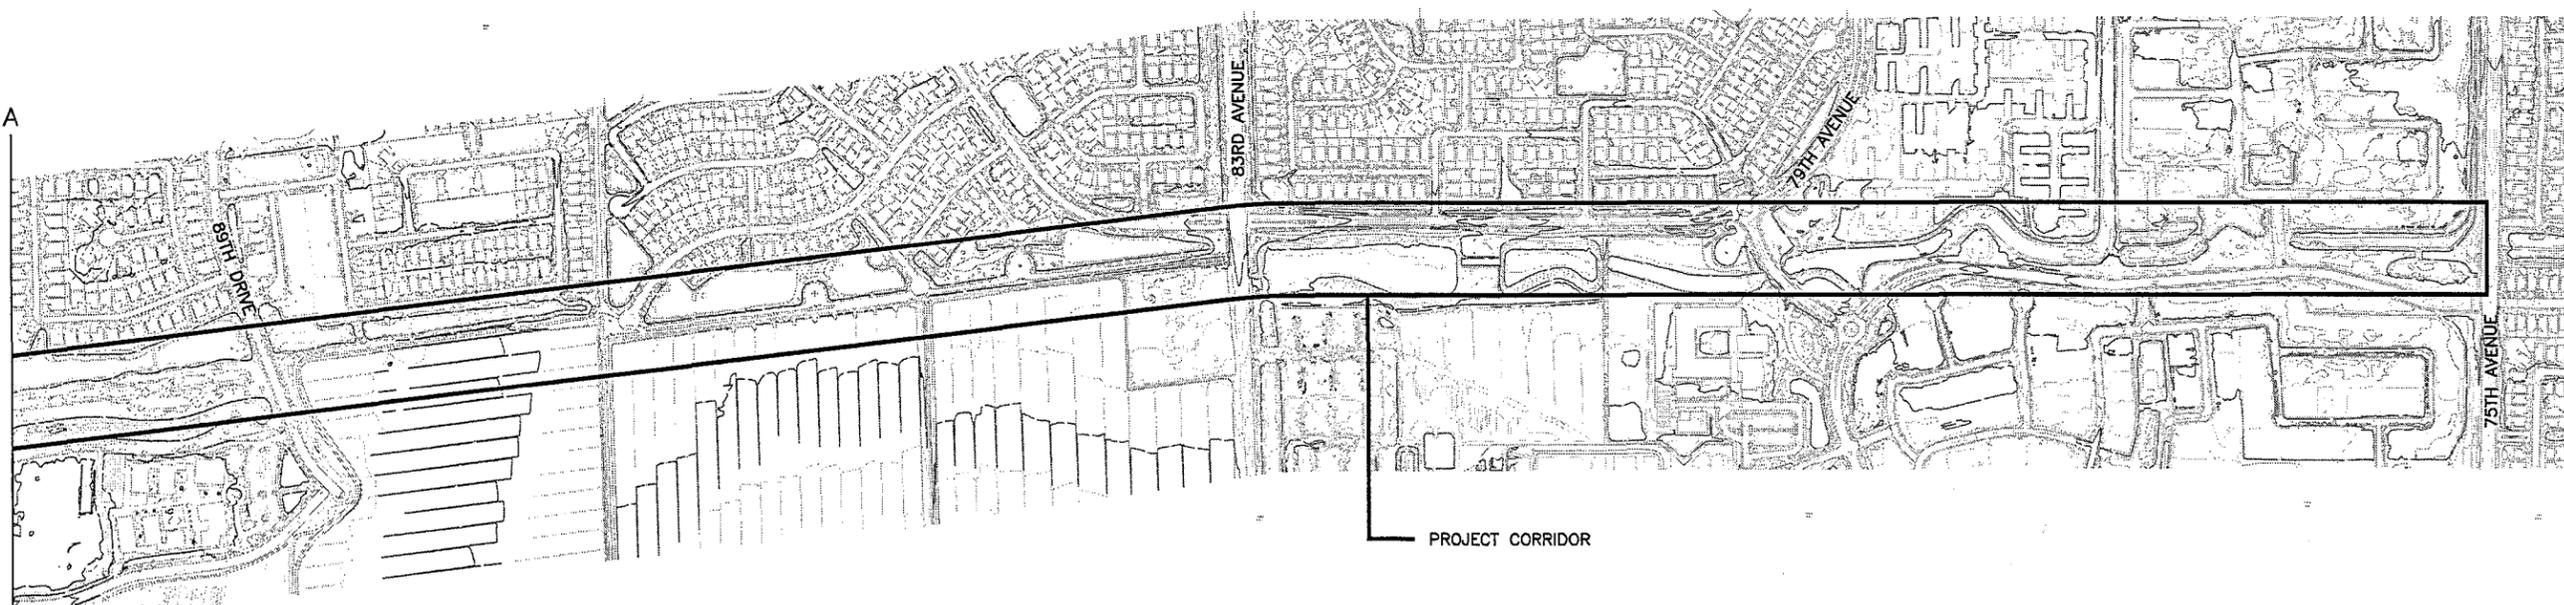
OVERALL SITE PLAN		FIGURE 1	
MACTEC PROJECT NAME: <u>DURANGO REGIONAL CONVEYANCE CHANNEL</u>			
MACTEC PROJECT NO: <u>4973-10-8043.01</u>			
DATE: <u>11-1-10</u>	E-FILE: <u>108043.01BLP</u>		
DRAWN BY: <u>DAK</u>	CHECKED BY: <u>[Signature]</u>

OVERALL SITE PLAN
SCALE:
NTS

- Figure 1 – Overall Site Plan
- Figures 2 through 8 – Boring Location Plans

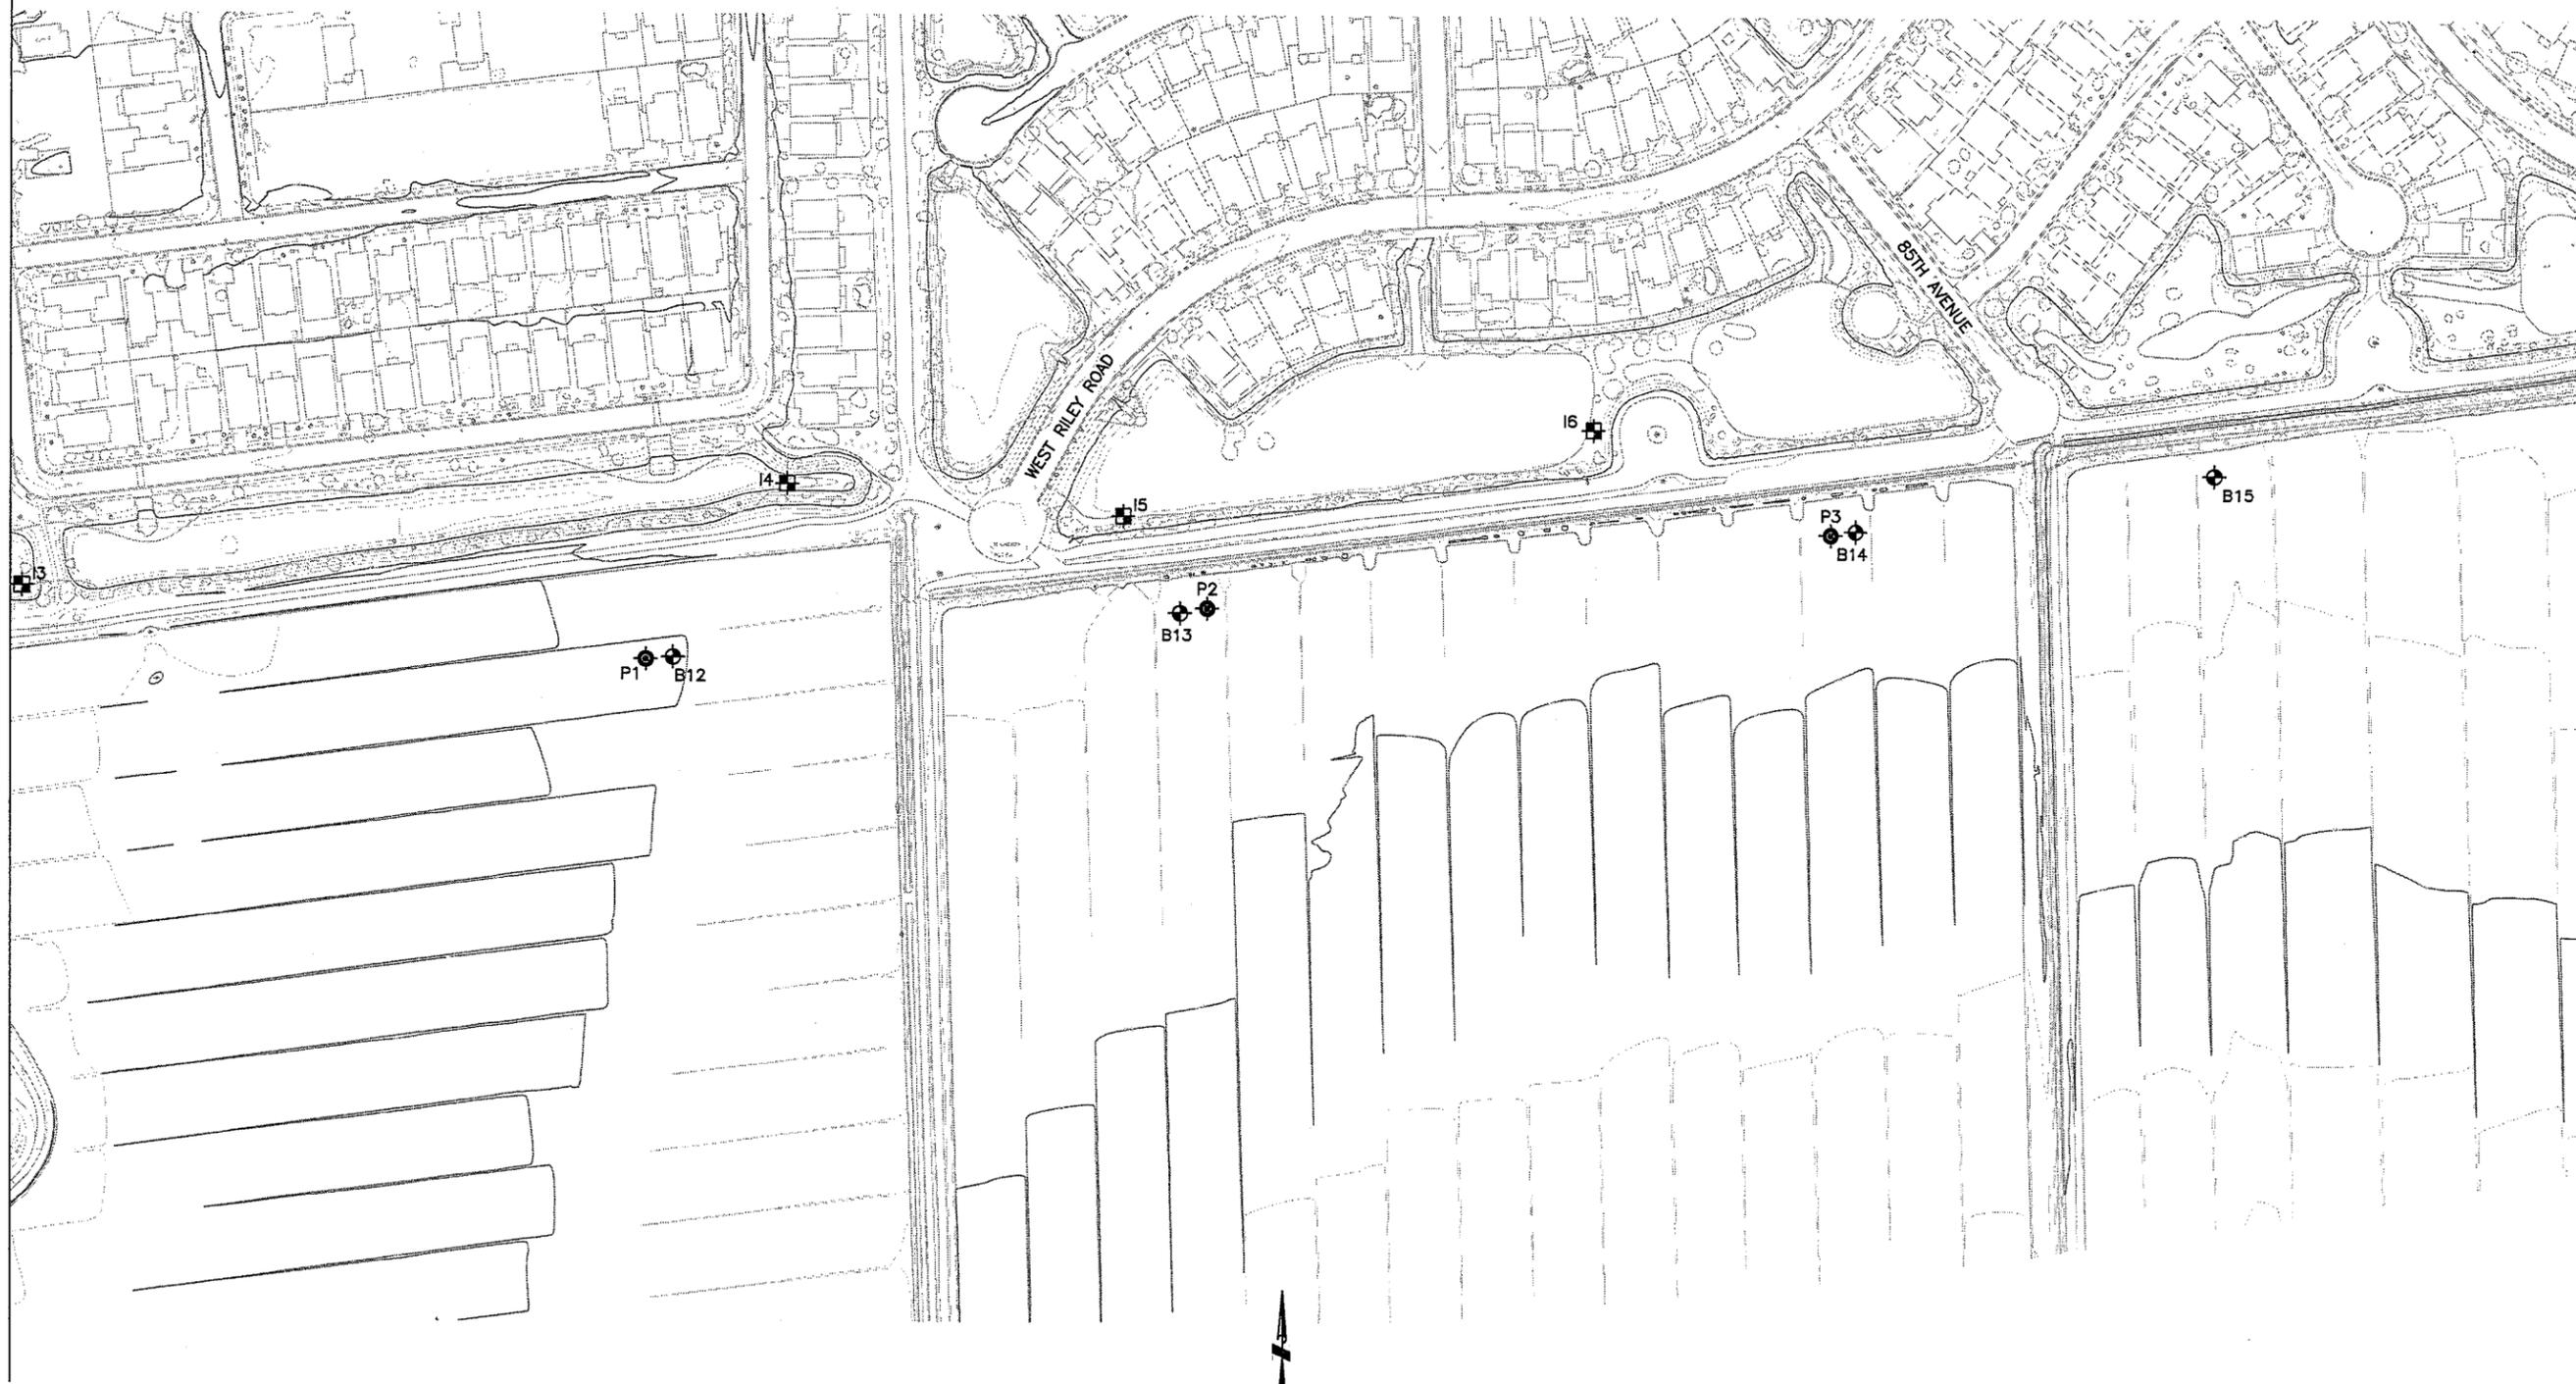
BORING LOCATION PLAN		FIGURE 6	
MACTEC PROJECT NAME: DURANGO REGIONAL CONVEYANCE CHANNEL			
MACTEC PROJECT NO: 4973-10-8043.01			
DATE: 11-1-10	E-FILE: 108043.01BLP		
DRAWN BY: DAK	CHECKED BY: [Signature]

BORING LOCATION PLAN
 APPROXIMATE SCALE:
 1" = 200'
 LEGEND:
 ◆ APPROXIMATE SOIL BORING LOCATION
 I1 APPROXIMATE DOUBLE RING INFILTRATION TEST LOCATION
 P1 APPROXIMATE DEEP PERCOLATION TEST LOCATION

The test borings and percolation tests were advanced using 8-inch and 12-inch O.D. hollow stem auger (HSA) advanced by truck-mounted Diedrich D-50 and D-125 drill rigs owned and operated by D & S Drilling, Inc. A City of Phoenix Right-of-Way Permit (No. CMC 10017187) was obtained prior to accessing the site, and the appropriate land owners and/or farmers were contacted for entry permission prior to accessing the site. The locations of the test borings, surficial samples collected, infiltration tests, and percolation tests are shown on the Boring Location Plans, included as Figures 2 through 8 in this report. The logs of the test borings are presented in Appendix A.

- (1) Test locations may be found on the Boring Location Plans.
- (2) Field measurements and calculated results reported in metric units, including infiltration velocity rate in centimeters per hour in accordance with ASTM D 3385.
- (3) Calculated infiltration rates converted from metric infiltration velocity rates in cm/hour to standard English volumetric infiltration rates.

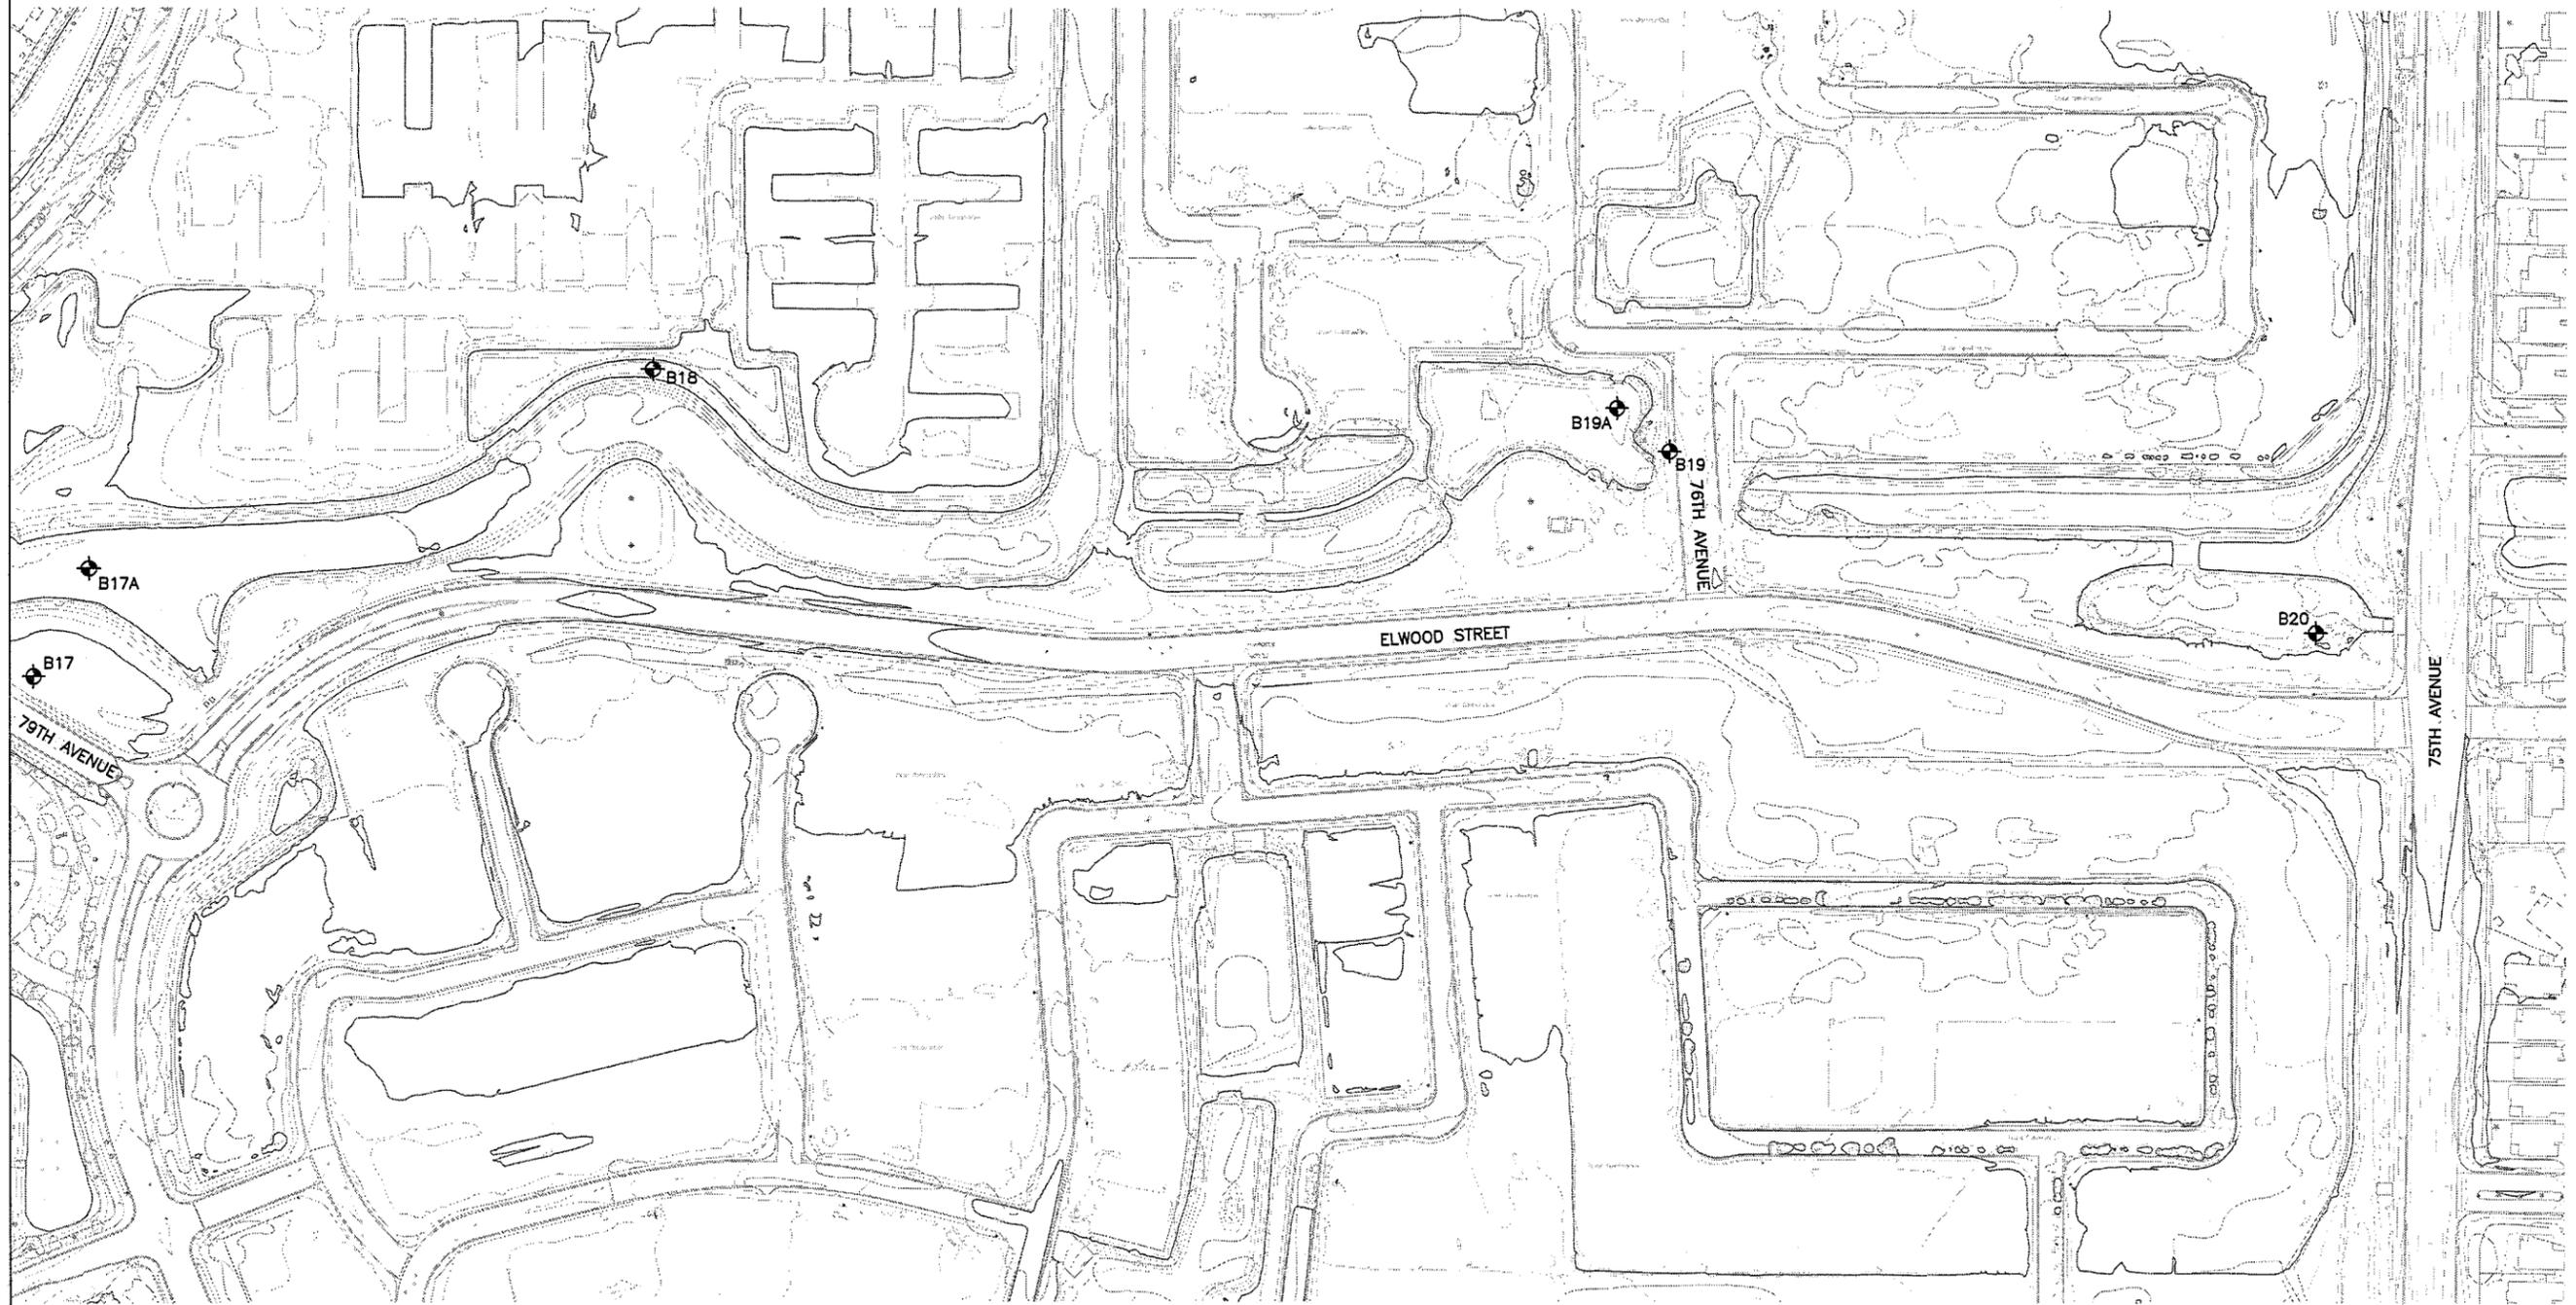
FIGURE 8

▲
BORING LOCATION PLAN
APPROXIMATE SCALE:
1" = 200'
LEGEND:
◆ APPROXIMATE
B1 SOIL BORING LOCATION

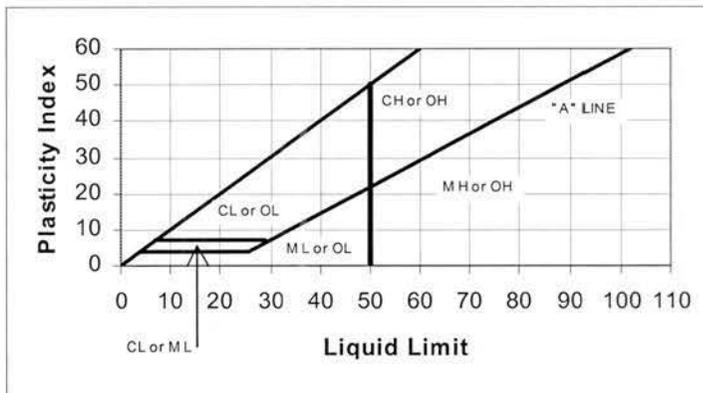
PLASTICITY CHART

CLAYS Limits Plot above "A" line & hatched zone on Plasticity chart.	CLAYS OF LOW PLASTICITY (Liquid Limit Less than 50)	CL	Inorganic clays at low to medium plasticity, gravelly clays, sandy clays, silty clays, lean clays.	
		CLAYS OF HIGH PLASTICITY (Liquid Limit More than 50)	CH	Inorganic clays with high plasticity, fat clays.	
	NOTE: Coarse soils with between 5% and 12% passing the No. 200 sieve and fine grained soils with plasticity values plotting in the hatched zone of the Plasticity Chart are to have dual symbols.

DEGREE OF PLASTICITY OF COHESIVE SOILS (FHWA, 2006)

Degree of Plasticity	Plasticity Index
Non-Plastic	0
Low	1 - 10
Medium	10 - 20
High	20 - 40
Very High	over 40

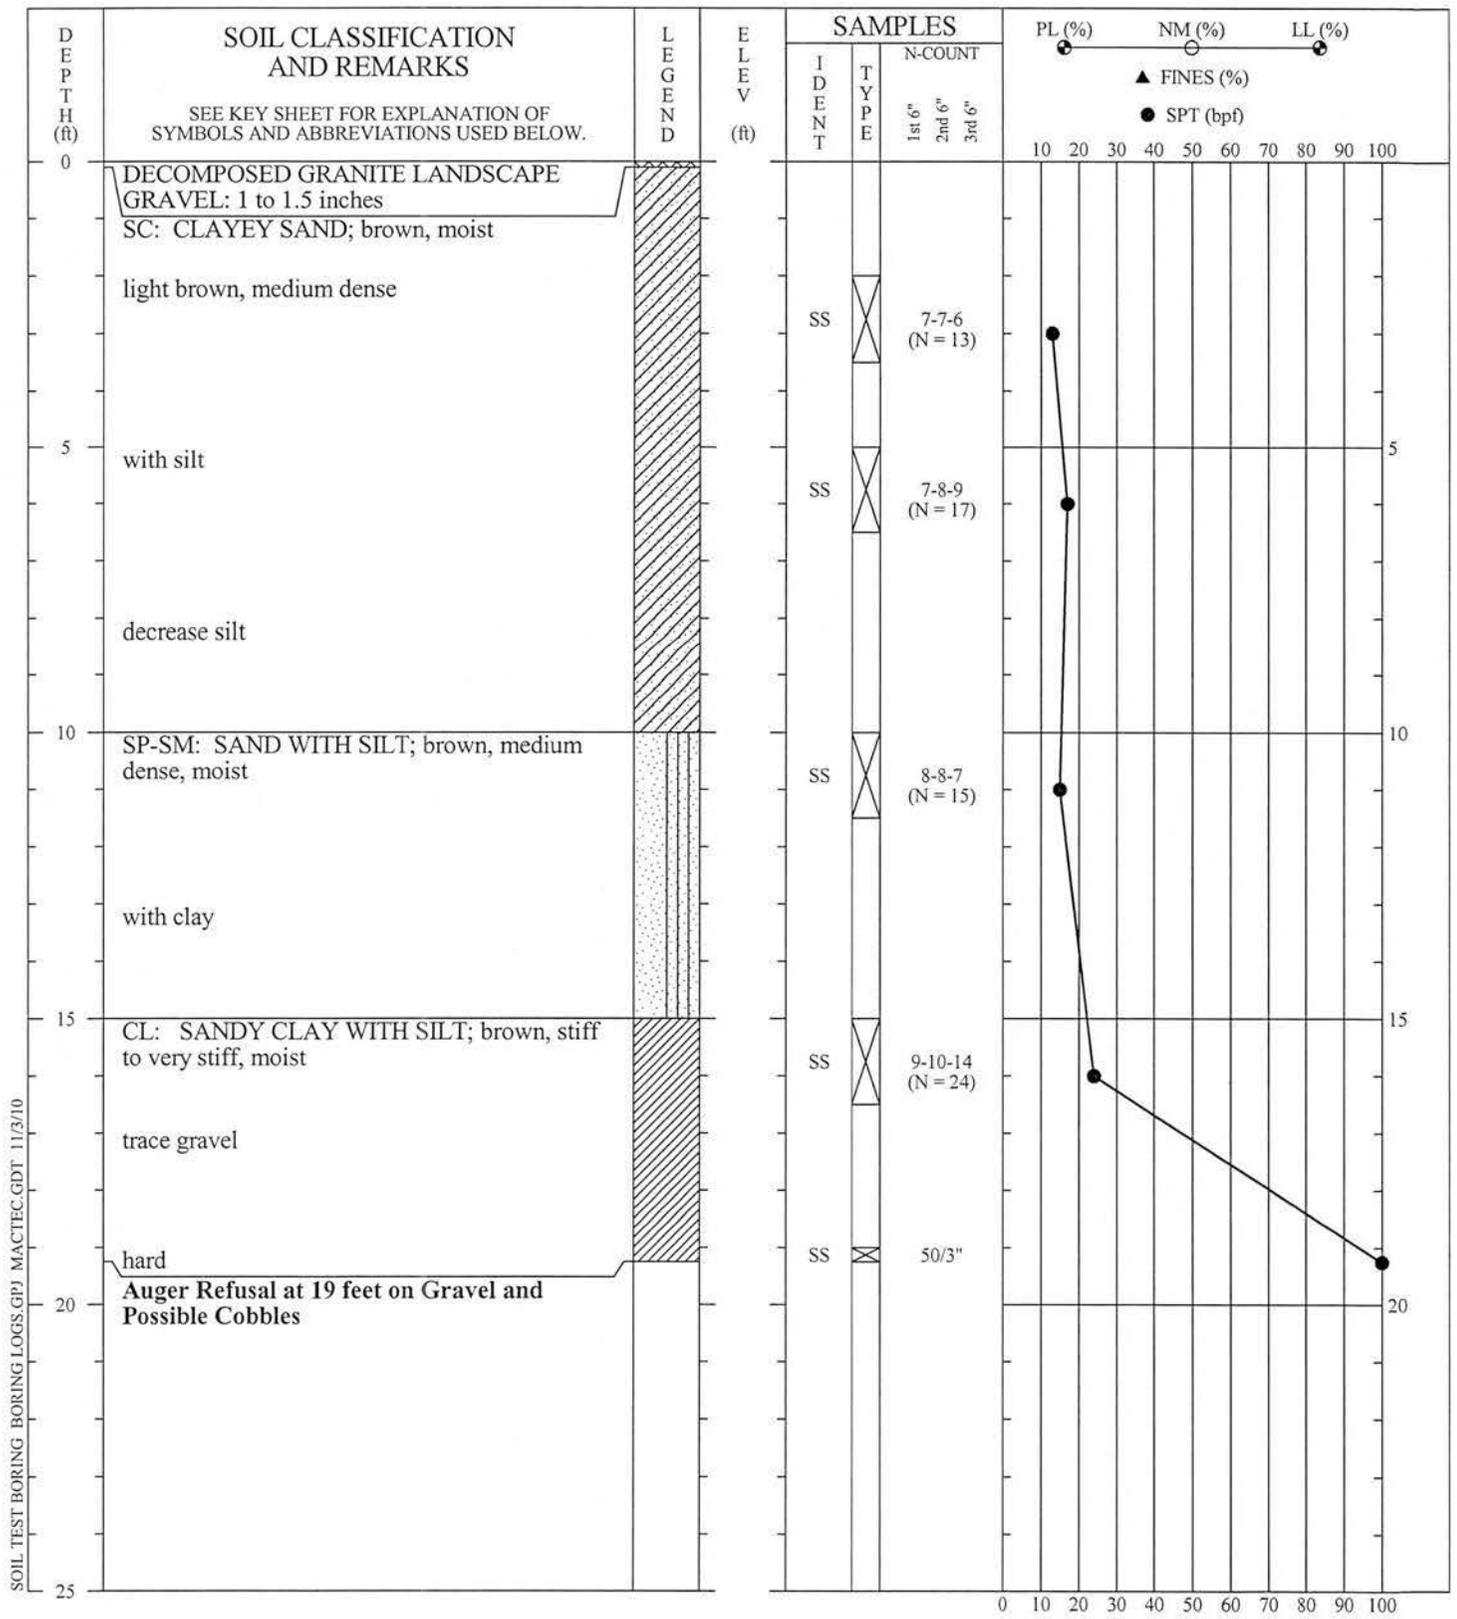
DRILLER: D&S Drilling
 EQUIPMENT: Diedrich D-50 (Auto-Hammer)
 METHOD: 8" HSA
 HOLE DIA.: 8 inches
 REMARKS: No Groundwater Encountered

SOIL TEST BORING RECORD	
BORING NO.:	2
PROJECT:	Durango Regional Conveyance Channel
LOCATION:	Elwood Alignment Between 75th & 107th Ave
DRILLED:	September 22, 2010
PROJECT NO.:	4975-10-8043.01
PAGE 1 OF 1

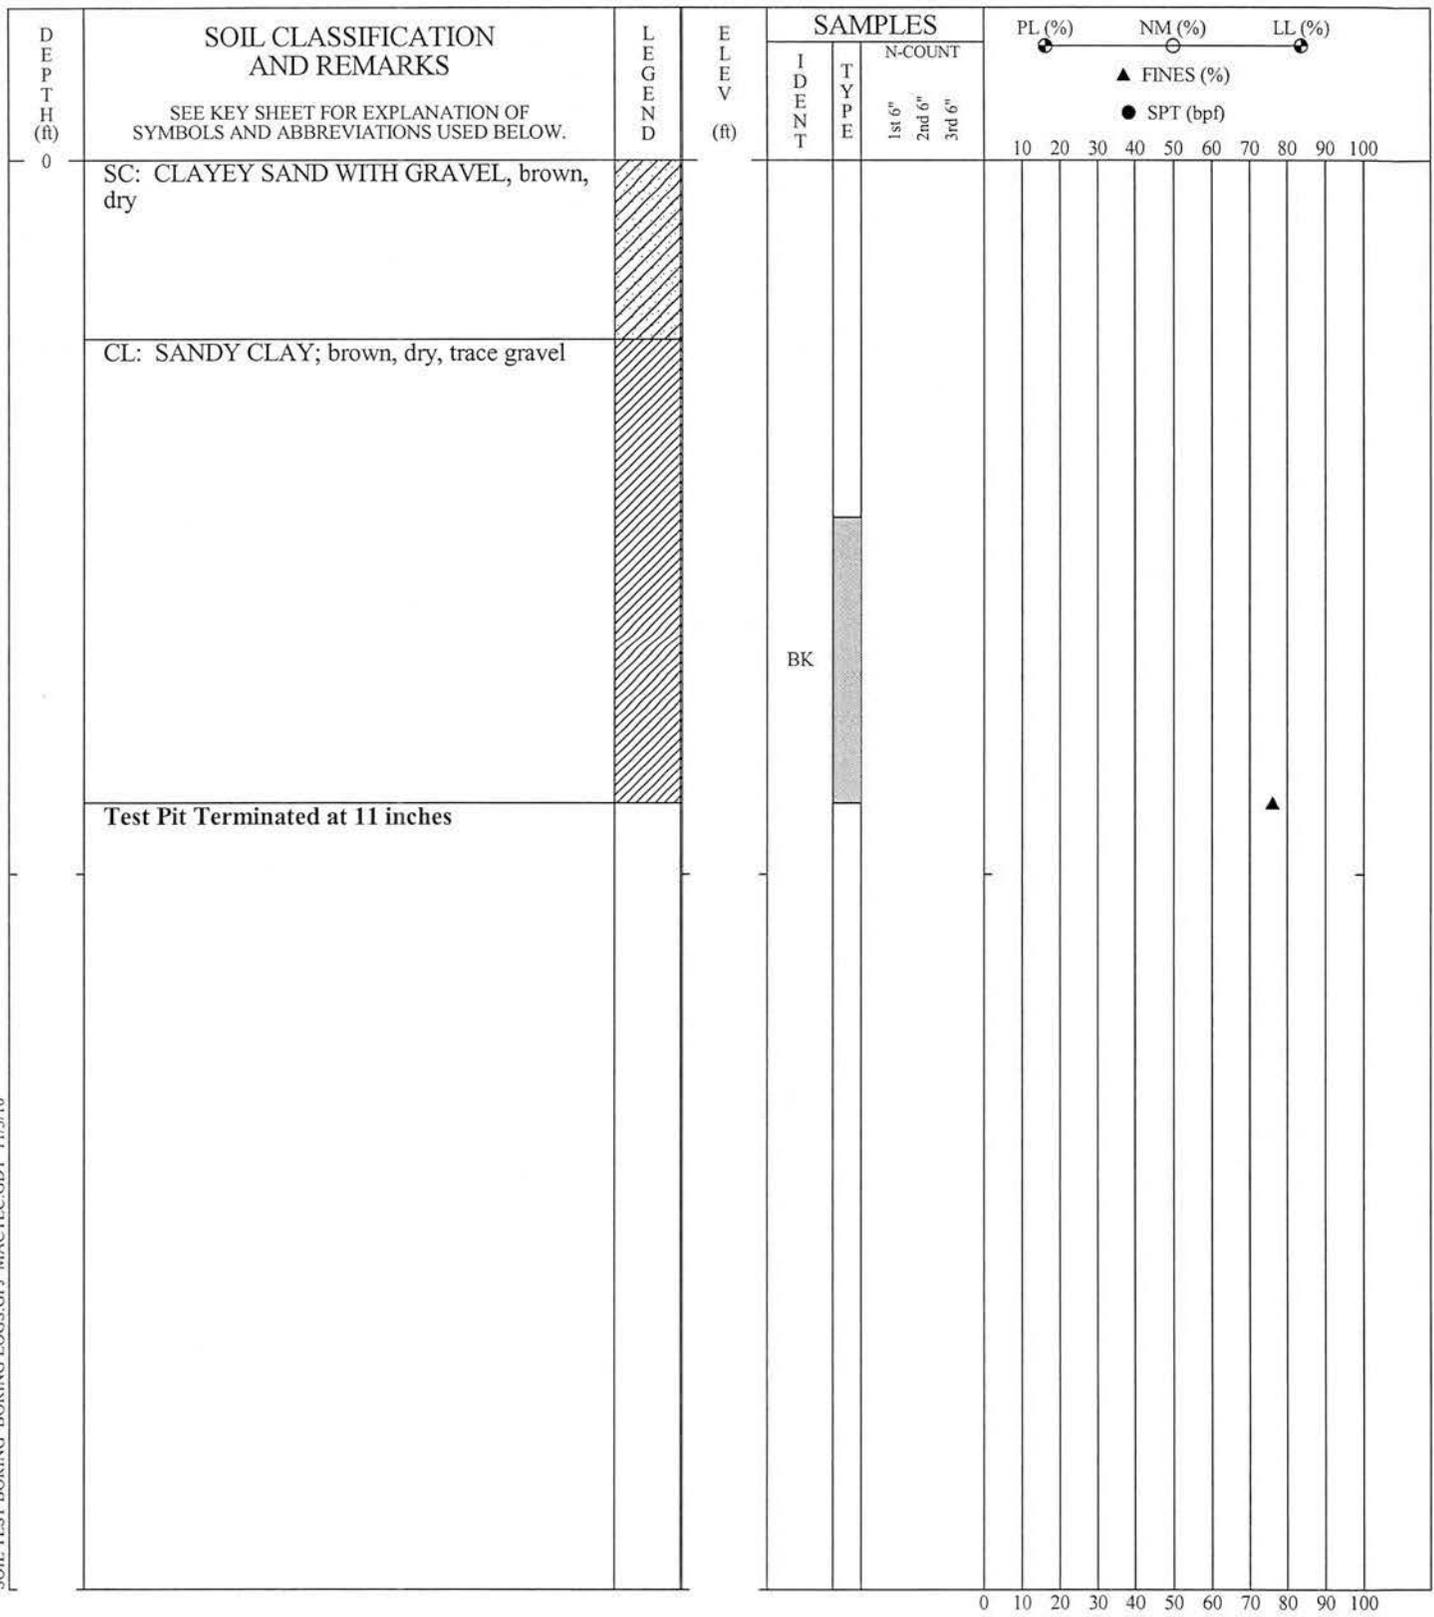
DRILLER: Dave Klann (MACTEC)
 EQUIPMENT: Hand Sampling
 METHOD:
 HOLE DIA.:
 REMARKS: No Groundwater Encountered

SOIL TEST BORING RECORD	
BORING NO.:	8A
PROJECT:	Durango Regional Conveyance Channel
LOCATION:	Elwood Alignment Between 75th & 107th Ave
DRILLED:	September 23, 2010
PROJECT NO.:	4975-10-8043.01
PAGE 1 OF 1	
N

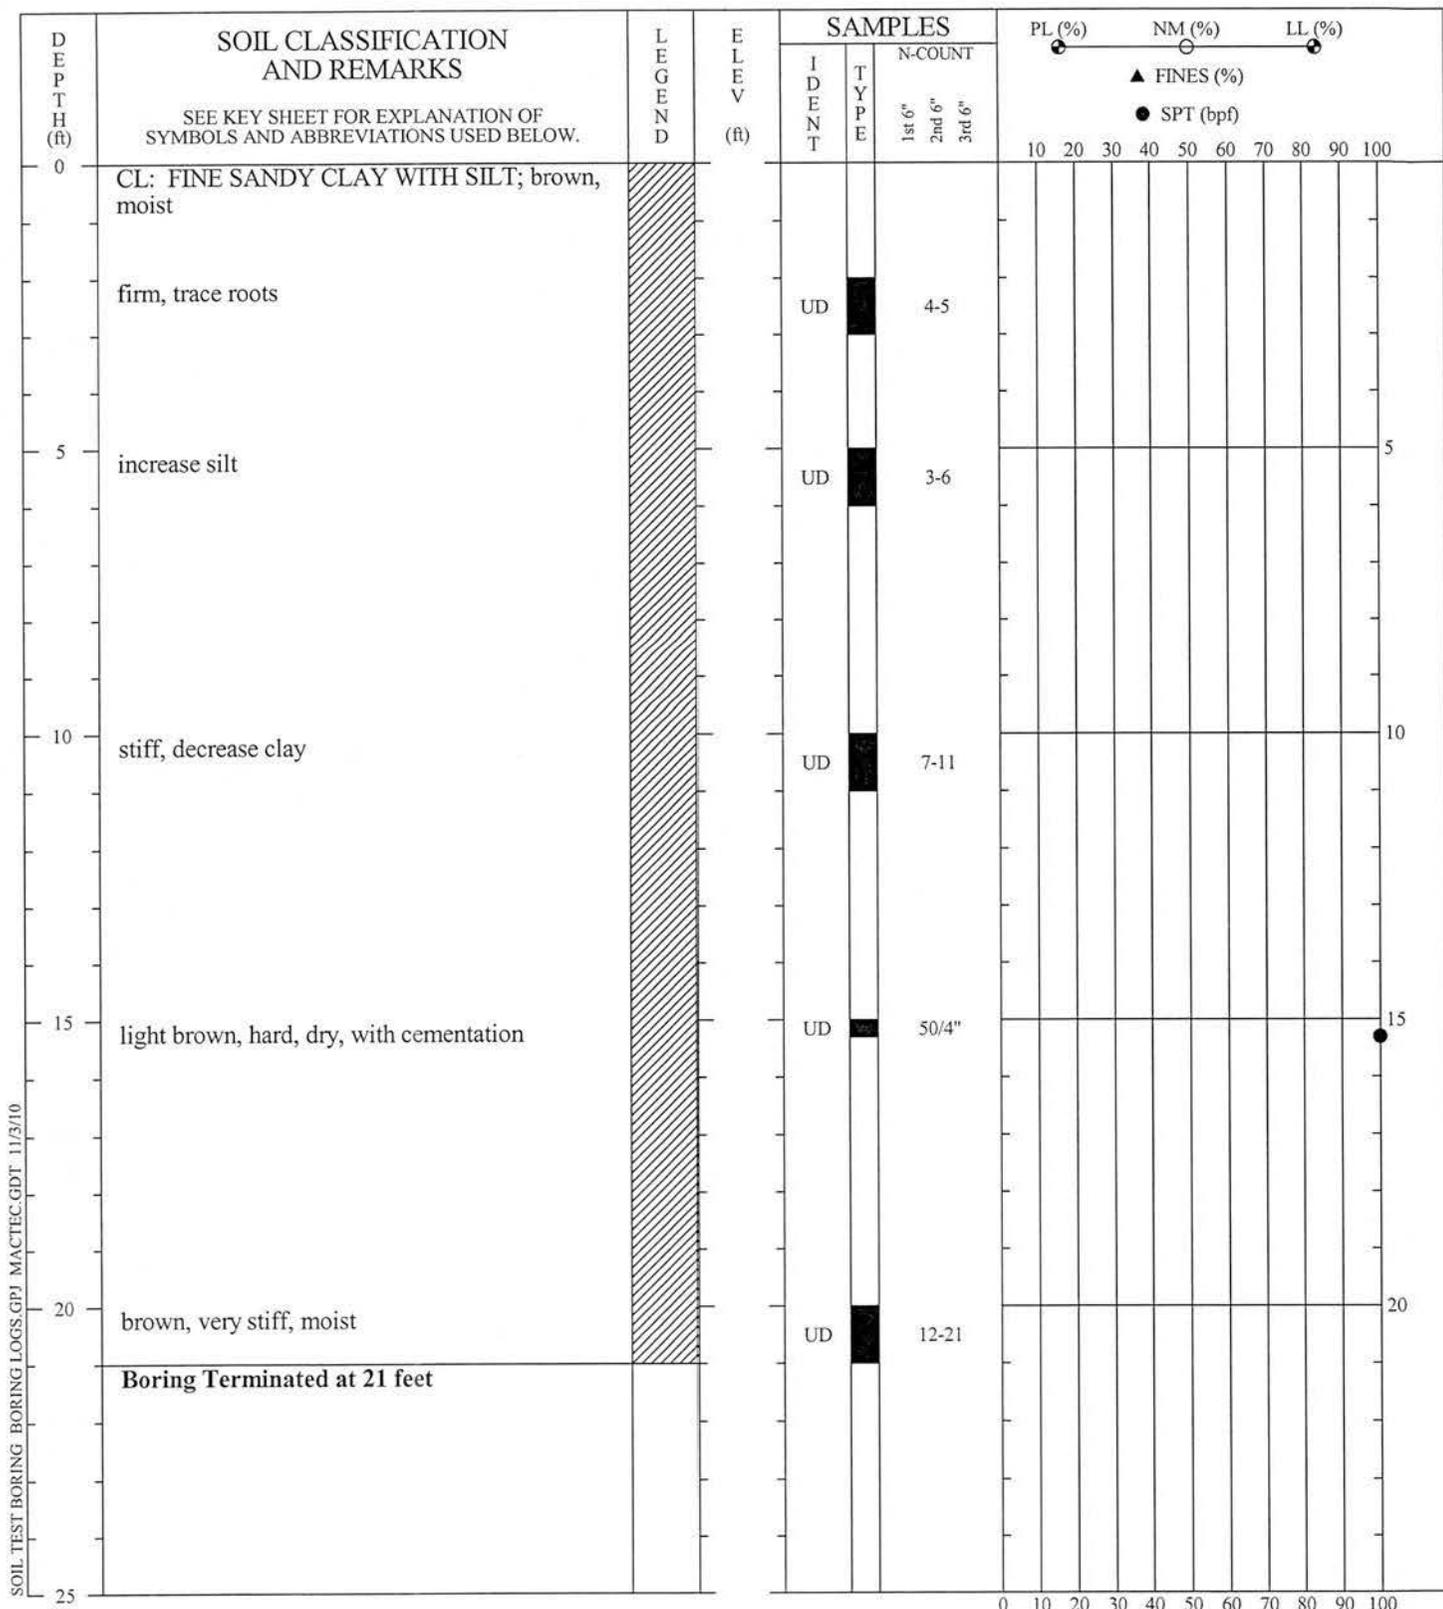
DRILLER: D&S Drilling
 EQUIPMENT: Diedrich D-125 (Auto-Hammer)
 METHOD: 8" HSA
 HOLE DIA.: 8 inches
 REMARKS: No Groundwater Encountered. Boring Located in Alfalfa Field

SOIL TEST BORING RECORD	
BORING NO.:	16
PROJECT:	Durango Regional Conveyance Channel
LOCATION:	Elwood Alignment Between 75th & 107th Ave
DRILLED:	October 27, 2010
PROJECT NO.:	4975-10-8043.01
PAGE 1 OF 1

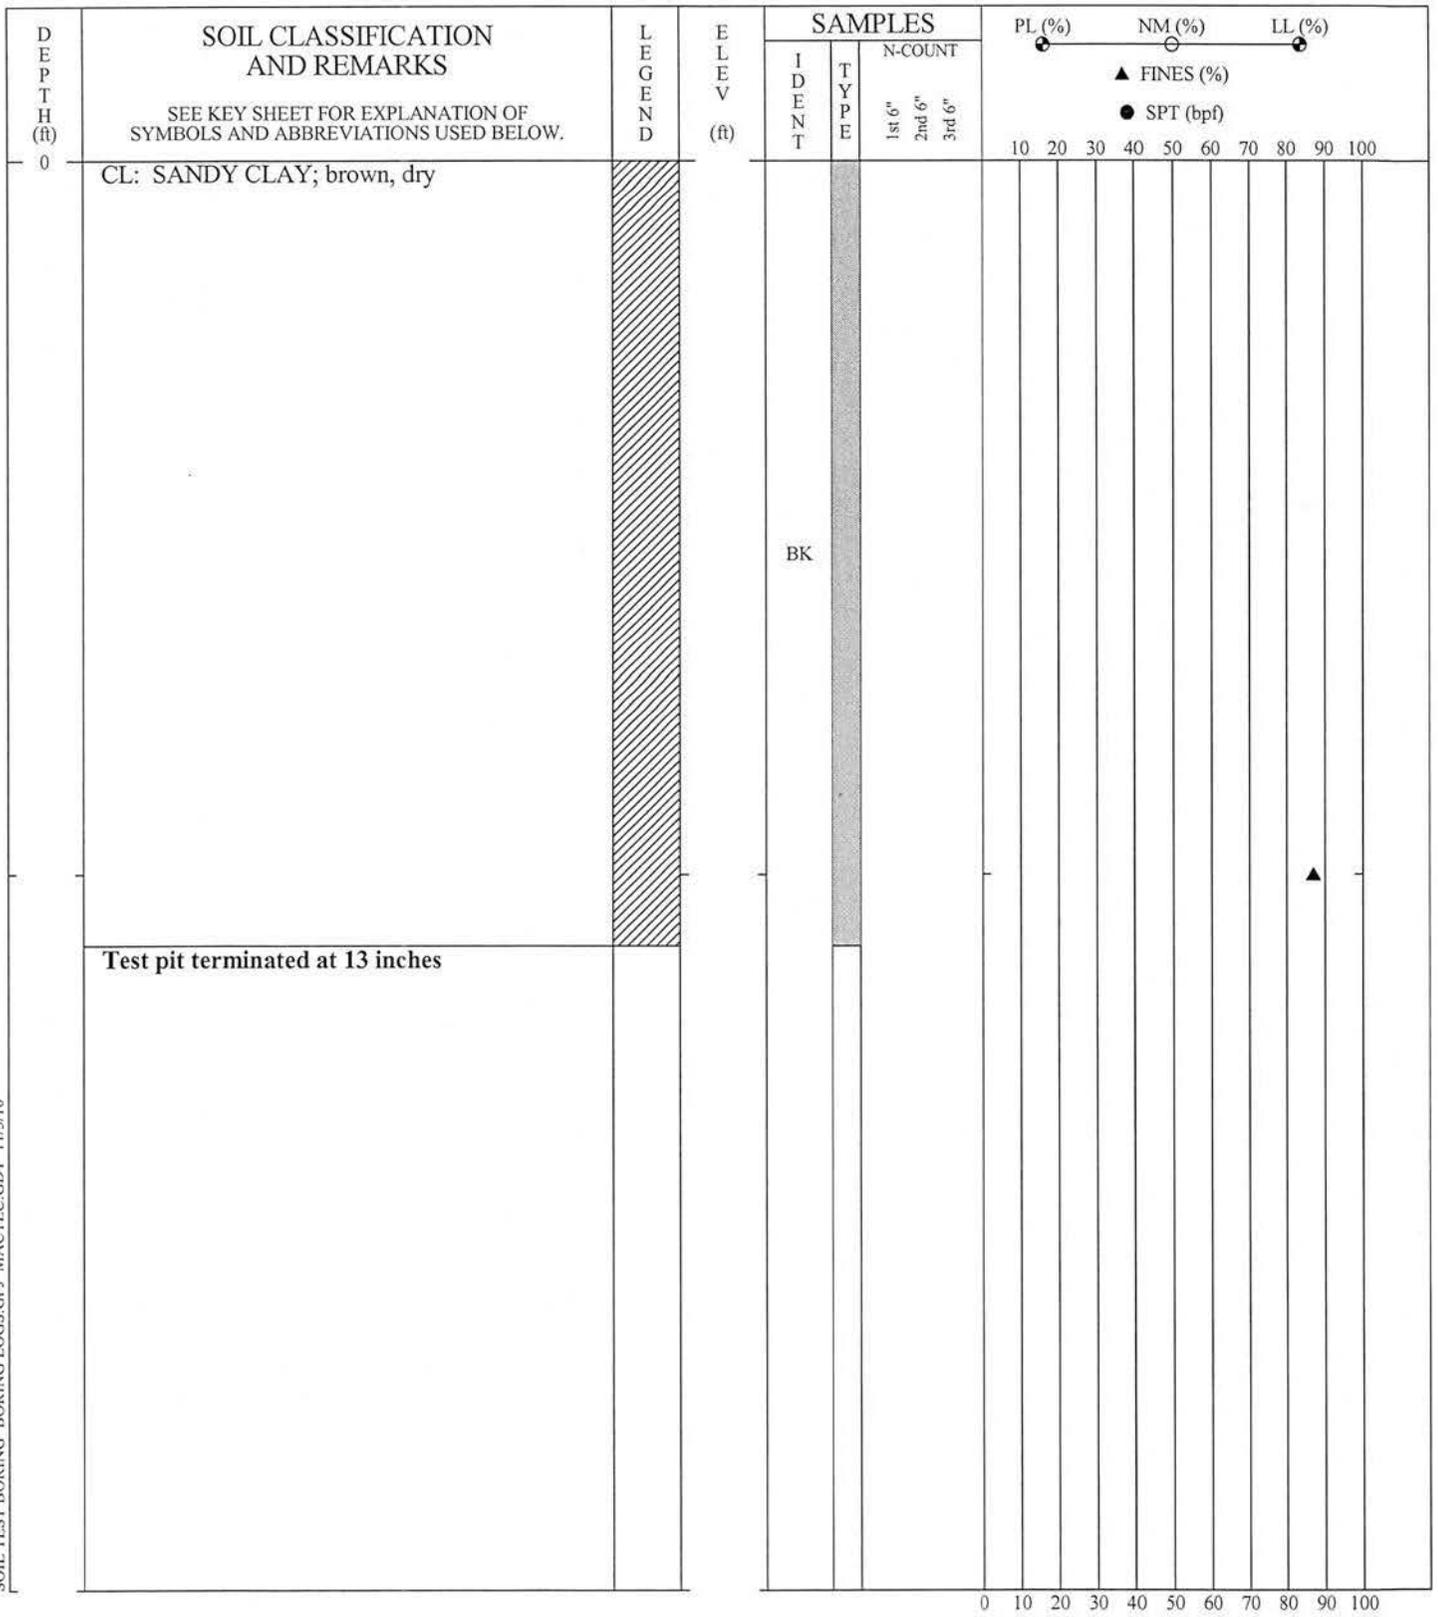
DRILLER: Dave Klann (MACTEC)
EQUIPMENT: Hand Sampling
METHOD:
HOLE DIA.:
REMARKS: No Groundwater Encountered

SOIL TEST BORING RECORD	
BORING NO.: 17A	PROJECT: Durango Regional Conveyance Channel
LOCATION: Elwood Alignment Between 75th & 107th Ave	DRILLED: October 15, 2010
PROJECT NO.: 4975-10-8043.01	PAGE 1 OF 1

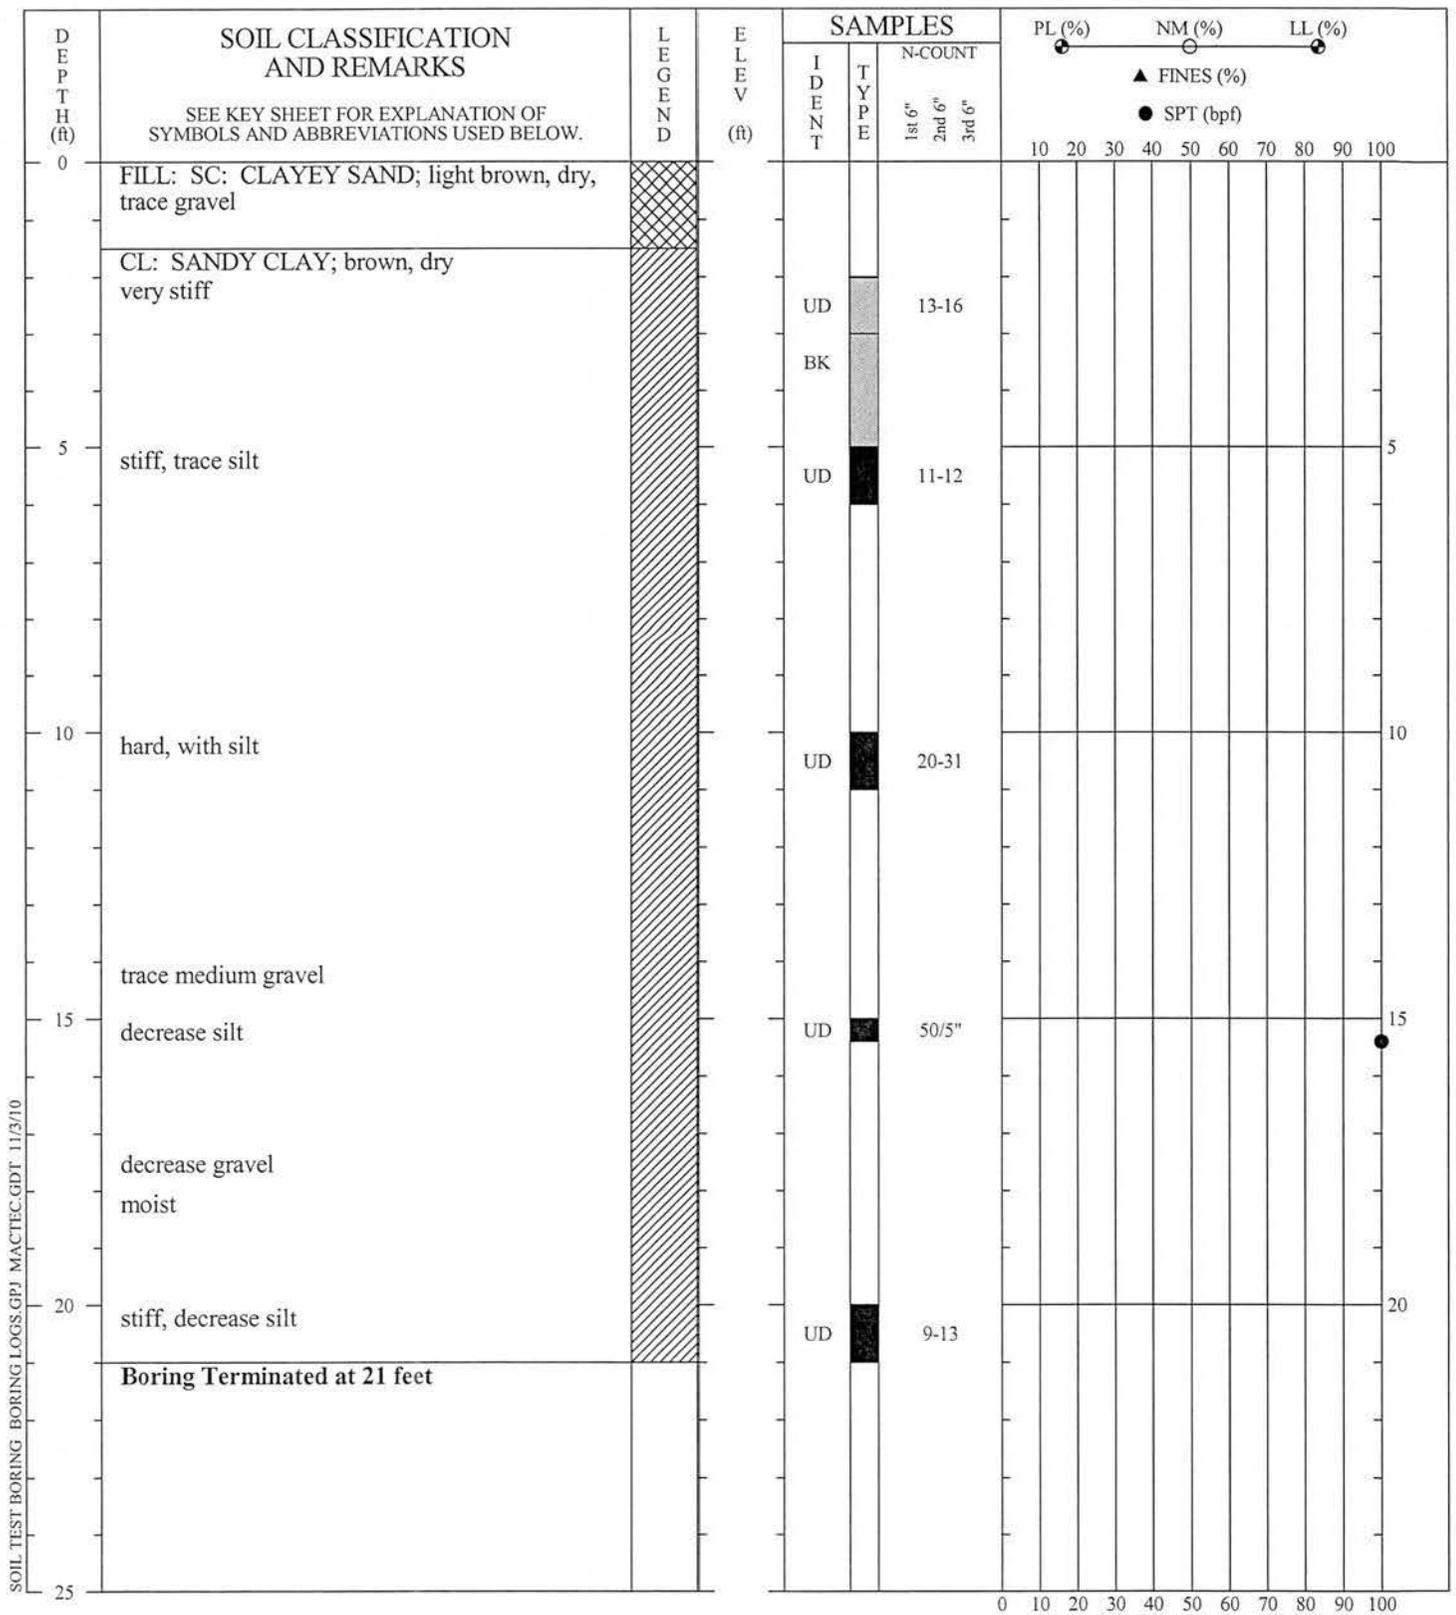
DRILLER: D&S Drilling
 EQUIPMENT: Diedrich D-50 (Auto-Hammer)
 METHOD: 8" HSA
 HOLE DIA.: 8 inches
 REMARKS: No Groundwater Encountered
