GEOTECHNICAL INVESTIGATION

**DURANGO REGIONAL CONVEYANCE
CHANNEL**

**ELWOOD STREET ALIGNMENT BETWEEN 75TH AVENUE AND
107TH AVENUE**

PHOENIX, ARIZONA

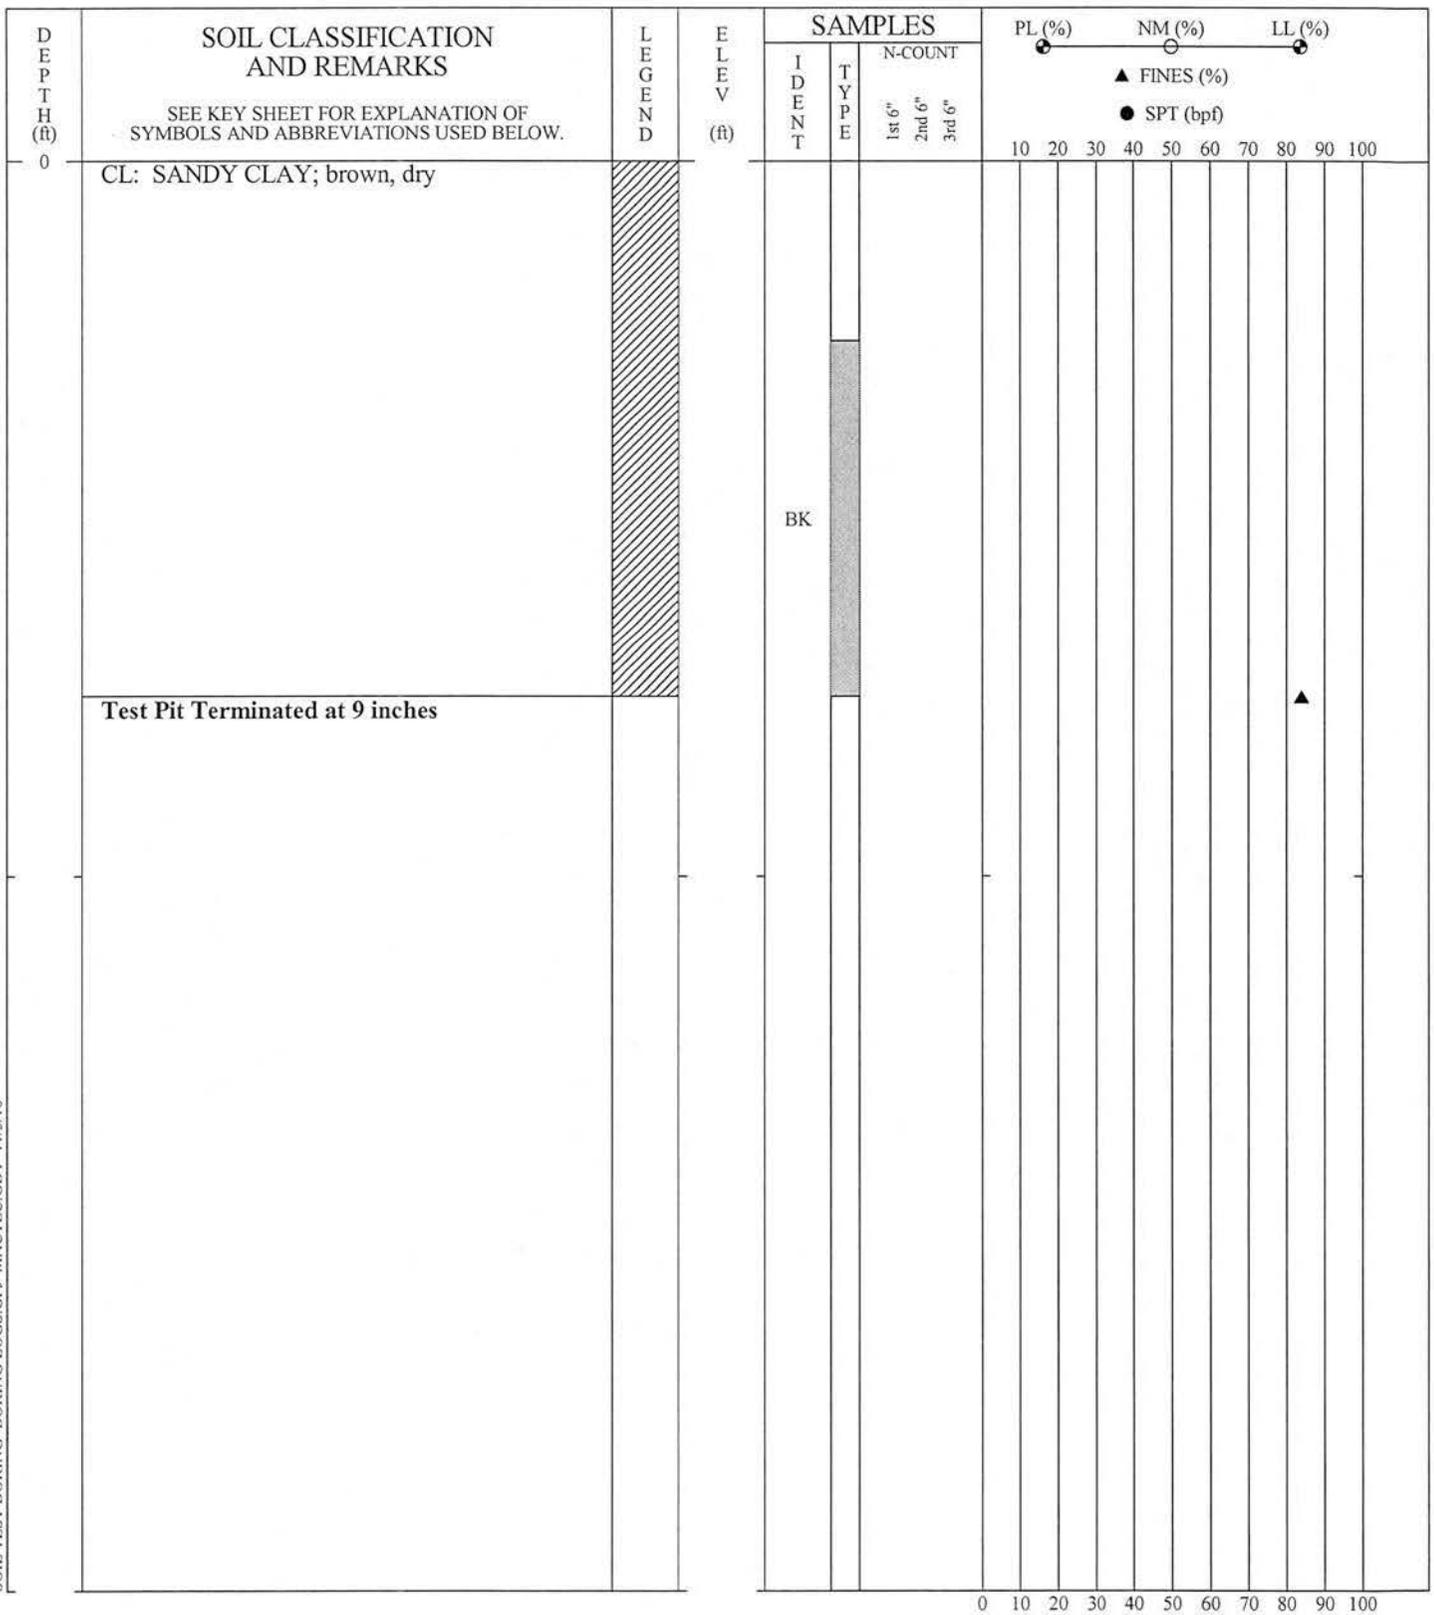
DRILLER: Dave Klann (MACTEC)
EQUIPMENT: Hand Sampling
METHOD:
HOLE DIA.:
REMARKS: No Groundwater Encountered

SOIL TEST BORING RECORD	
BORING NO.:	19A
PROJECT:	Durango Regional Conveyance Channel
LOCATION:	Elwood Alignment Between 75th & 107th Ave
DRILLED:	September 23, 2010
PROJECT NO.:	4975-10-8043.01
PAGE 1 OF 1

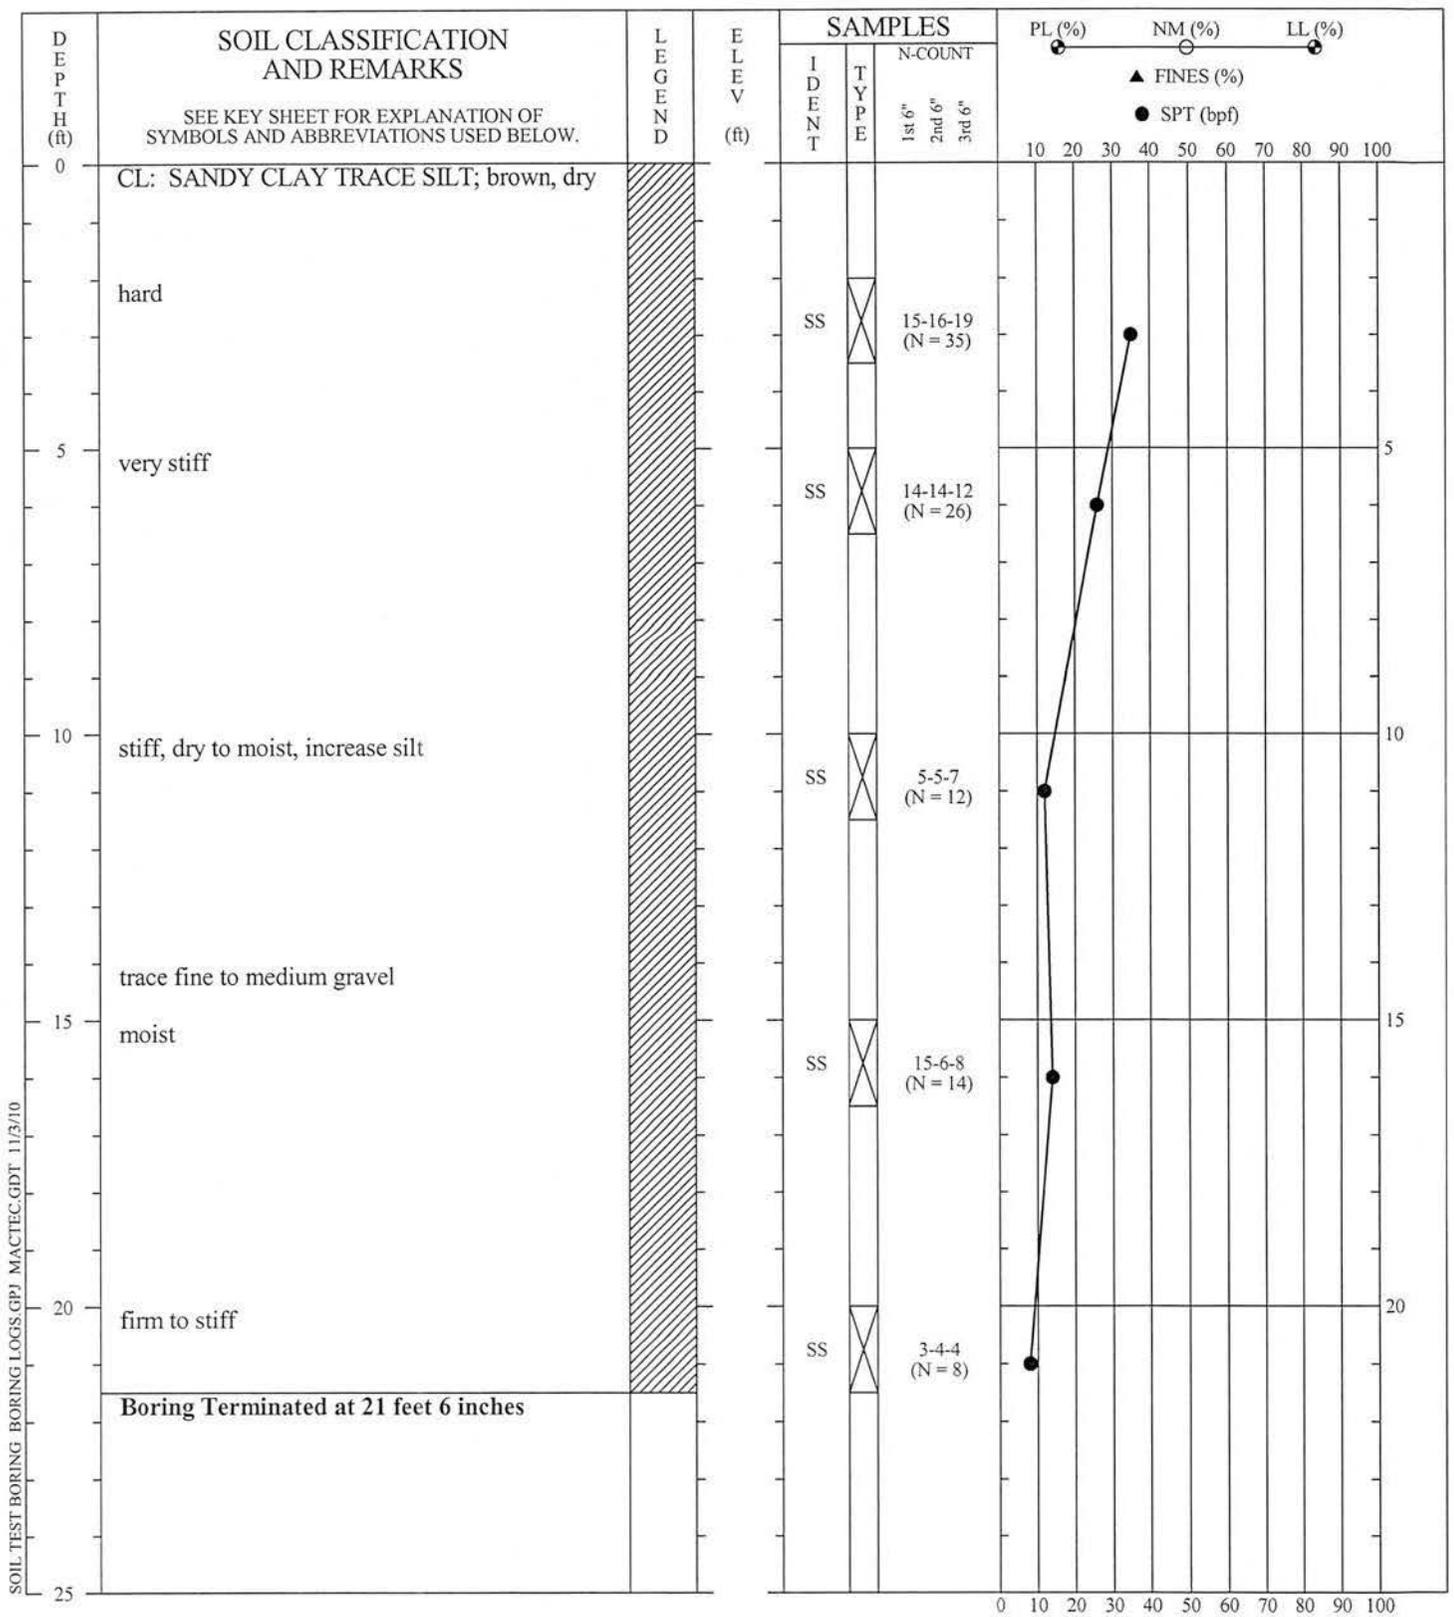
DRILLER: D&S Drilling
 EQUIPMENT: Diedrich D-50 (Auto-Hammer)
 METHOD: 8" HSA
 HOLE DIA.: 8 inches
 REMARKS: No Groundwater Encountered

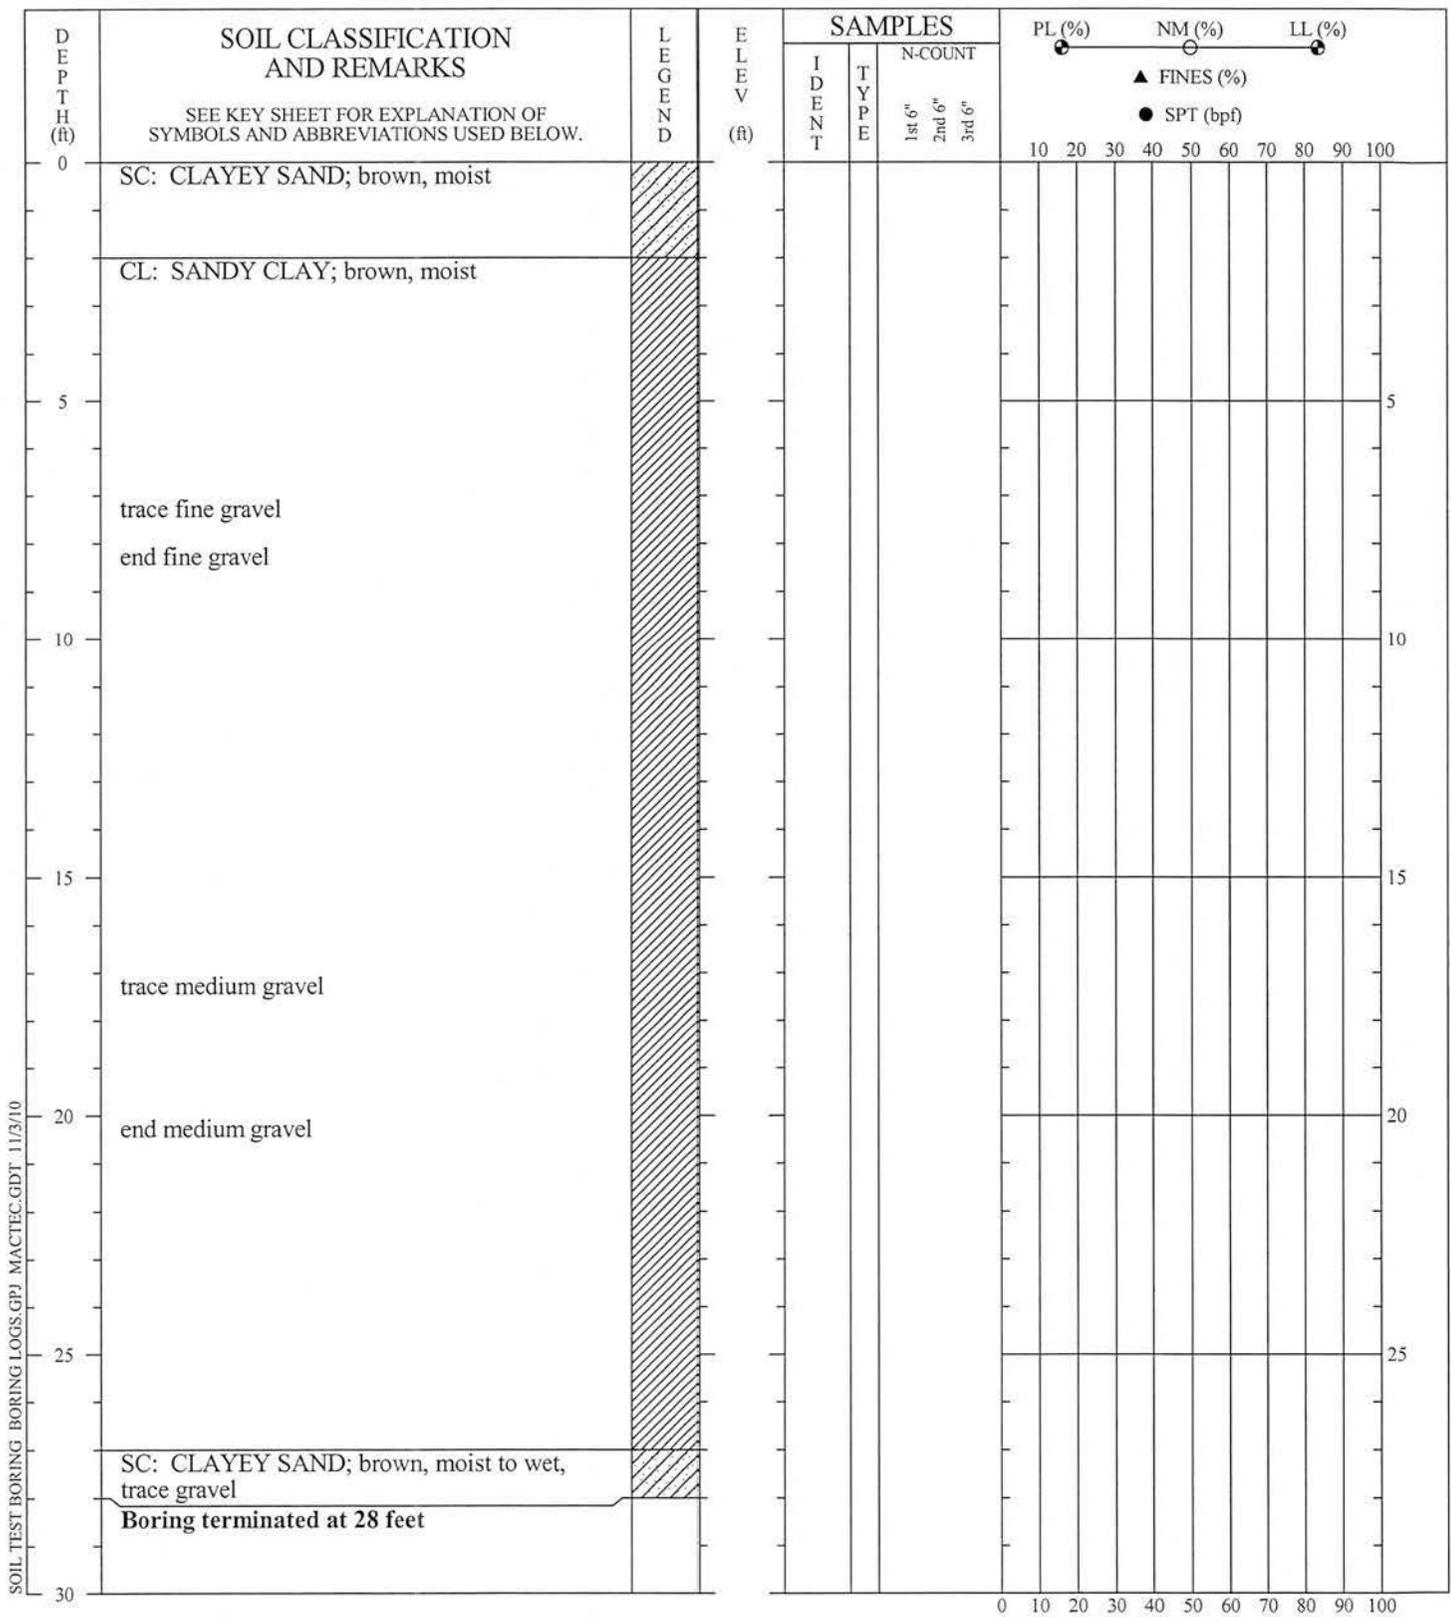
DRILLER: D&S Drilling
EQUIPMENT: Diedrich D-125 (Auto-Hammer)
METHOD: 12" HSA
HOLE DIA.: 12 inches
REMARKS: No Groundwater Encountered. Boring Located in Alfalfa Field

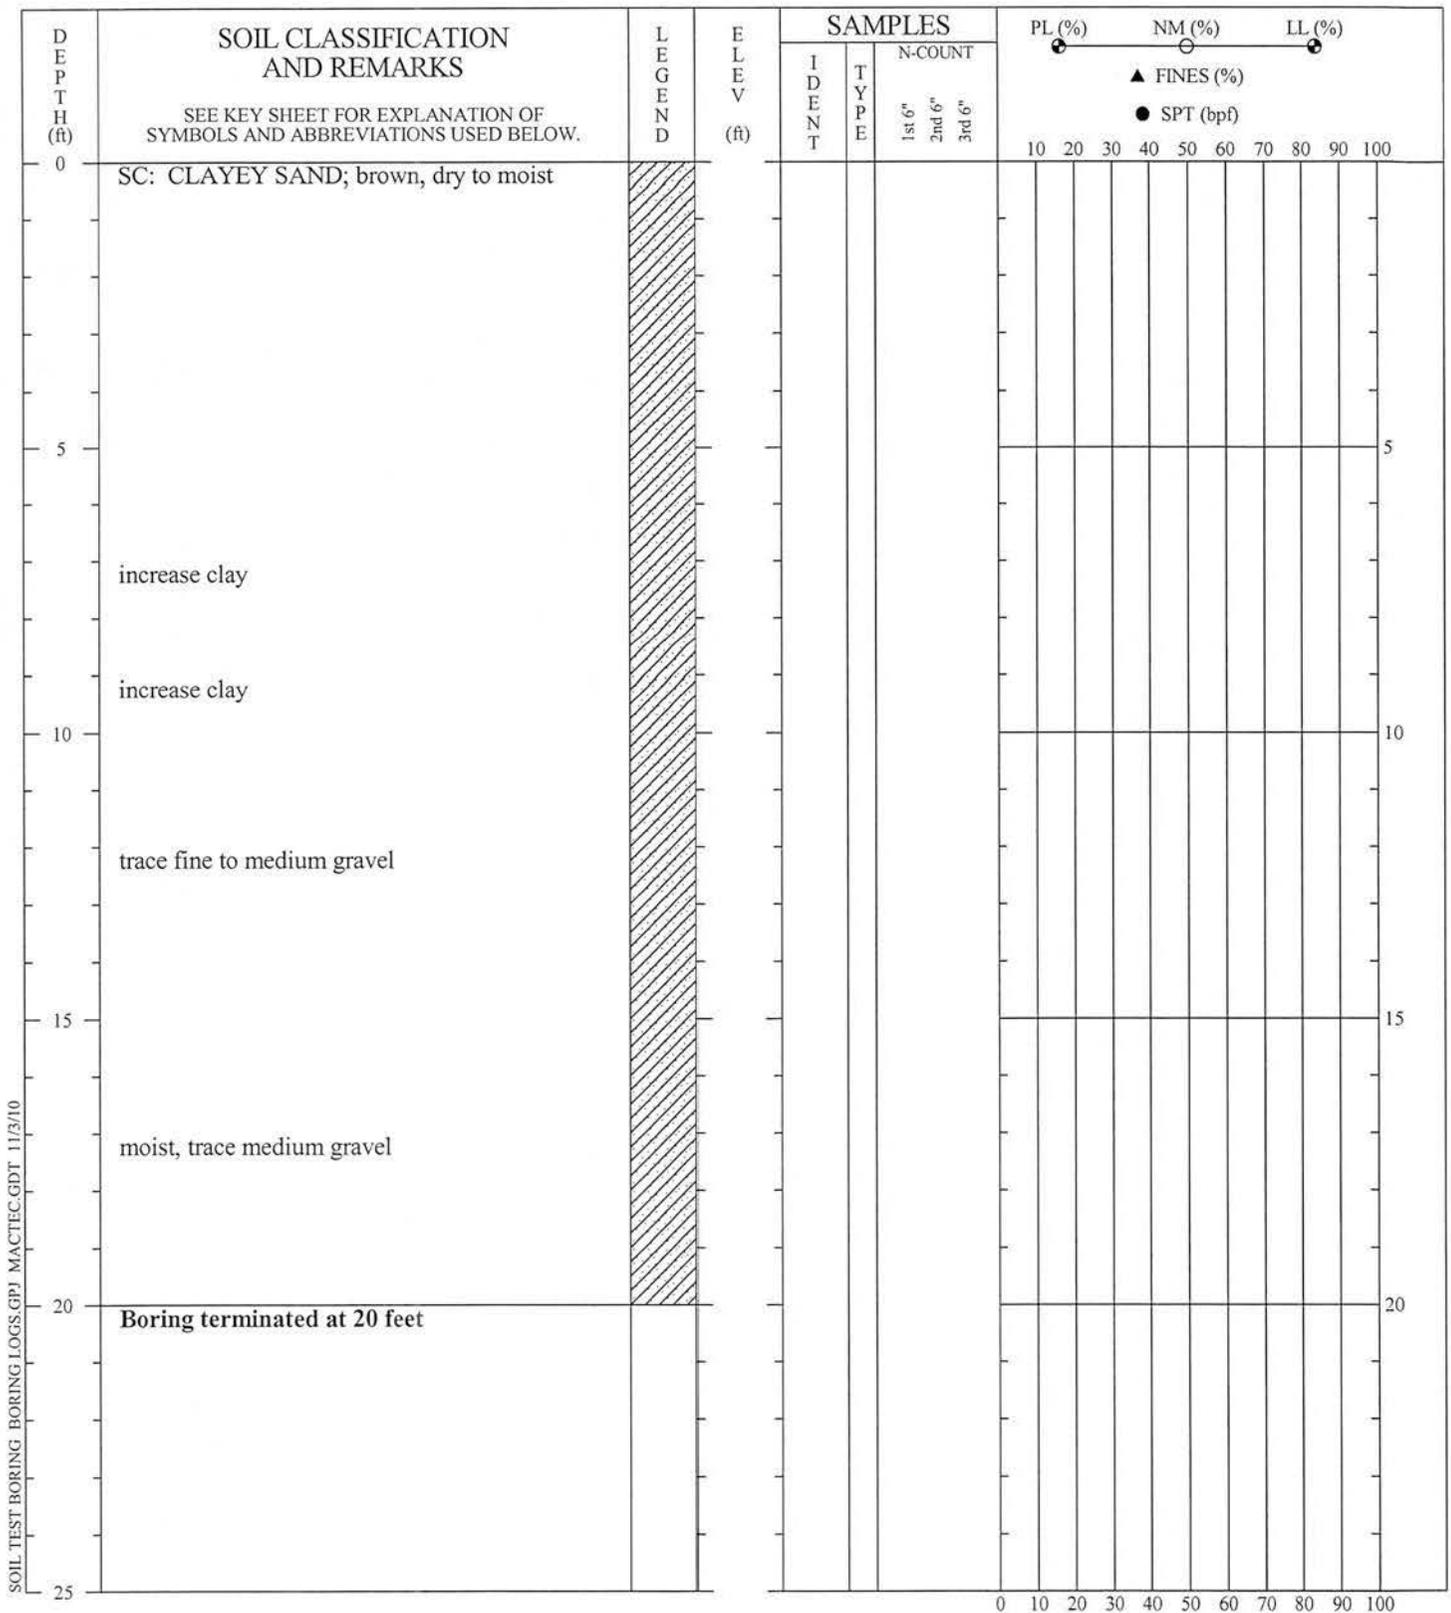
DRILLER: D&S Drilling
 EQUIPMENT: Diedrich D-125 (Auto-Hammer)
 METHOD: 12" HSA
 HOLE DIA.: 12 inches
 REMARKS: No Groundwater Encountered. Boring Located in Alfalfa Field

SOIL TEST BORING RECORD	
BORING NO.:	P2
PROJECT:	Durango Regional Conveyance Channel
LOCATION:	Elwood Alignment Between 75th & 107th Ave
DRILLED:	October 14, 2010
PROJECT NO.:	4975-10-8043.01
PAGE 1 OF 1

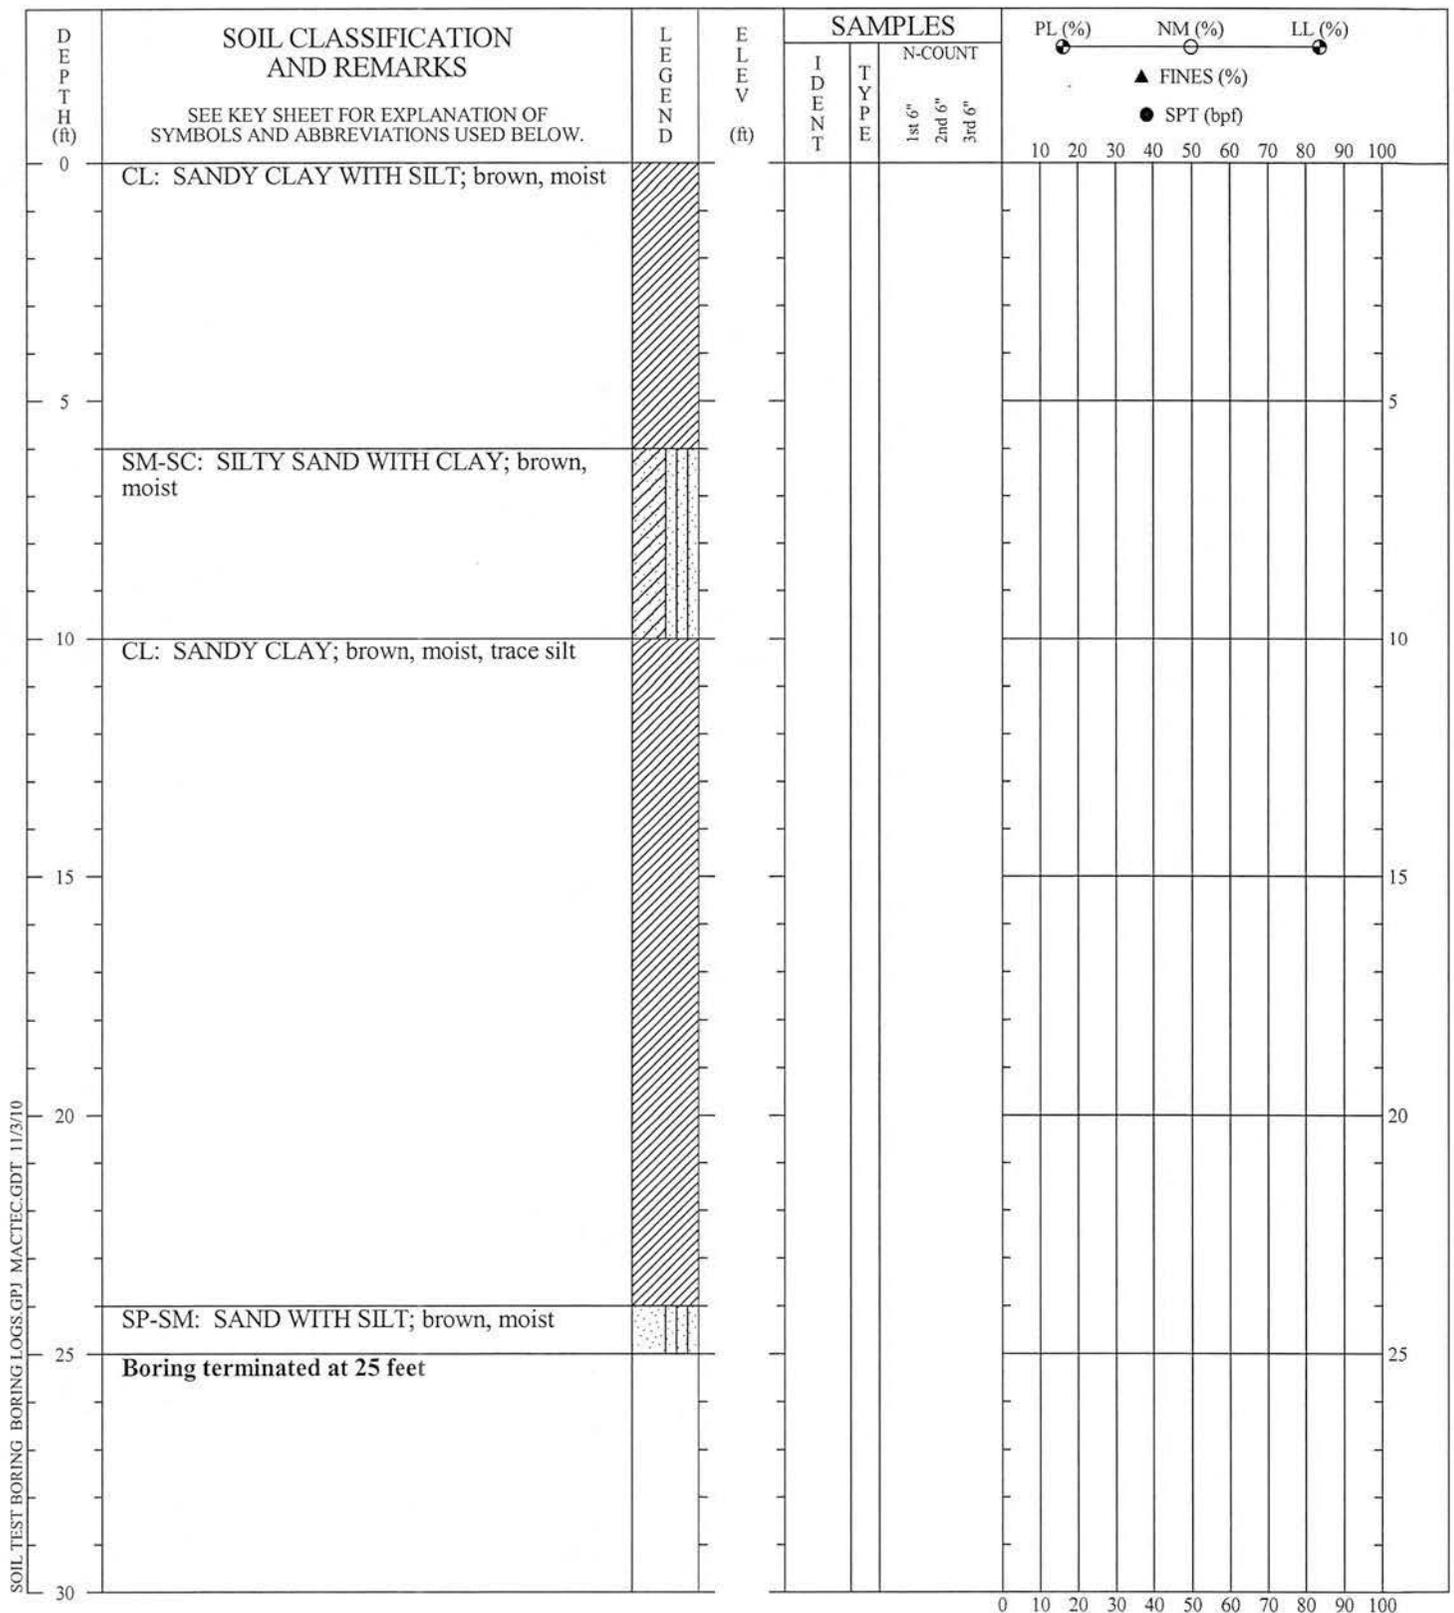
DRILLER: D&S Drilling
 EQUIPMENT: Diedrich D-125 (Auto-Hammer)
 METHOD: 12" HSA
 HOLE DIA.: 12 inches
 REMARKS: No Groundwater Encountered. Boring Located in Alfalfa Field
