Subject: ENG-Stability and Erosion Analysis of the RWCD  
Floodway Reaches 1 and 2

Date: May 23, 1985

Introduction

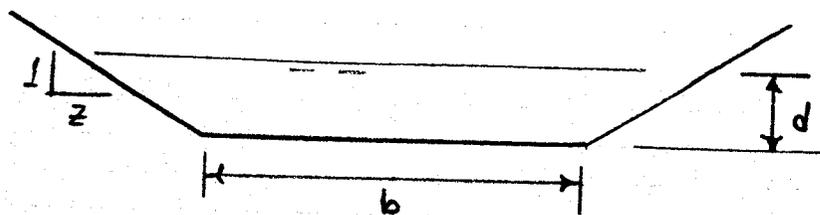
STATE		PROJECT RCD Floodway			
BY [Signature]	DATE 5/21/85	CHECKED BY	DATE	JOB NO.	
SUBJECT Flow Analysis				SHEET 2 OF 5

- $Q = (1.486/m) A R^{2/3} \sqrt{S_0}$  , cfs
- $A = (b \cdot d) + (z \cdot d^2)$  , ft<sup>2</sup>
- $P = b + d \sqrt{1+z^2}$  , ft
- $R = A/P$  , ft
- $\tau = \gamma R S_0$  , #/ft<sup>2</sup>
- $V = Q/A$  , fps
- tractive power =  $\tau \cdot V$  , ft-# / sec / ft<sup>2</sup>
- $d_{50} \geq 11 \cdot d \cdot S_0$  (shields initiation & motion) , ft.

Reach No.	cfs Q	ft b	z	ft/ft S <sub>0</sub>	m	remarks
1 & 2 below conc. chute	8700	200	3	0.0015	0.027	design historical
	2500	200	3	0.0015	0.027	
2 above conc. chute	8700	200	3	0.0003	0.027	design historical
	2500	200	3	0.0003	0.027	
3	8100	200	3	0.0003	0.027	design historical
	2328	200	3	0.0003	0.027

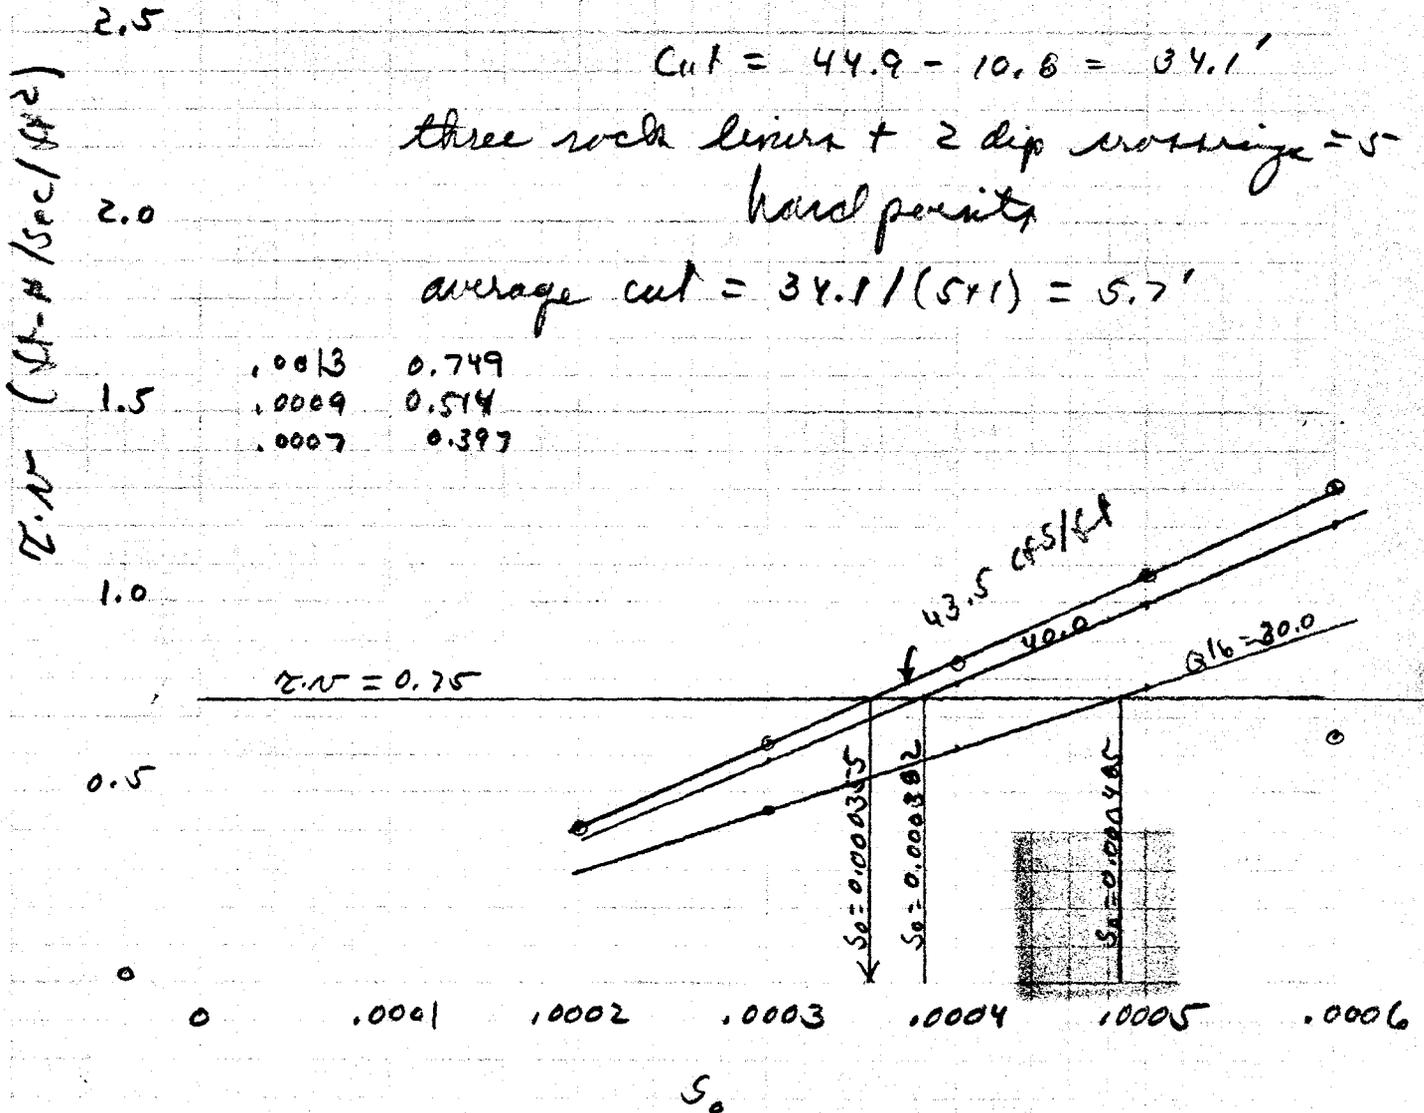
three rock lines + 2 dip crossings = 5 hard points

average cut = 34.1 / (5+1) = 5.7'

S<sub>0</sub> = 0.000448

The distance between the downstream end of the concrete chute and (sta 1160+22) and upstream end of the rock chute (sta 1464+00) is 30,378 feet with a drop of 44.9 feet. The compacted earth-lining can safely withstand only 10.8 feet of that fall. There are 4291 feet of rock-lined sections that safely removed 6.4 feet of the drop. The remaining 27.7 feet of fall must be safely withstood or that much accumulative bed degradation can be eventually expected with subsequent downstream deposition that will encroach on the design capacity.
