SIGNAL BUTTE  
F.R.S.

Design Report

Soil  
Conservation  
Service

April 17, 1985

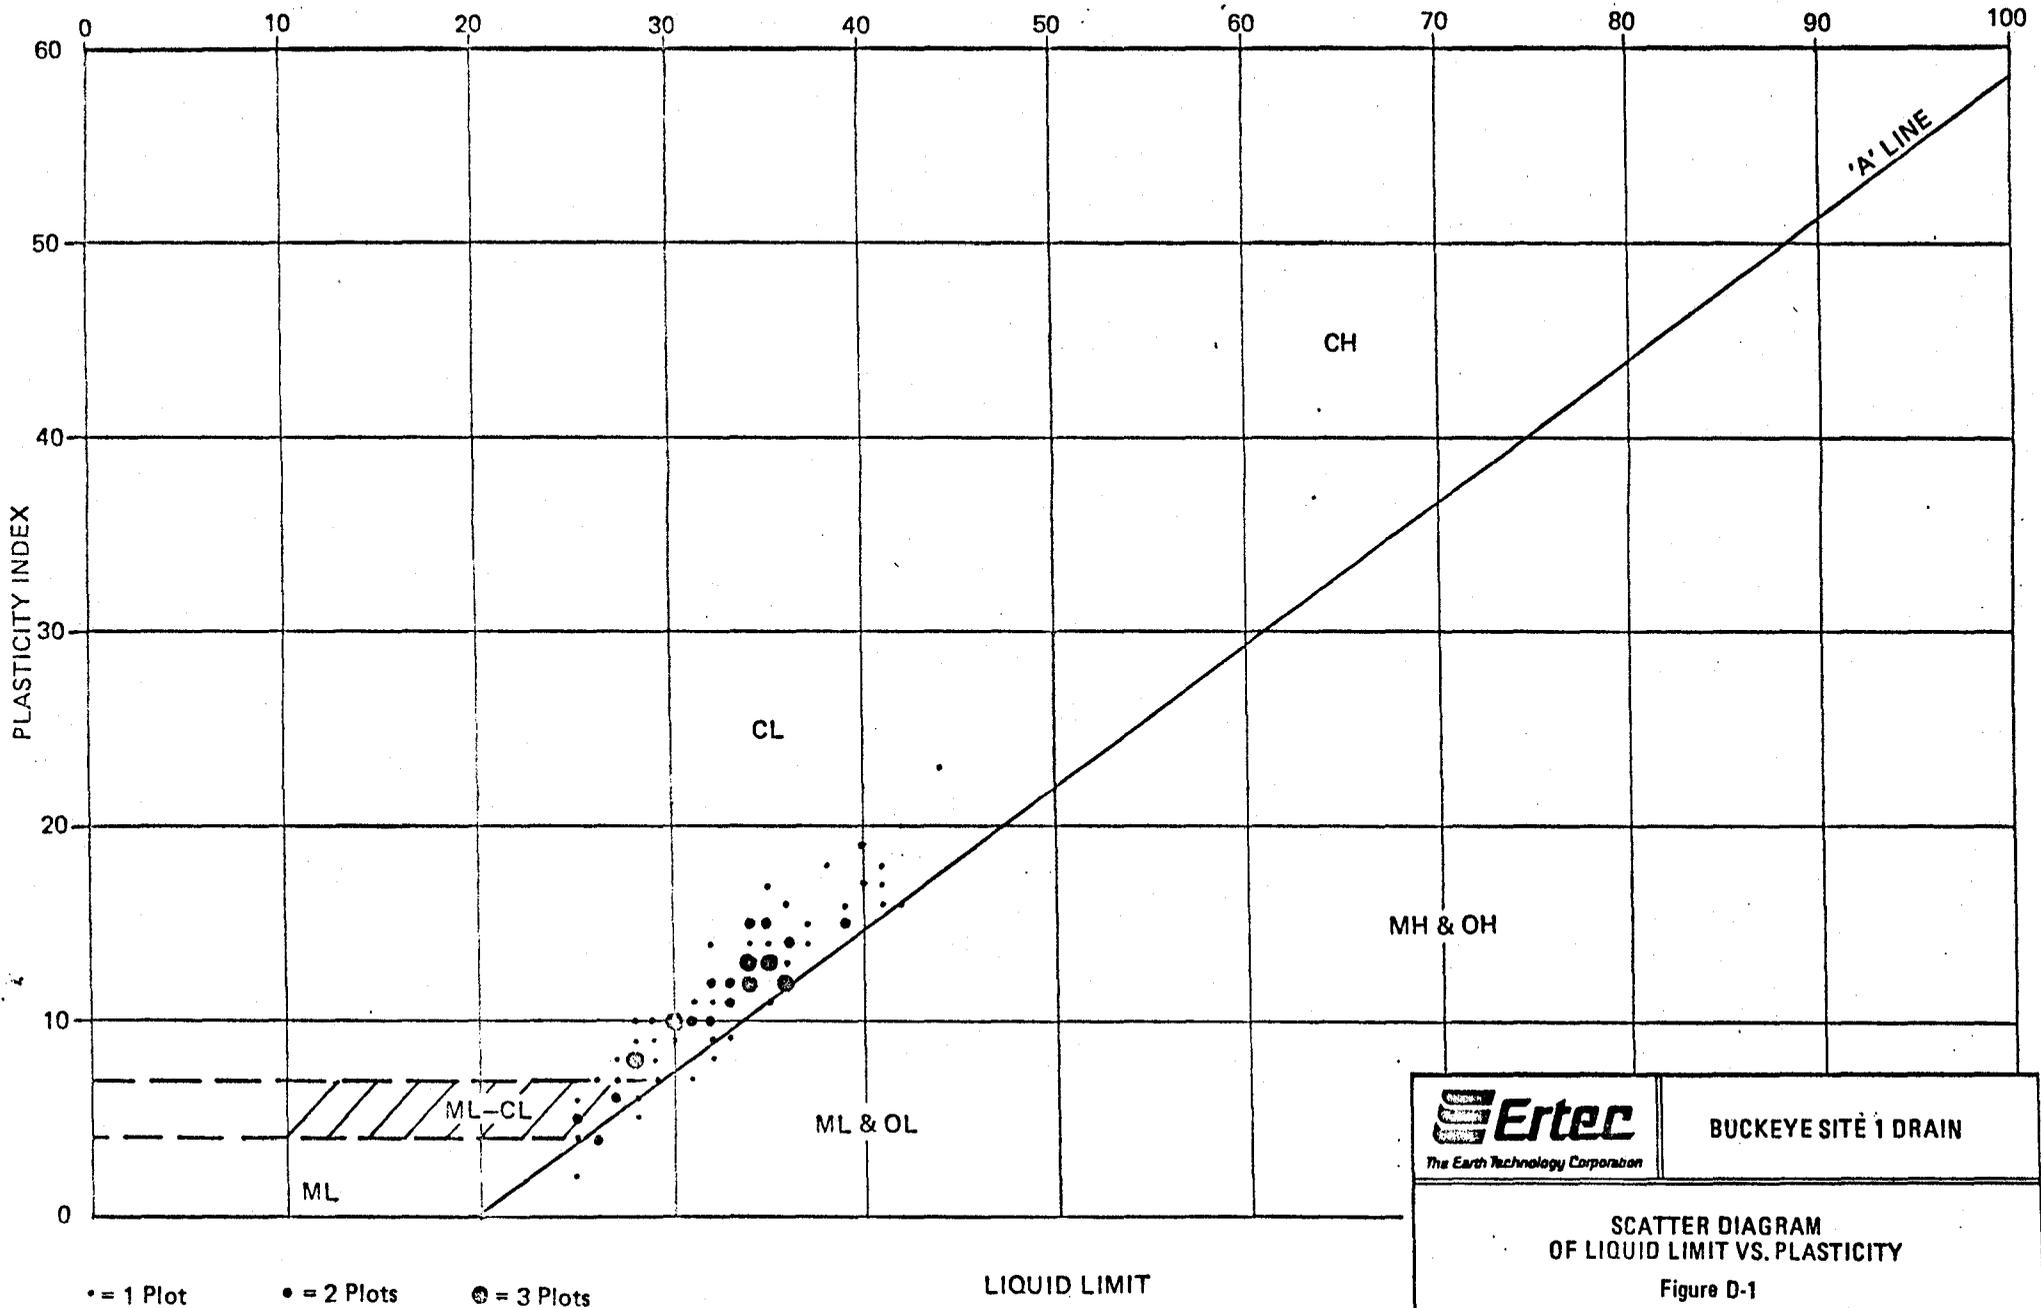
SCATTER DIAGRAM OF LIQUID LIMIT VS. PLASTICITY INDEX  
 BUCKEYE NO. 1 F.R.S.

The Earth Technology Corporation	BUCKEYE SITE 1 DRAIN
SCATTER DIAGRAM OF LIQUID LIMIT VS. PLASTICITY Figure D-1 Ertec (formerly Fugro) Project Number 80-200 SCS Contract Number 53-8A02-0-00113

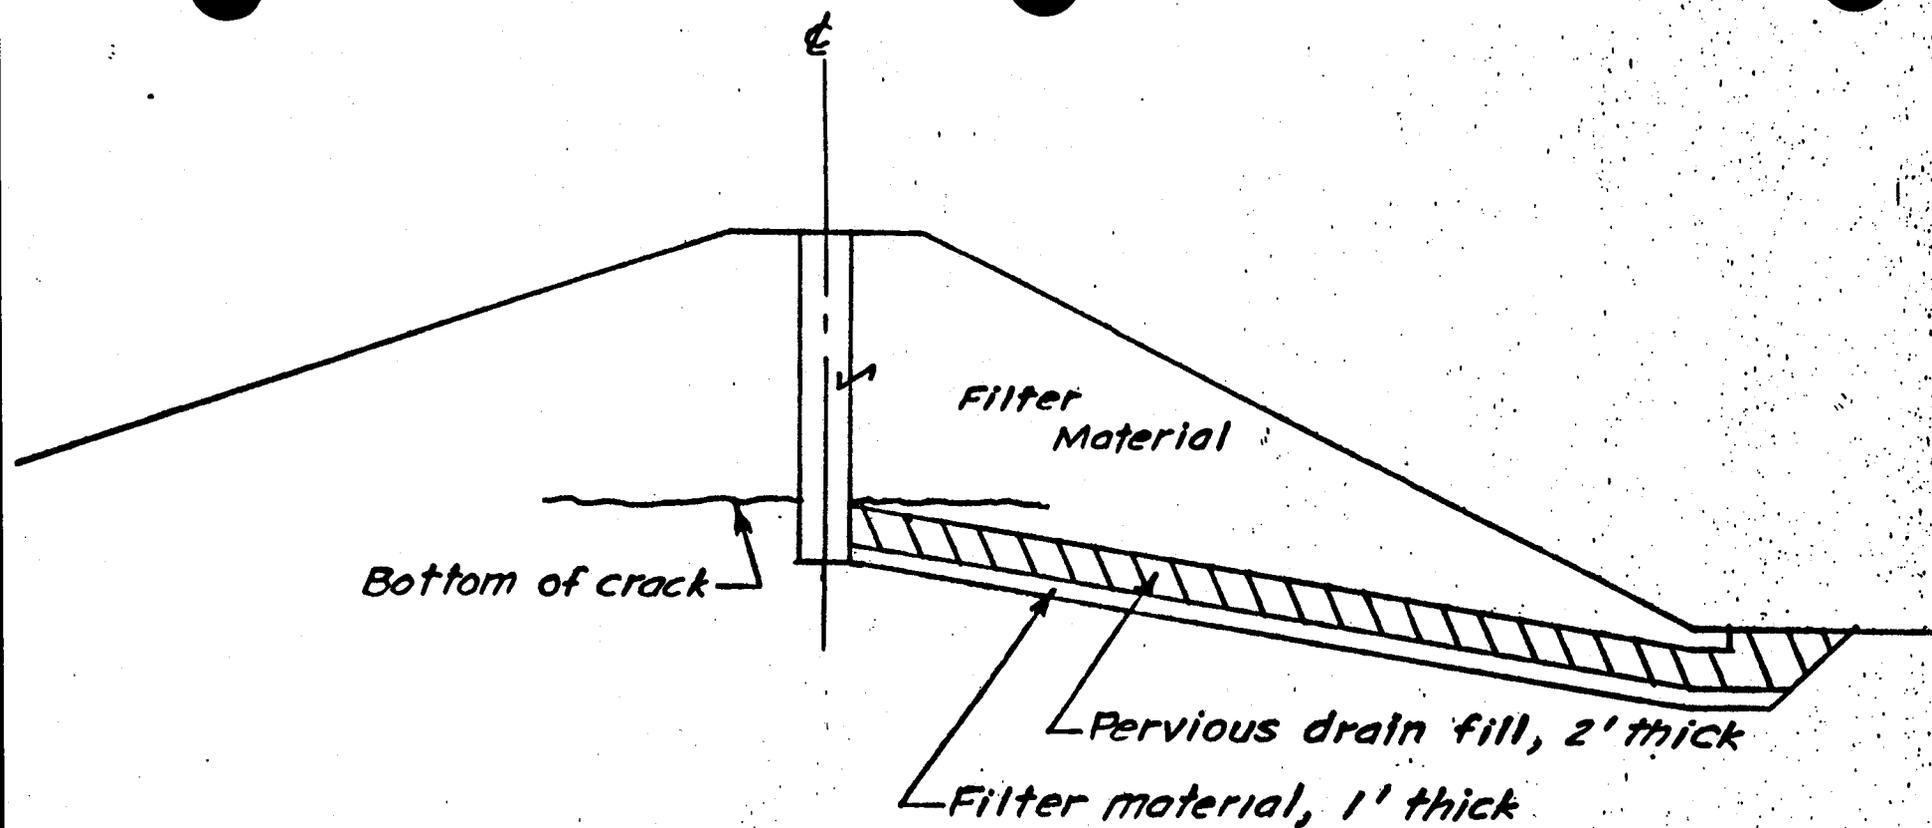
Bottom of crack

Filter Material

2. To prevent filter material from washing into cracks downstream:

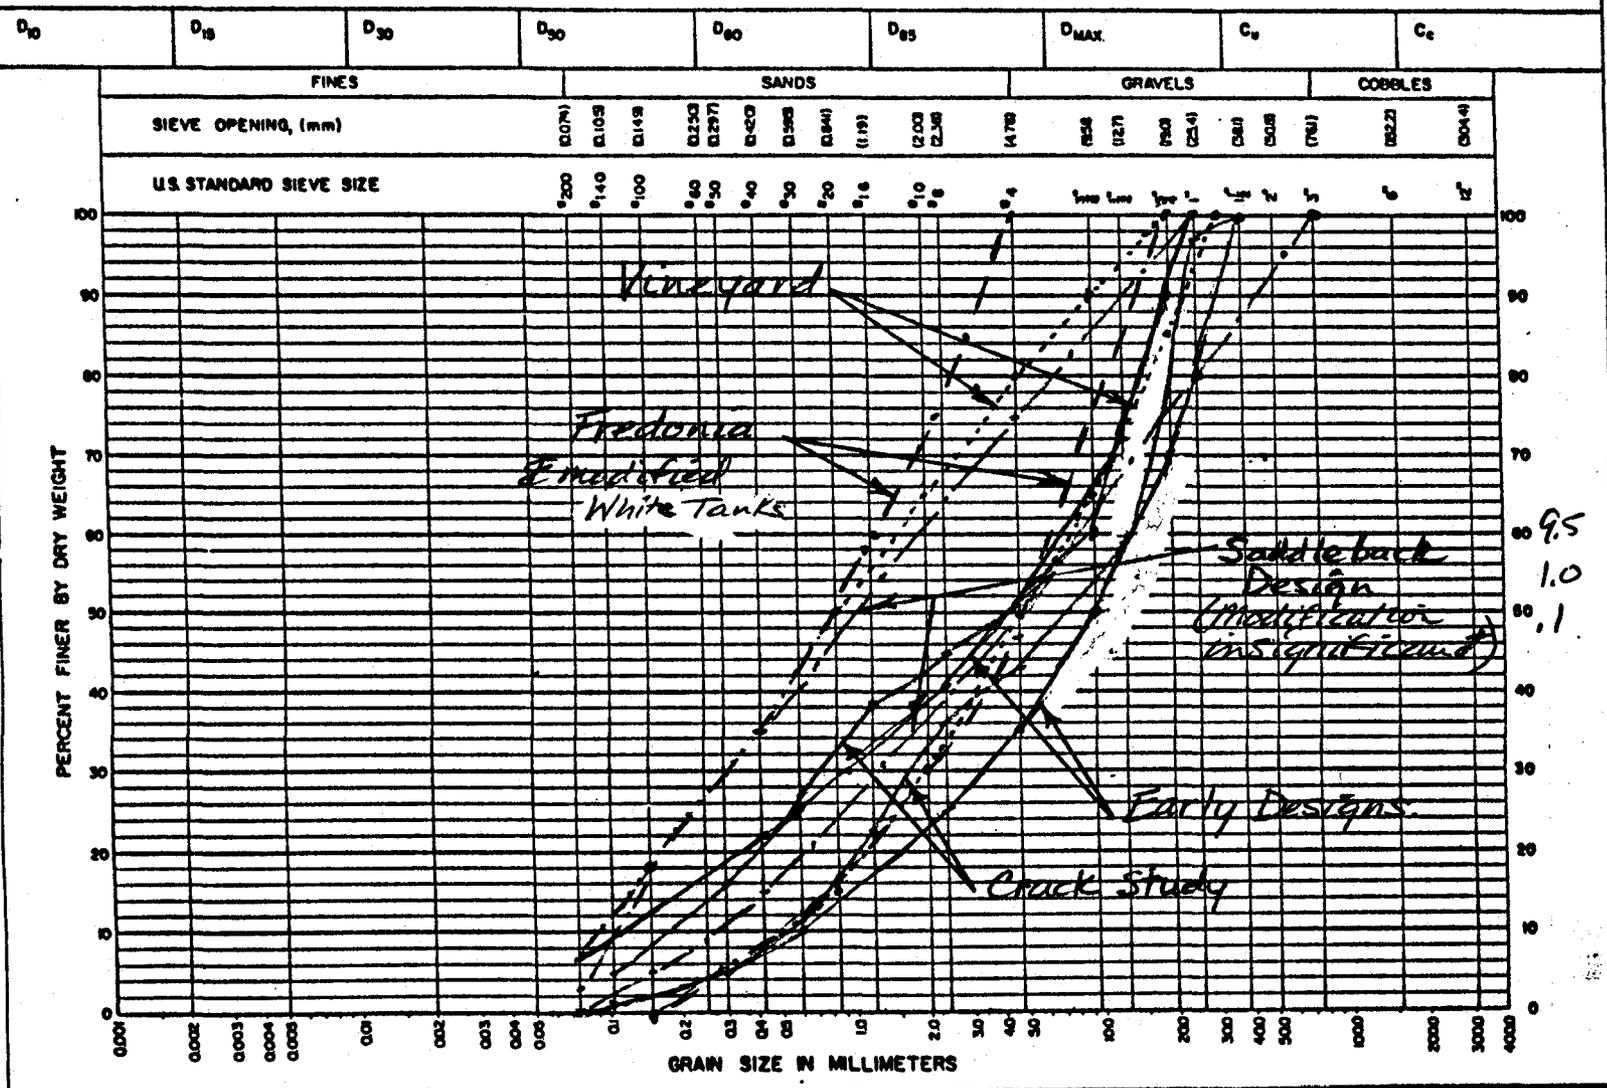
**GRAIN SIZE DISTRIBUTION**

SPECIFIC GRAVITY (G <sub>s</sub> )		ATTERBERG LIMITS				SOLUBLE SALTS		SHRINKAGE LIMIT		UNDISTURBED CONDITION	
		NATURAL MOISTURE		AIR DRY		OVEN DRY				MOISTURE	
(-) <sup>0.4</sup>	(+) <sup>0.4</sup>	LL	PI	LL	PI	LL	PI	%	%	%	g/cc
											pcf

REMARKS: *2.1 mm 3 mm* *1.25 0.3 0.1* *C<sub>c</sub> = 1.72 C<sub>u</sub> = 12.5*
