**CORRESPONDENCE REPORT
FOR
SKUNK CREEK CHANNEL IMPROVEMENTS**

FCD CONTRACT No. 95-38
90% SUBMITTAL

JANUARY, 1998

Prepared by:
Simons, Li & Associates, Inc.
4600 South Mill Avenue, Suite 200
Tempe, Arizona 85282
(602) 491-1393

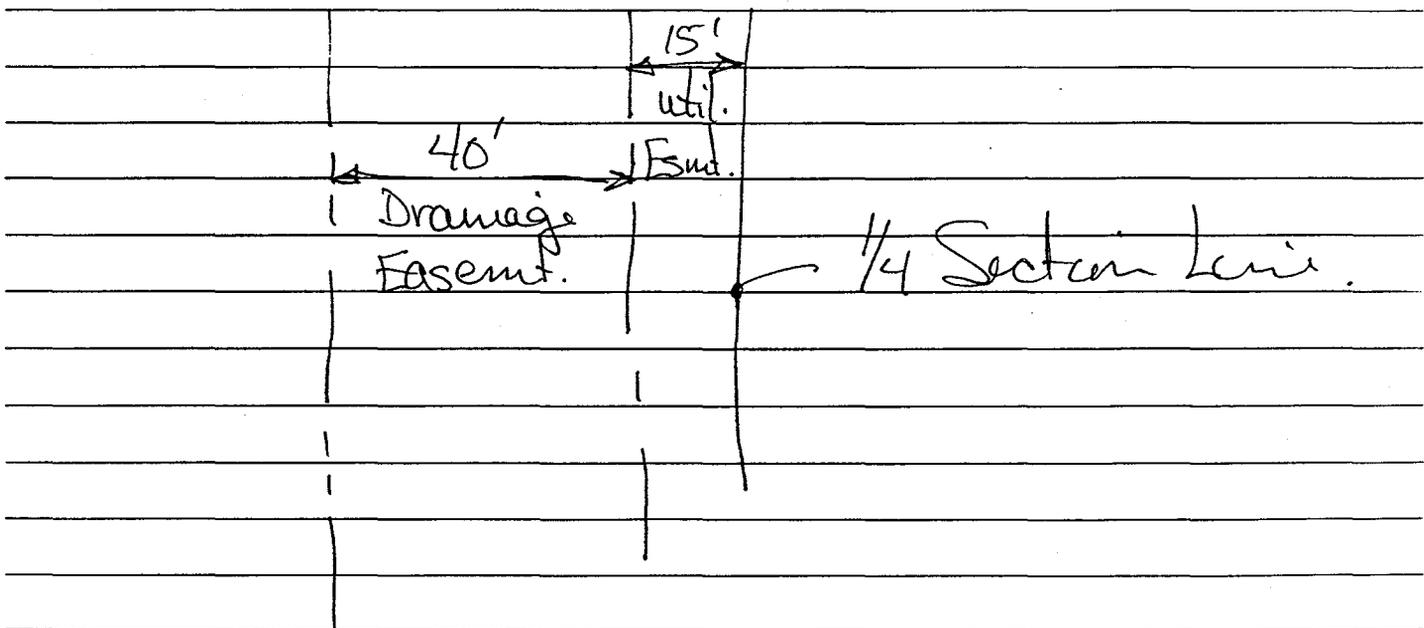
ITEMS DISCUSSED: Ken gave me the following
info on R/W @ the 55th Ave Channel.

Check against location of AP's poles.
