# **90 PERCENT DESIGN REPORT**

**WHITE TANKS FLOOD RETARDING STRUCTURE NO. 3  
REMEDICATION DESIGN PROJECT  
PHASE 1**

**FLOOD CONTROL DISTRICT OF MARICOPA COUNTY**

**CONTRACT FCD 2004C017**

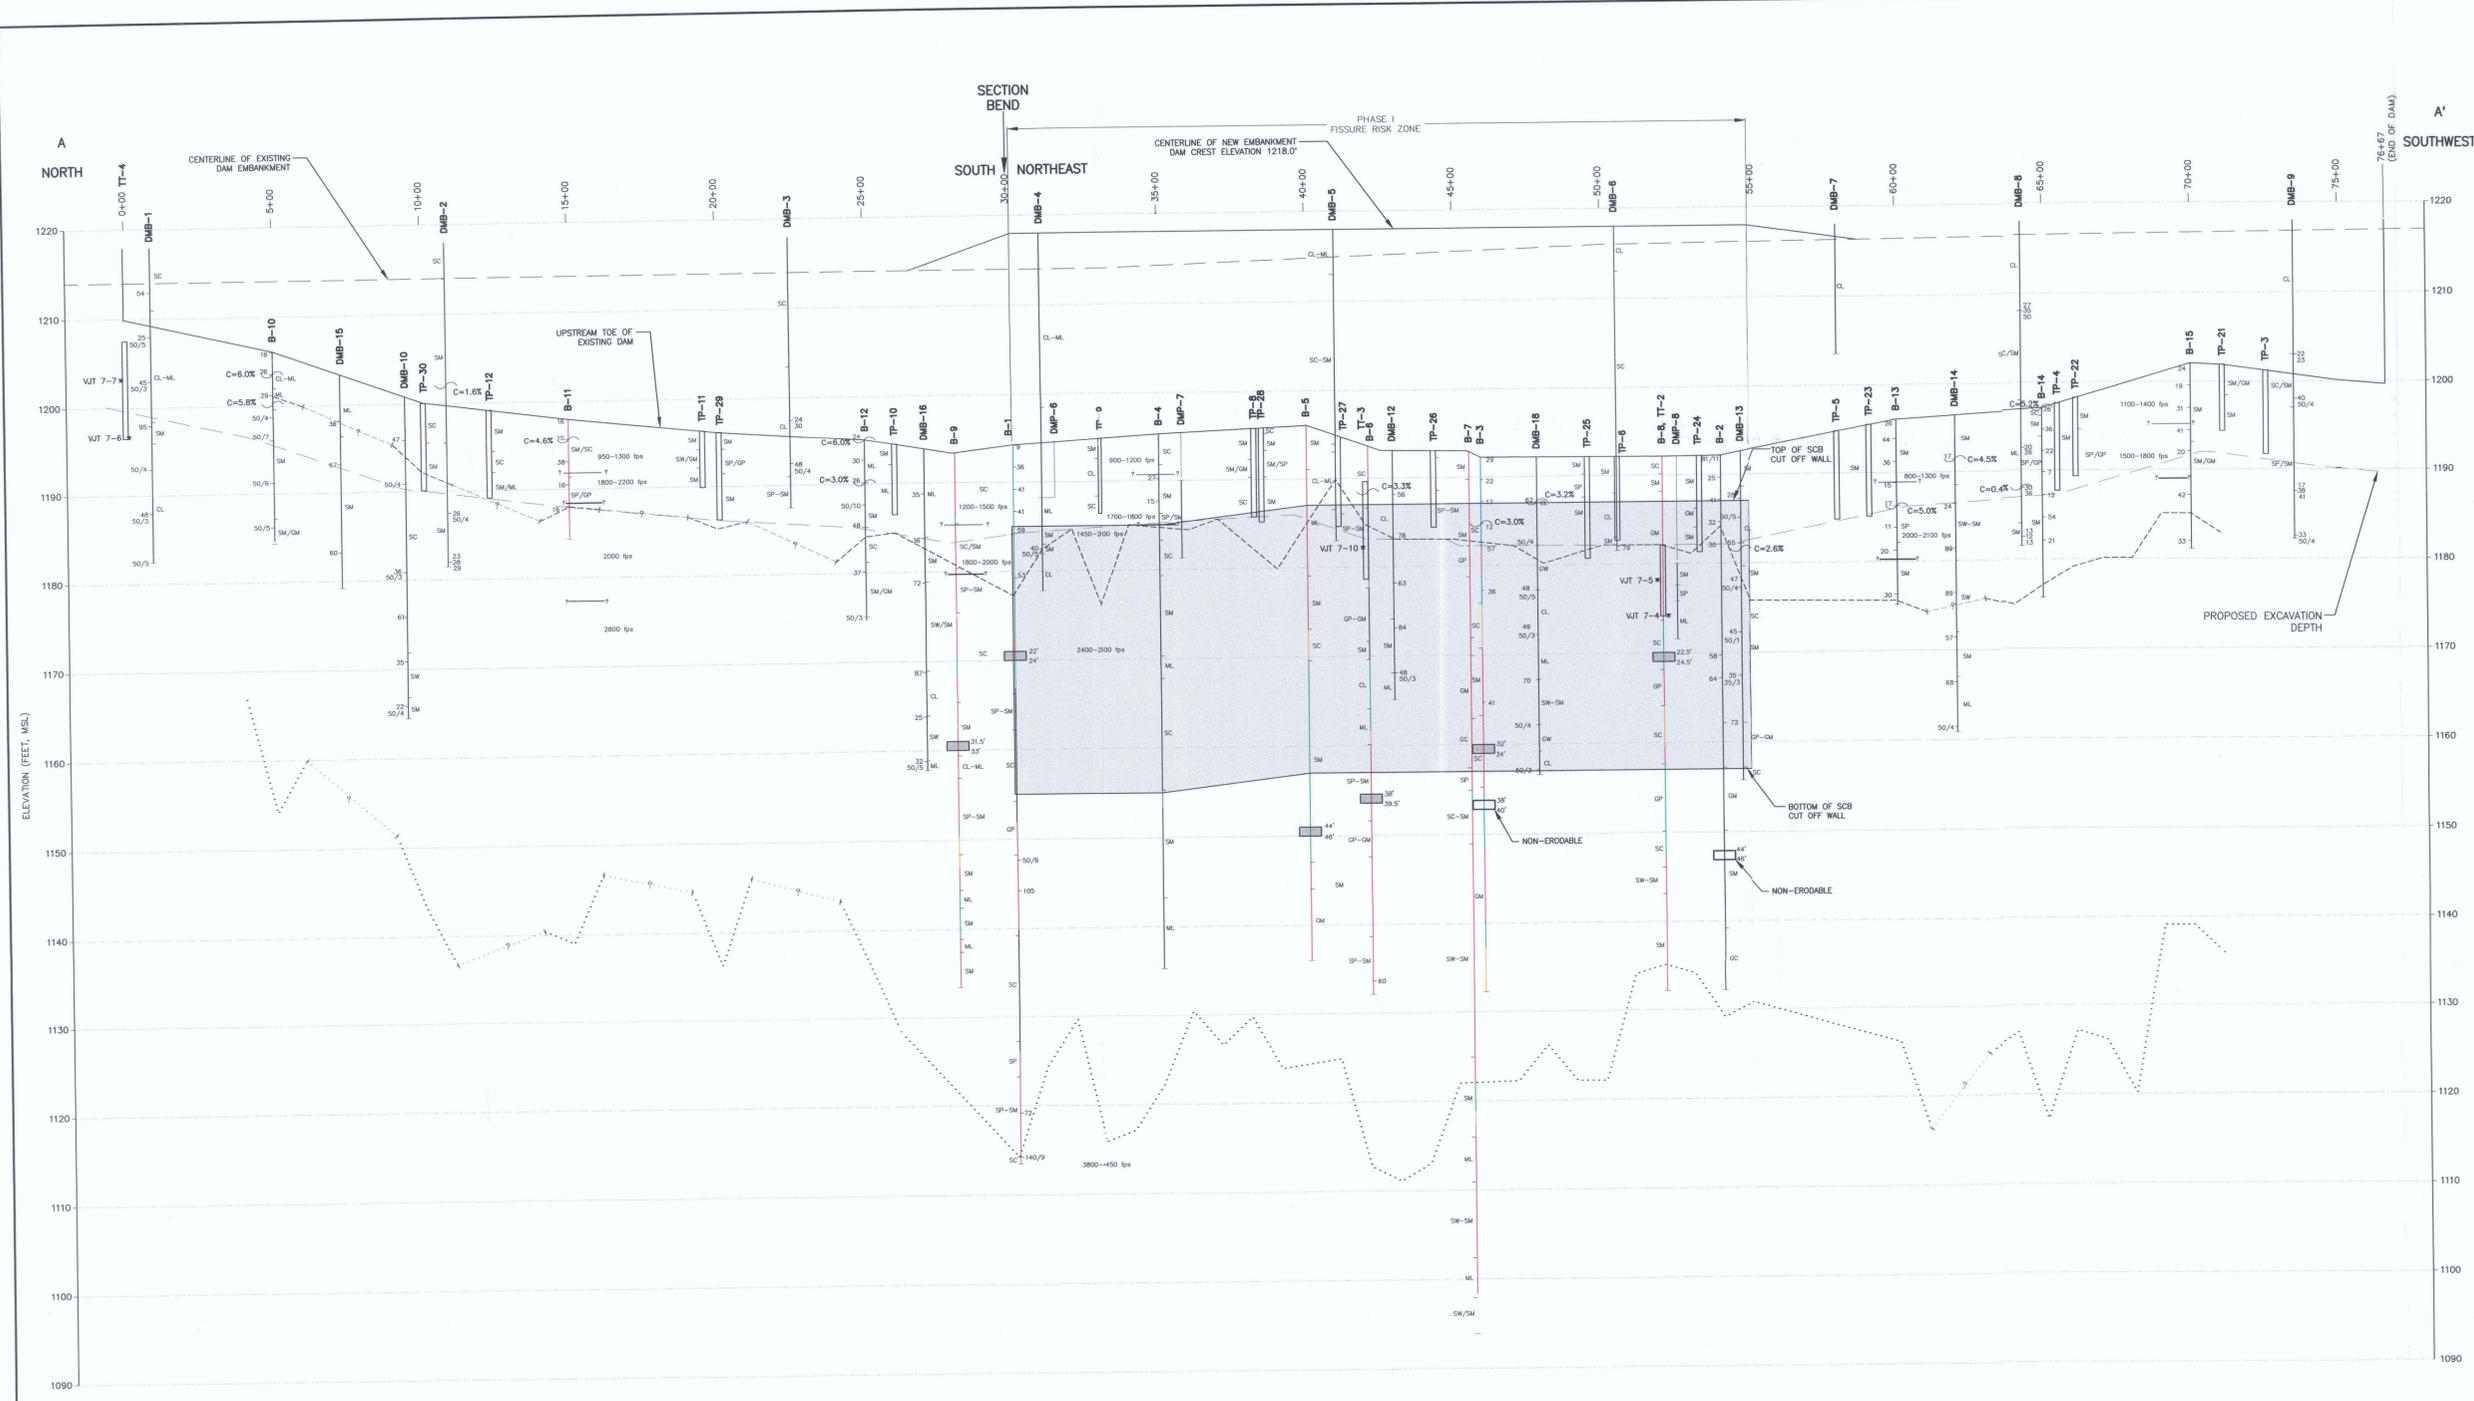
WHITE TANKS F.R.S. NO. 3  
 GENERALIZED CROSS SECTION A-A'  
 FIGURE 7-2  
 URS JOB NO. 2343748

**LEGEND**  
 GEOCONSULTANTS SEISMIC REFRACTION LINES (JULY 2004)

Locations of all previous and current test and exploration locations are shown in plan view on Figure 7-1. A graphical representation of embankment foundation soil conditions is shown in section view on Figure 7-2. The focus of the characterization of subsurface soils in the following paragraphs is to establishing representative classifications, index properties, and engineering properties used in geotechnical analyses, modeling, and design.

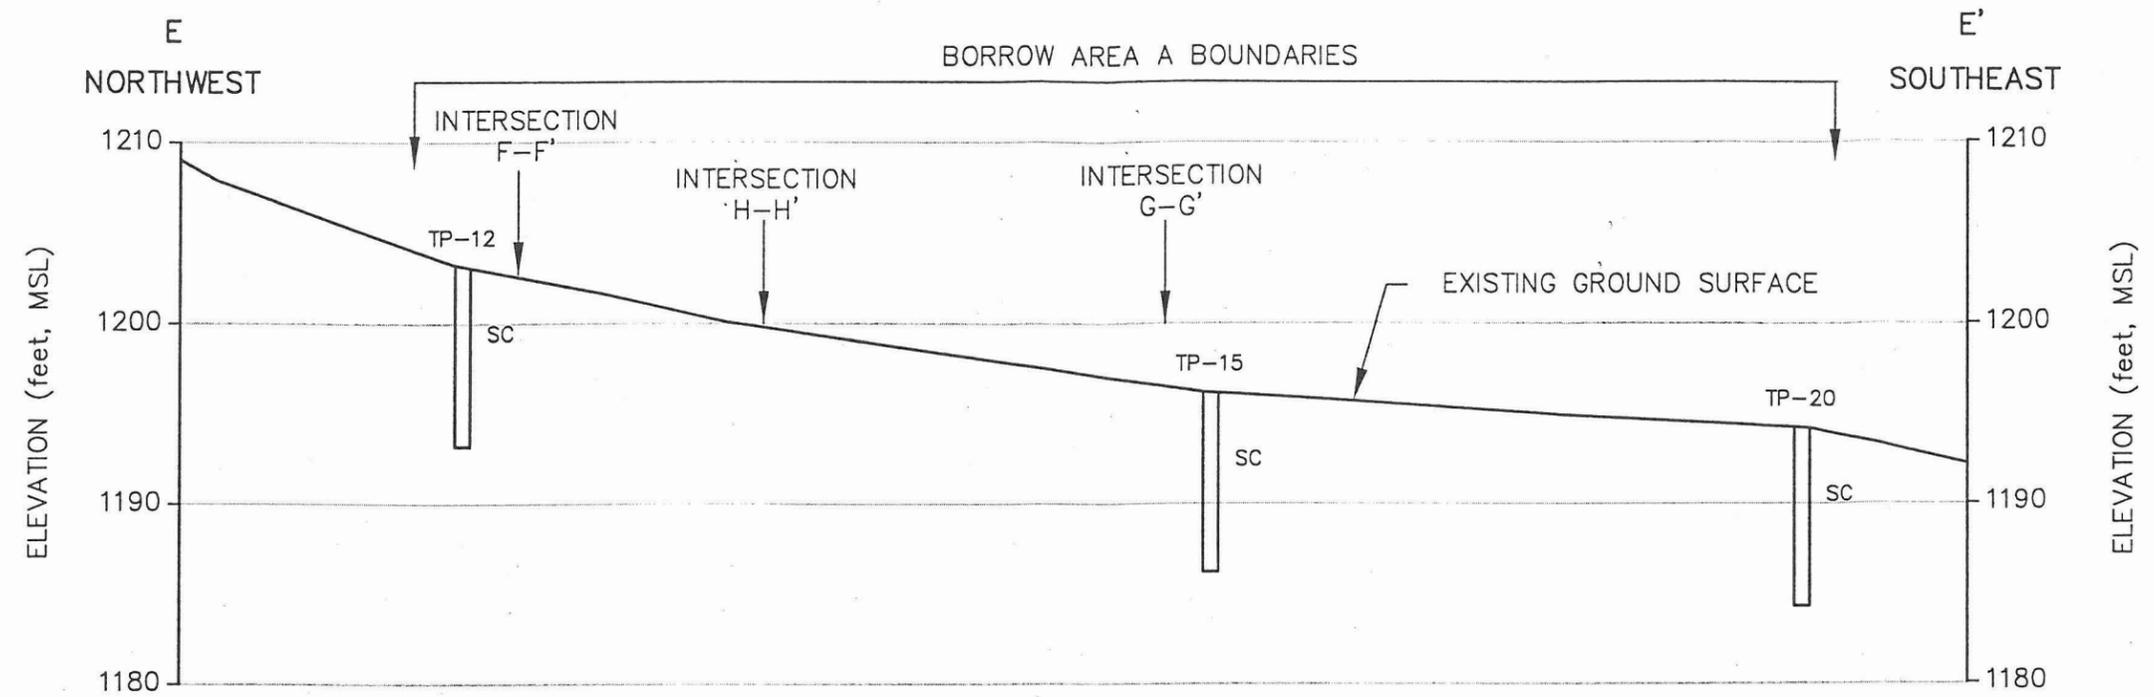
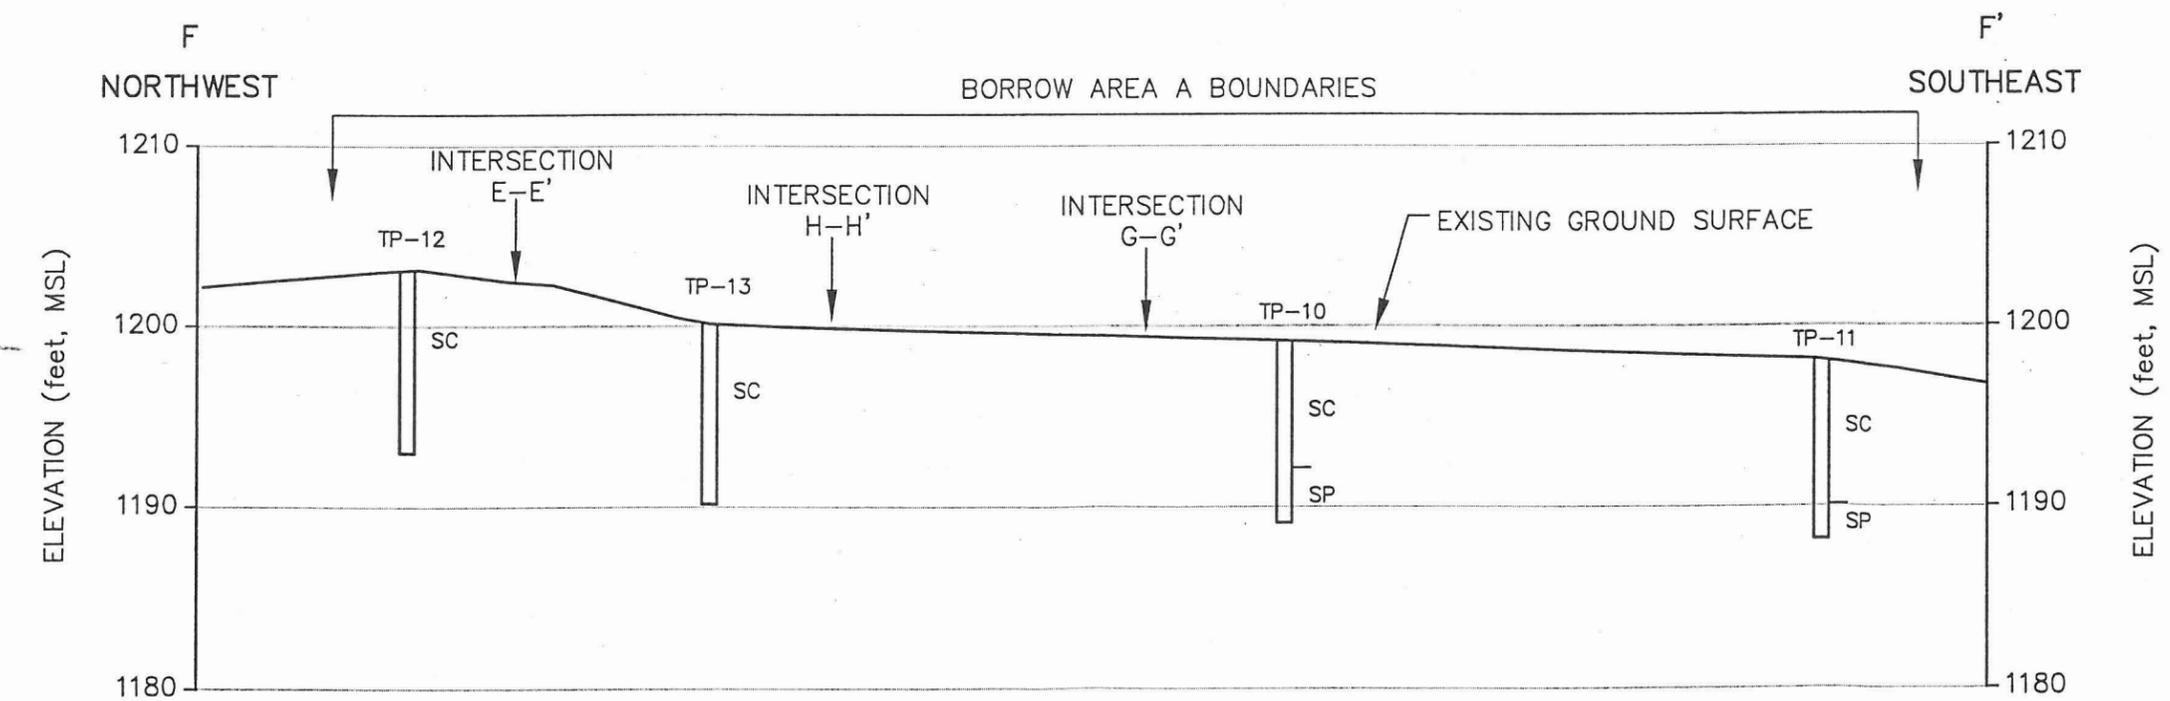
<b>EMERGENCY SPILLWAY (BORROW AREA A)</b>			
<b>GENERALIZED CROSS SECTIONS E-E' AND F-F'</b>			
<b>WHITE TANKS F.R.S. #3</b>			
<b>URS</b>	100 0 100 200 Feet	CHECKED BY:	DATE: 8-20-04
	SCALE, HOR: 1" = 200', VERT: 1" = 10'	PM:	PROJ. NO: 23443748.00037
			FIG. NO: 7-5

VERTICAL EXAGGERATION = 20x

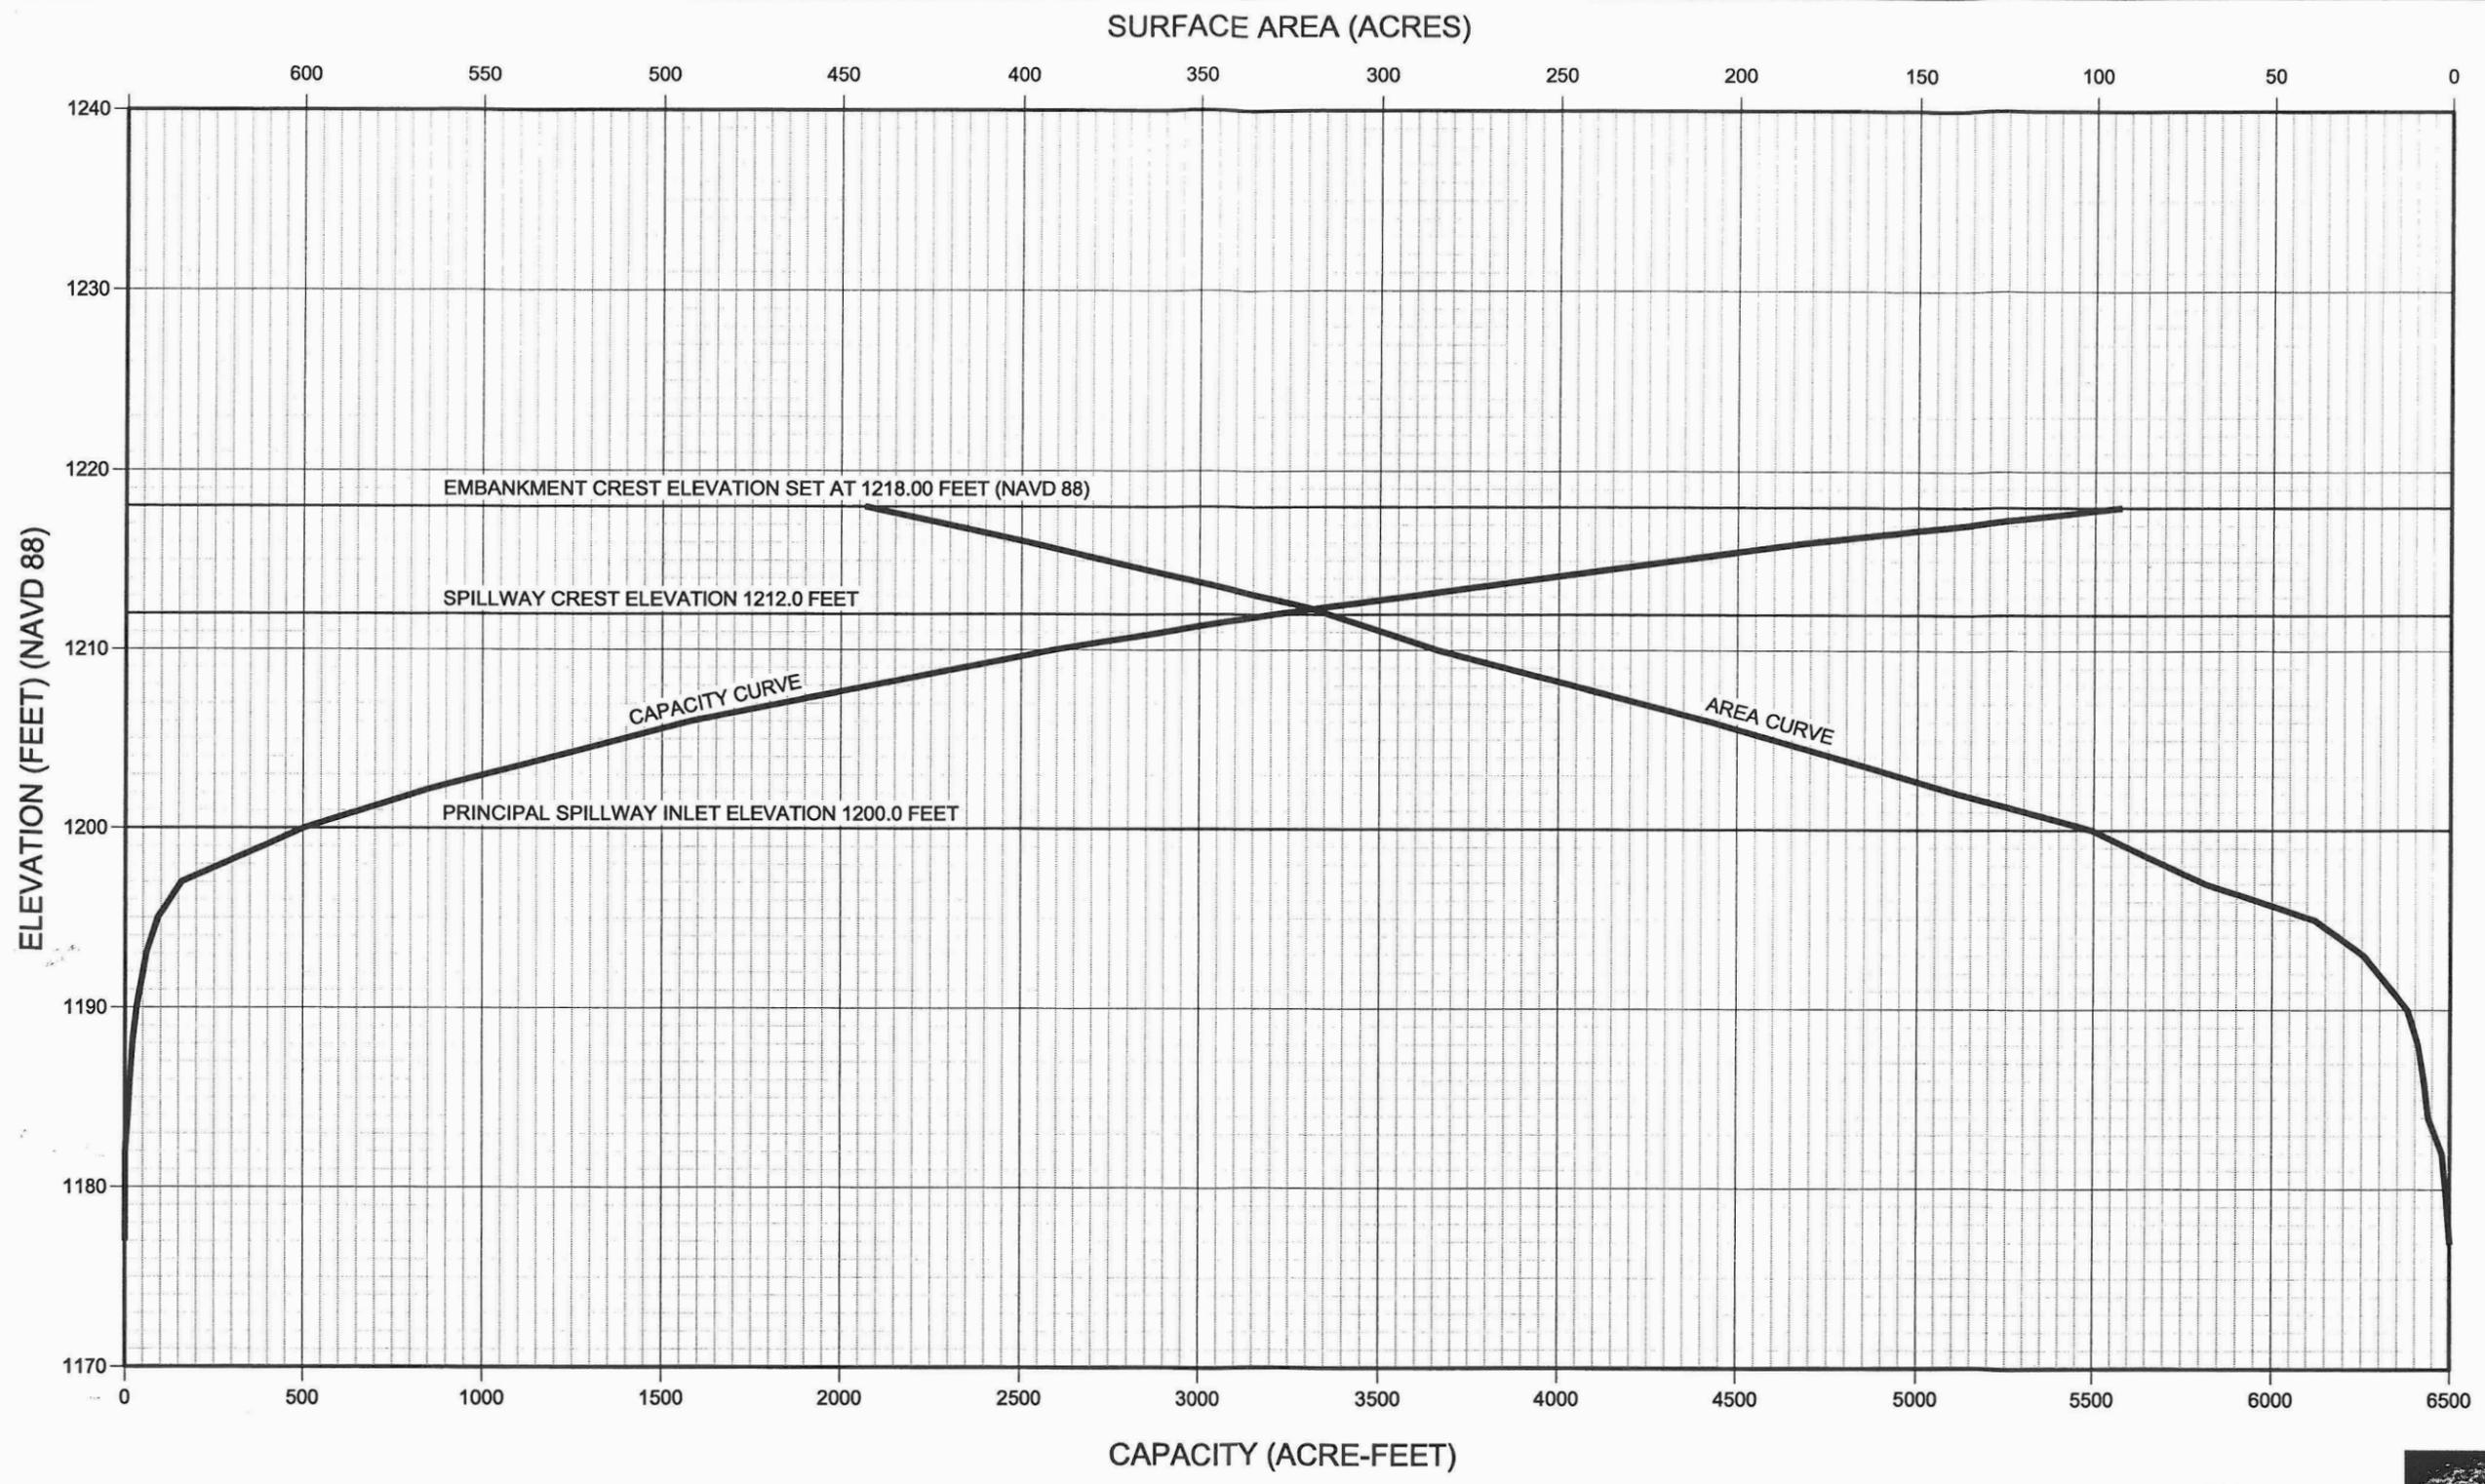
Figure 8-2

Elevation-Area-Capacity Curve

The existing elevation-area-capacity curve will be used for reservoir routing and estimating the design embankment crest elevation. The evaluation of impacts to the reservoir routing results due to estimated modifications of the elevation-area-capacity curve indicated no significant impact to the results. The elevation-area-capacity data is summarized in Table 8-3 and presented graphically on Figure 8-2. The detailed computations related to determination of elevation-area-capacity curve for White Tank FRS No.3 are provided in a calculation package in Appendix C. An as-built elevation-area-capacity curve will be developed following completion of both Phase 1 and Phase 2 construction.

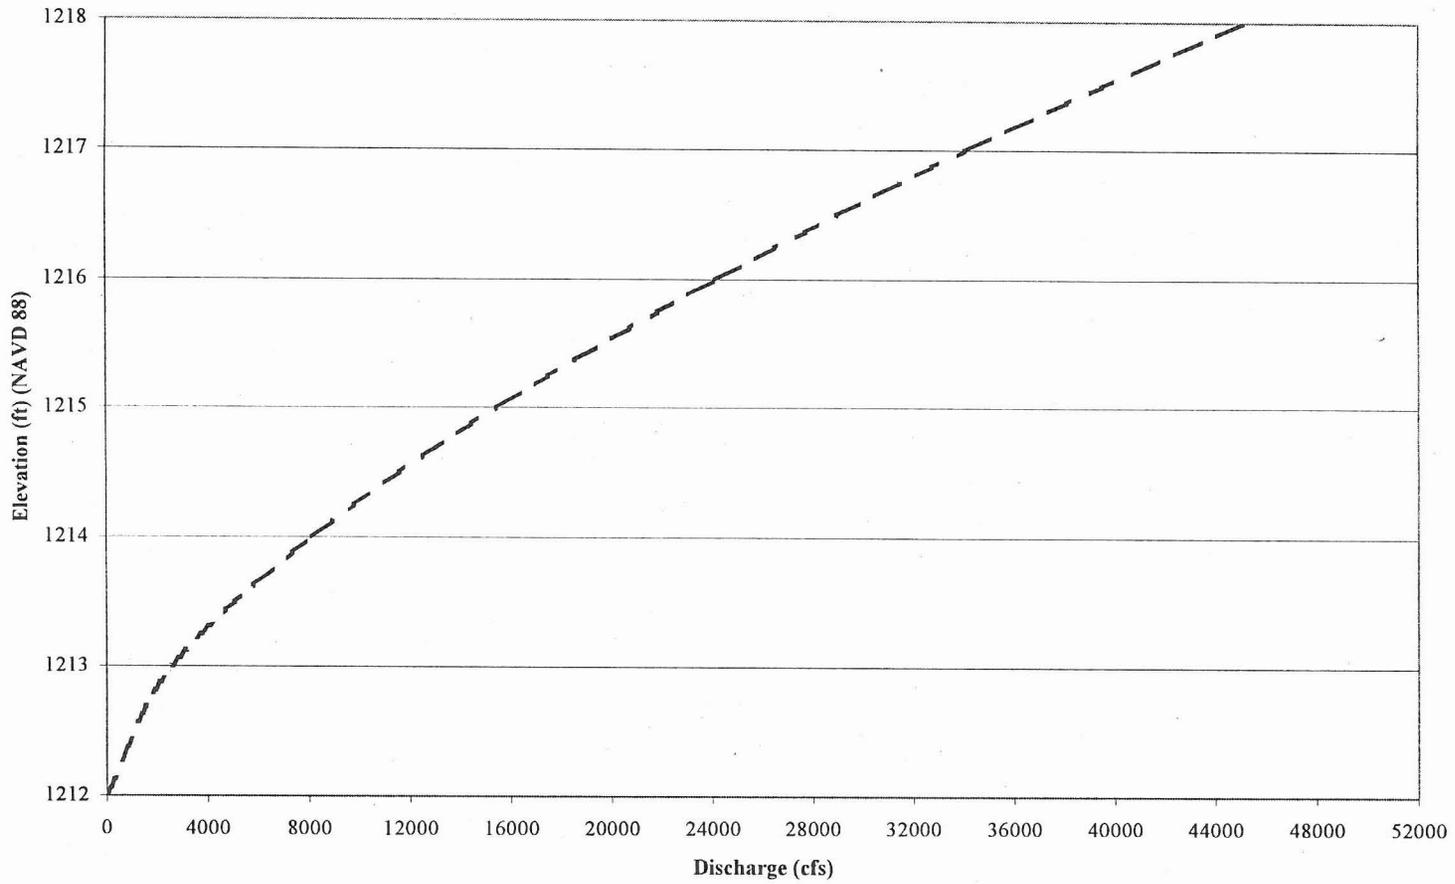
Figure 9-1

FIGURE 9-1  
EMERGENCY SPILLWAY DISCHARGE RATING CURVE

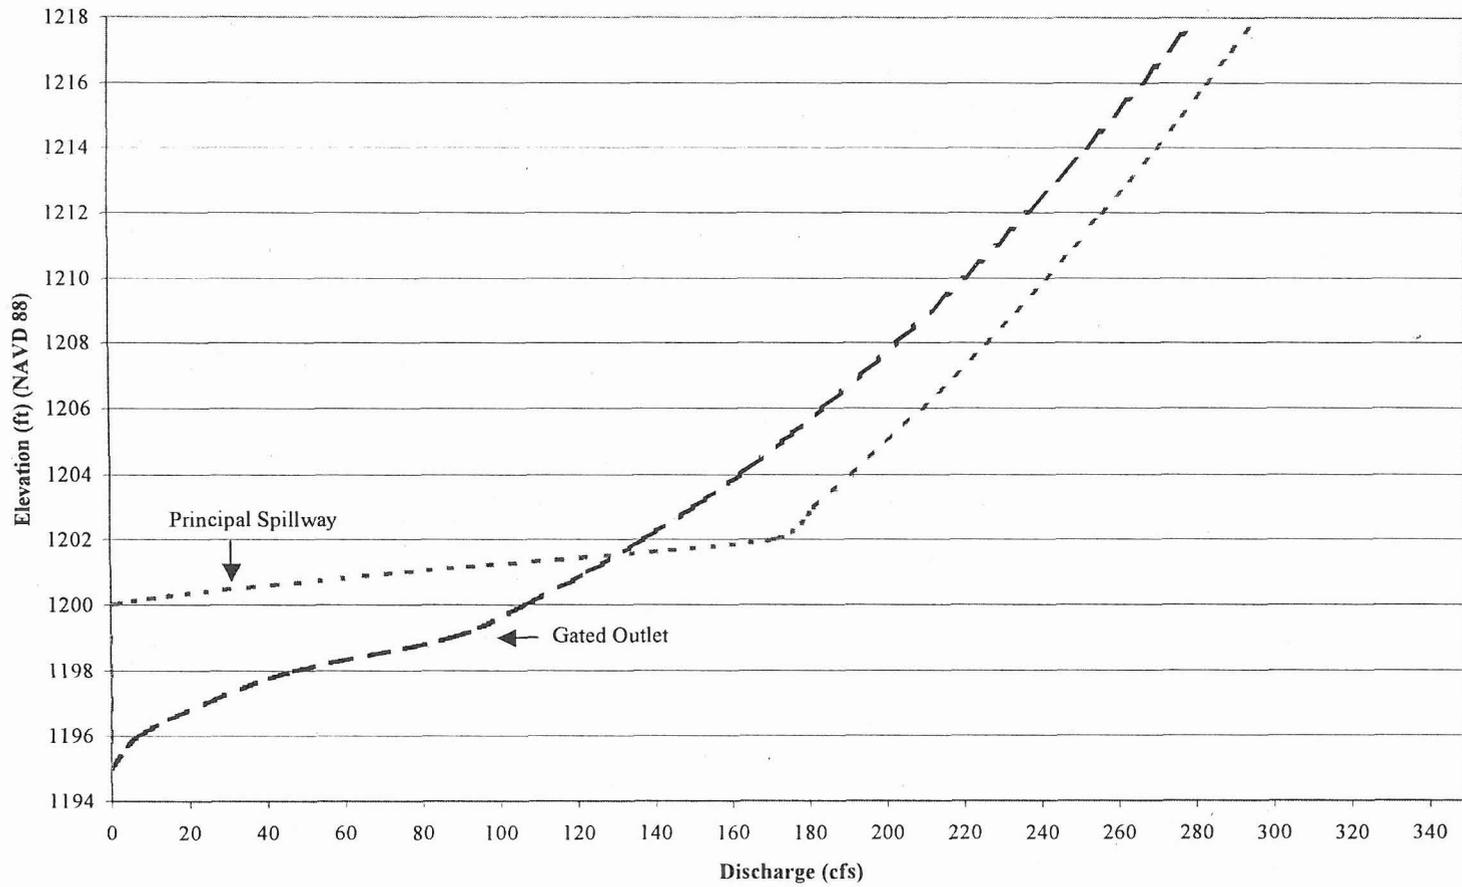
Figure 14-1

FIGURE 14-1  
OUTLET WORKS DISCHARGE RATING CURVE

The discharge rating curve for the Gated Outlet is presented in Table 14-2 and on Figure 14-1. The Gated Outlet has sufficient capacity to drain down the reservoir from the emergency spillway crest elevation in approximately 7 days. A vent pipe is installed at the upstream end of the conduit and extends to the crest of the embankment.

The Principal Spillway will consist of an NRCS-type riser with an inlet elevation of 1,200 feet (NAVD 88). The inlet elevation has been set at this elevation to be above the 100-year sediment pool. The riser structure will be constructed of reinforced concrete and incorporate trash racks at the inlet. The foundation of the riser structure will consist of soil cement, which will be constructed in a manner similar to the soil cement core of the South FRZ Embankment. The principal spillway conduit will connect to the riser at the base of the structure. The Principal Spillway has sufficient capacity to drain down the reservoir to elevation 1,200 ft (NAVD 88) from the emergency spillway crest elevation in approximately 6.5 days. The discharge rating curve for the Principal Spillway is presented in Table 14-2 and on Figure 14-1. Details of the riser design are provided in the plans.

The discharge rating curve for the Bypass Gated Outlet is presented in Table 14-2 and on Figure 14-1. The Bypass Gated Outlet has sufficient capacity to drain down the reservoir from the emergency spillway crest elevation in approximately 7 days. The combined flow capacity of the Gated Outlet and Bypass Gated Outlet allows for drain down of the reservoir in approximately 3.5 days. A vent pipe will be installed at the upstream end of the Principal Spillway conduit to protect against pressure buildup during flow through the Bypass Gated Outlet.
