REPORT ON GEOTECHNICAL INVESTIGATION

DESIGNATION: Dysart Drainage Canal

LOCATION: Dysart Road N/O
Glendale Avenue
Maricopa County, Arizona

PROJECT NO: 92113SA1

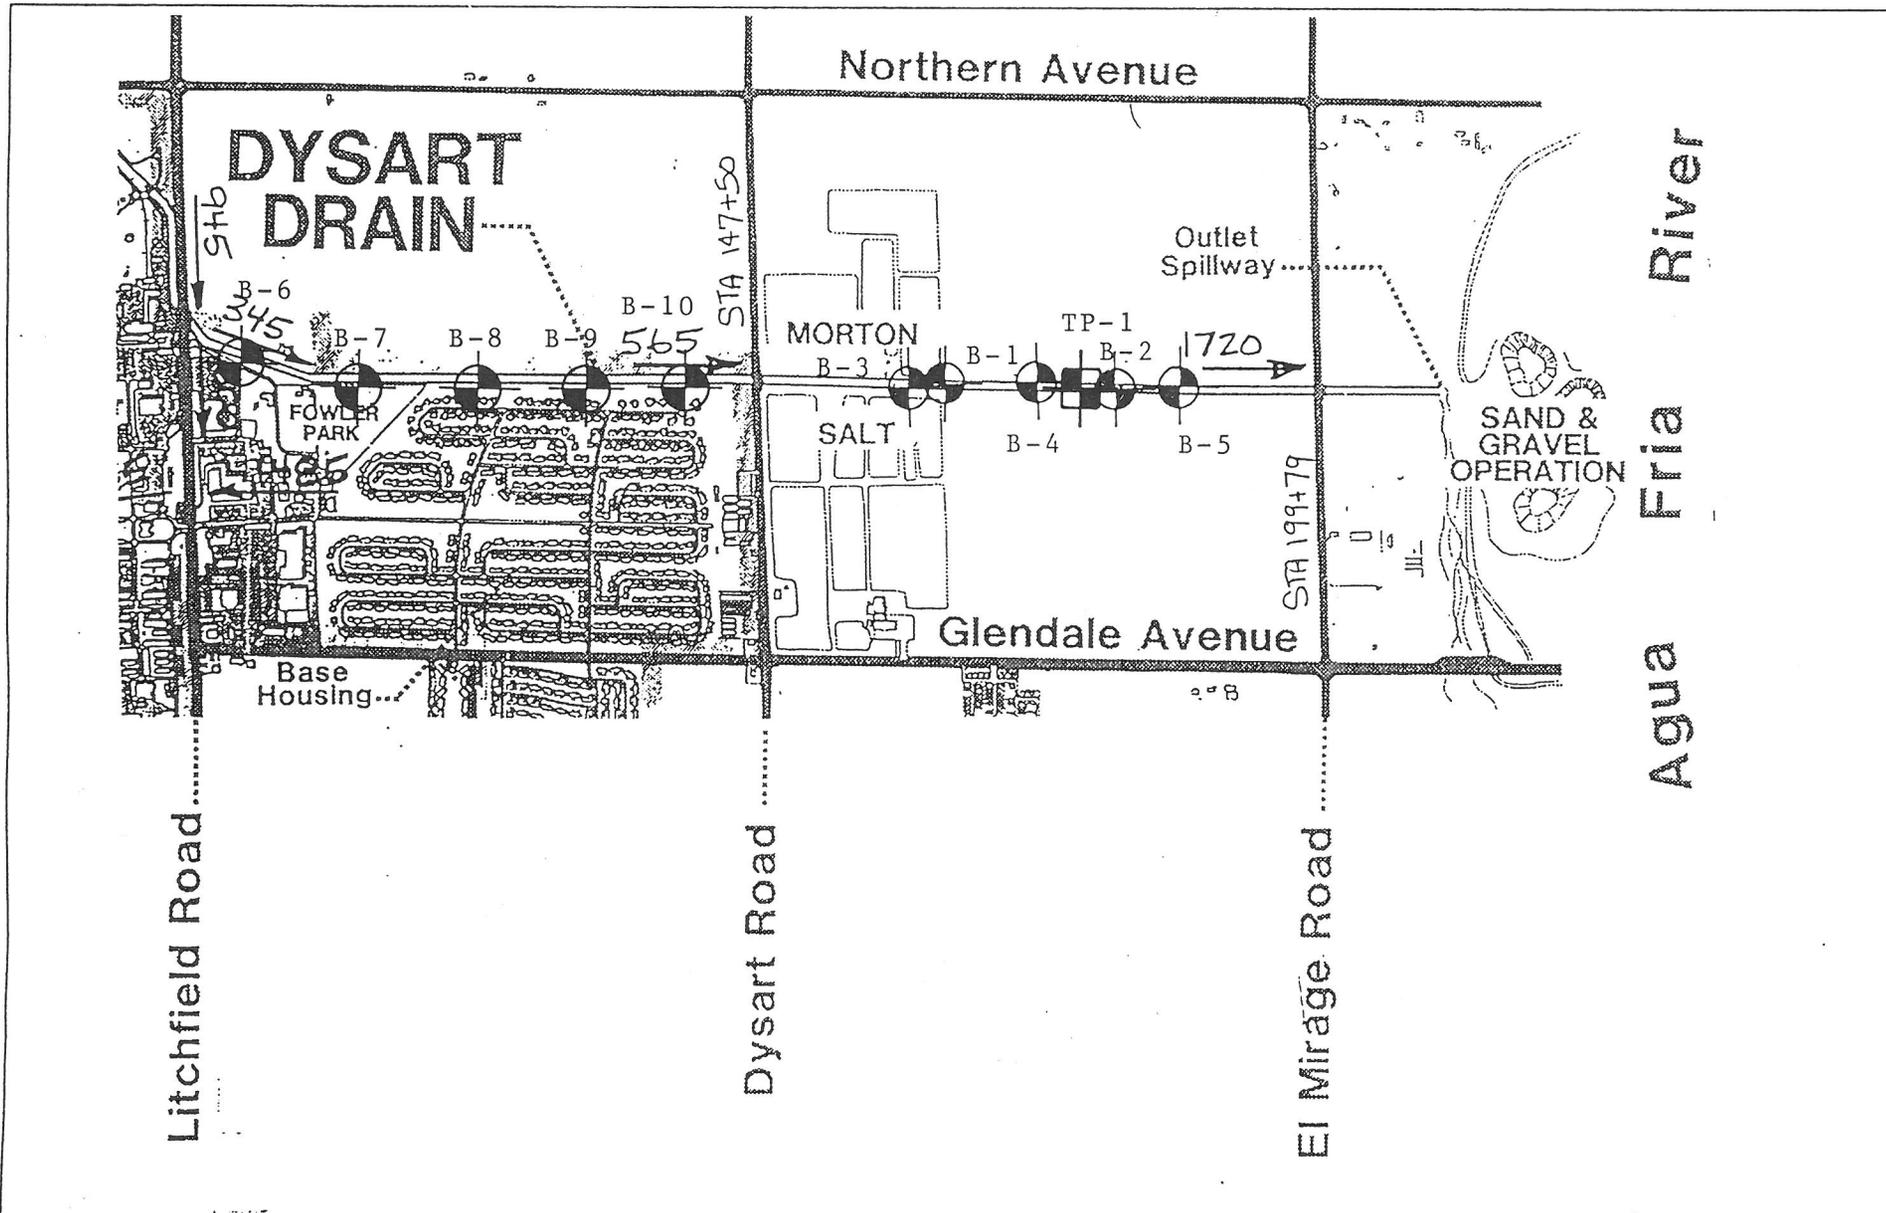
SOIL BORING LOCATION PLAN	
Dysart Drainage Canal Dysart Rd. N/O Glendale Maricopa County, Arizona	
SPEEDIE AND ASSOCIATES <small>GEOTECHNICAL / MATERIALS / SITE ENGINEERS</small>	
PROJECT NO. 92113SA1

Approximate Boring Location

On February 19, 1993, four concrete cores and two soil test borings were drilled at the approximate locations shown on the attached Soil Boring Location Plan. On March 24, 1993, three additional soil test borings were drilled in the drain bottom at the approximate Stations indicated on the Log of Test Borings. On March 31, 1993, a test pit was excavated by Maricopa County work forces in the Drain bottom at the location indicated on the Log of Test Pit. On April 2, 1993, five soil test borings were drilled at the approximate Stations indicated on the Log of Test Borings. All drilling exploration work was carried out under the full-time supervision of our staff geologist, who recorded subsurface conditions and obtained samples for laboratory testing. The soil borings were advanced with a truck-mounted CME-55 drill rig utilizing 7-inch diameter hollow stem flight augers. Detailed information regarding the borings and samples obtained can be found on an individual Log of Test Boring prepared for each drilling location.

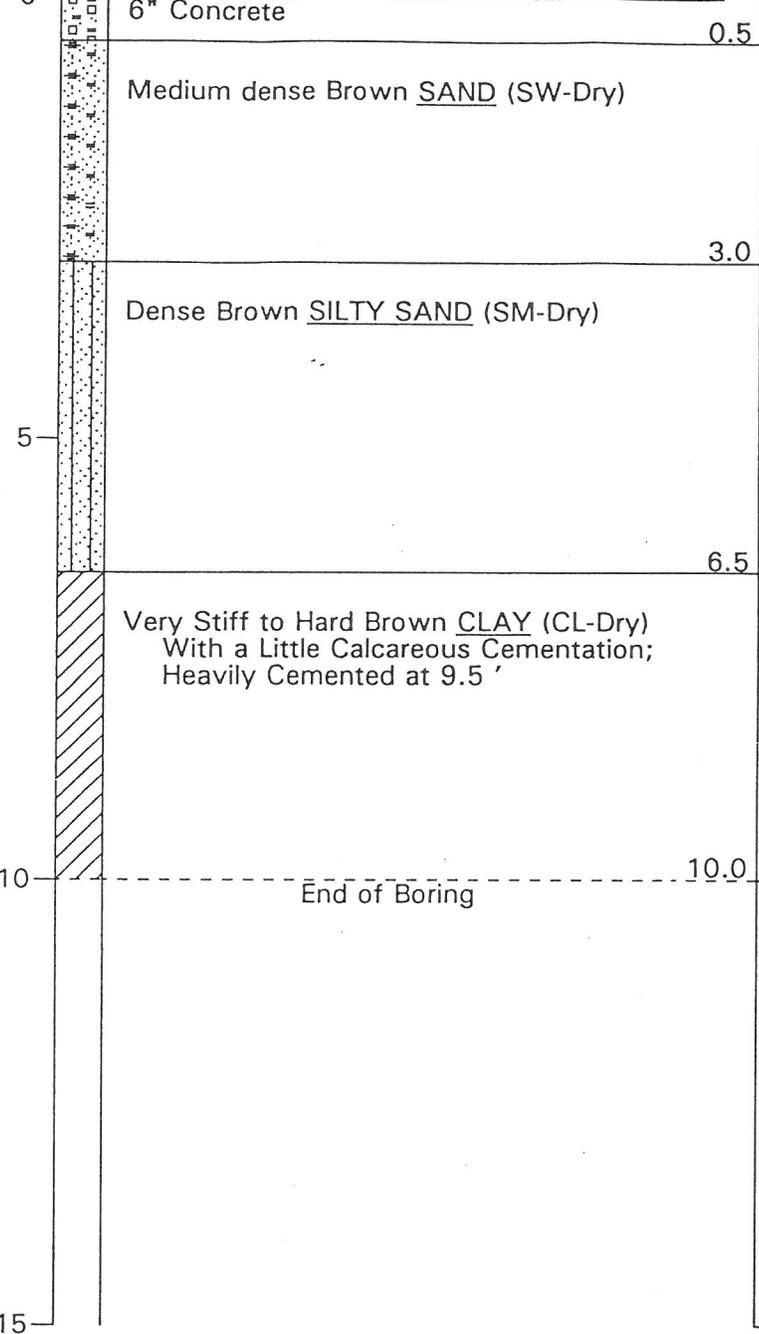
Sample Number	Depth of Sample	Natural Water Content (%)	In-place Dry Density (P.C.F.)	Penetration Resistance Blows per Foot
				0 25 50
S-1	2.5	--	--	
RS-2	4.5	5.4	133.2	
S-3	10.0	--	--

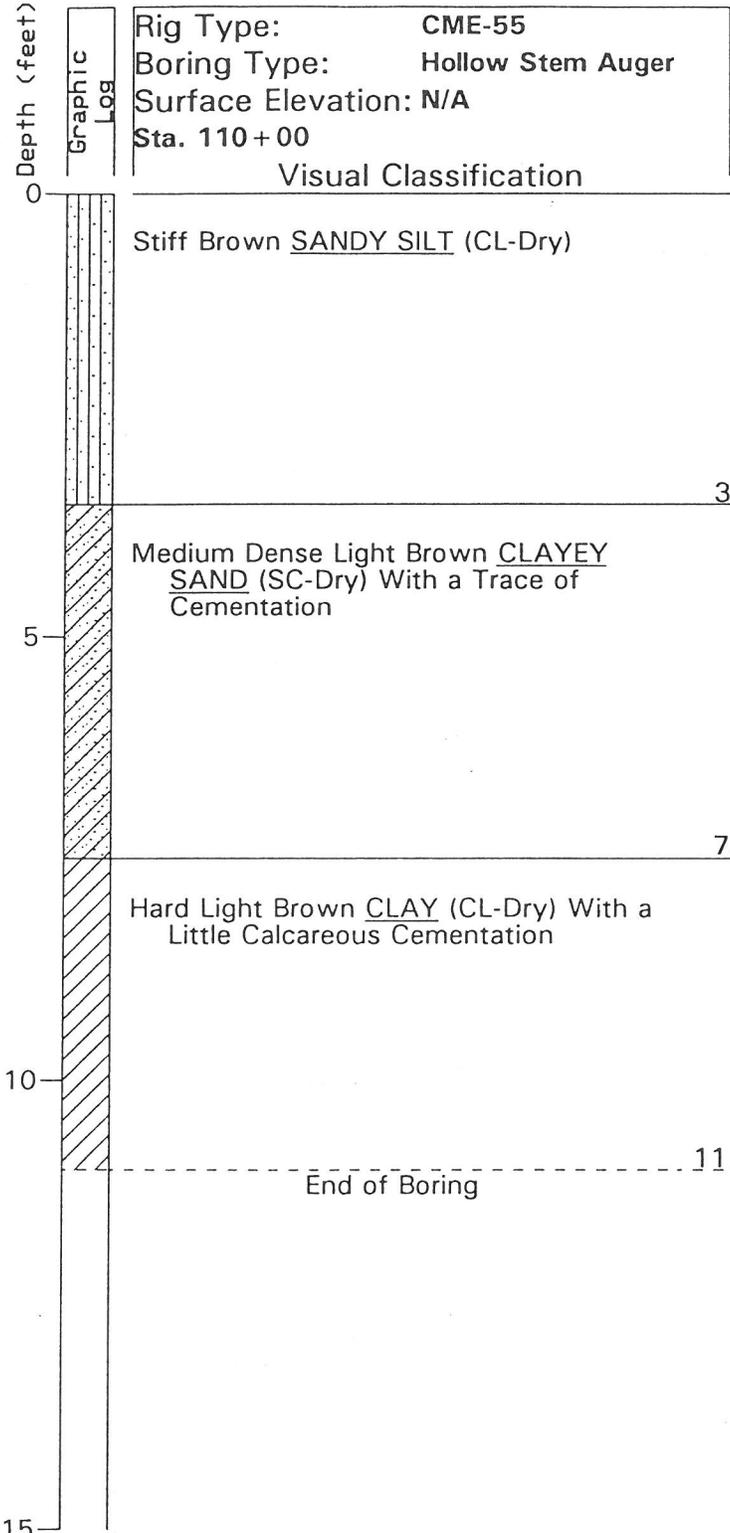
SPEEDIE AND ASSOCIATES
 Log of Test Boring Number: B- 6
 Dysart Drain
 Dysart Road N/O Glendale Avenue
 Maricopa County, Arizona
 Project No.: 92113SA1

Sample Number	Depth of Sample	Natural Water Content (%)	In-place Dry Density (P.C.F.)	Penetration Resistance Blows per Foot
RS-1	2.5	11.3	109.9	
S-2	6.0	--	--	
S-3	11.0	--	--	91/12"

Boring Date: 4-2-93
 Field Engineer/Technician: C. Spencer
 Driller: S. Belsky
 Contractor: Heber Mining

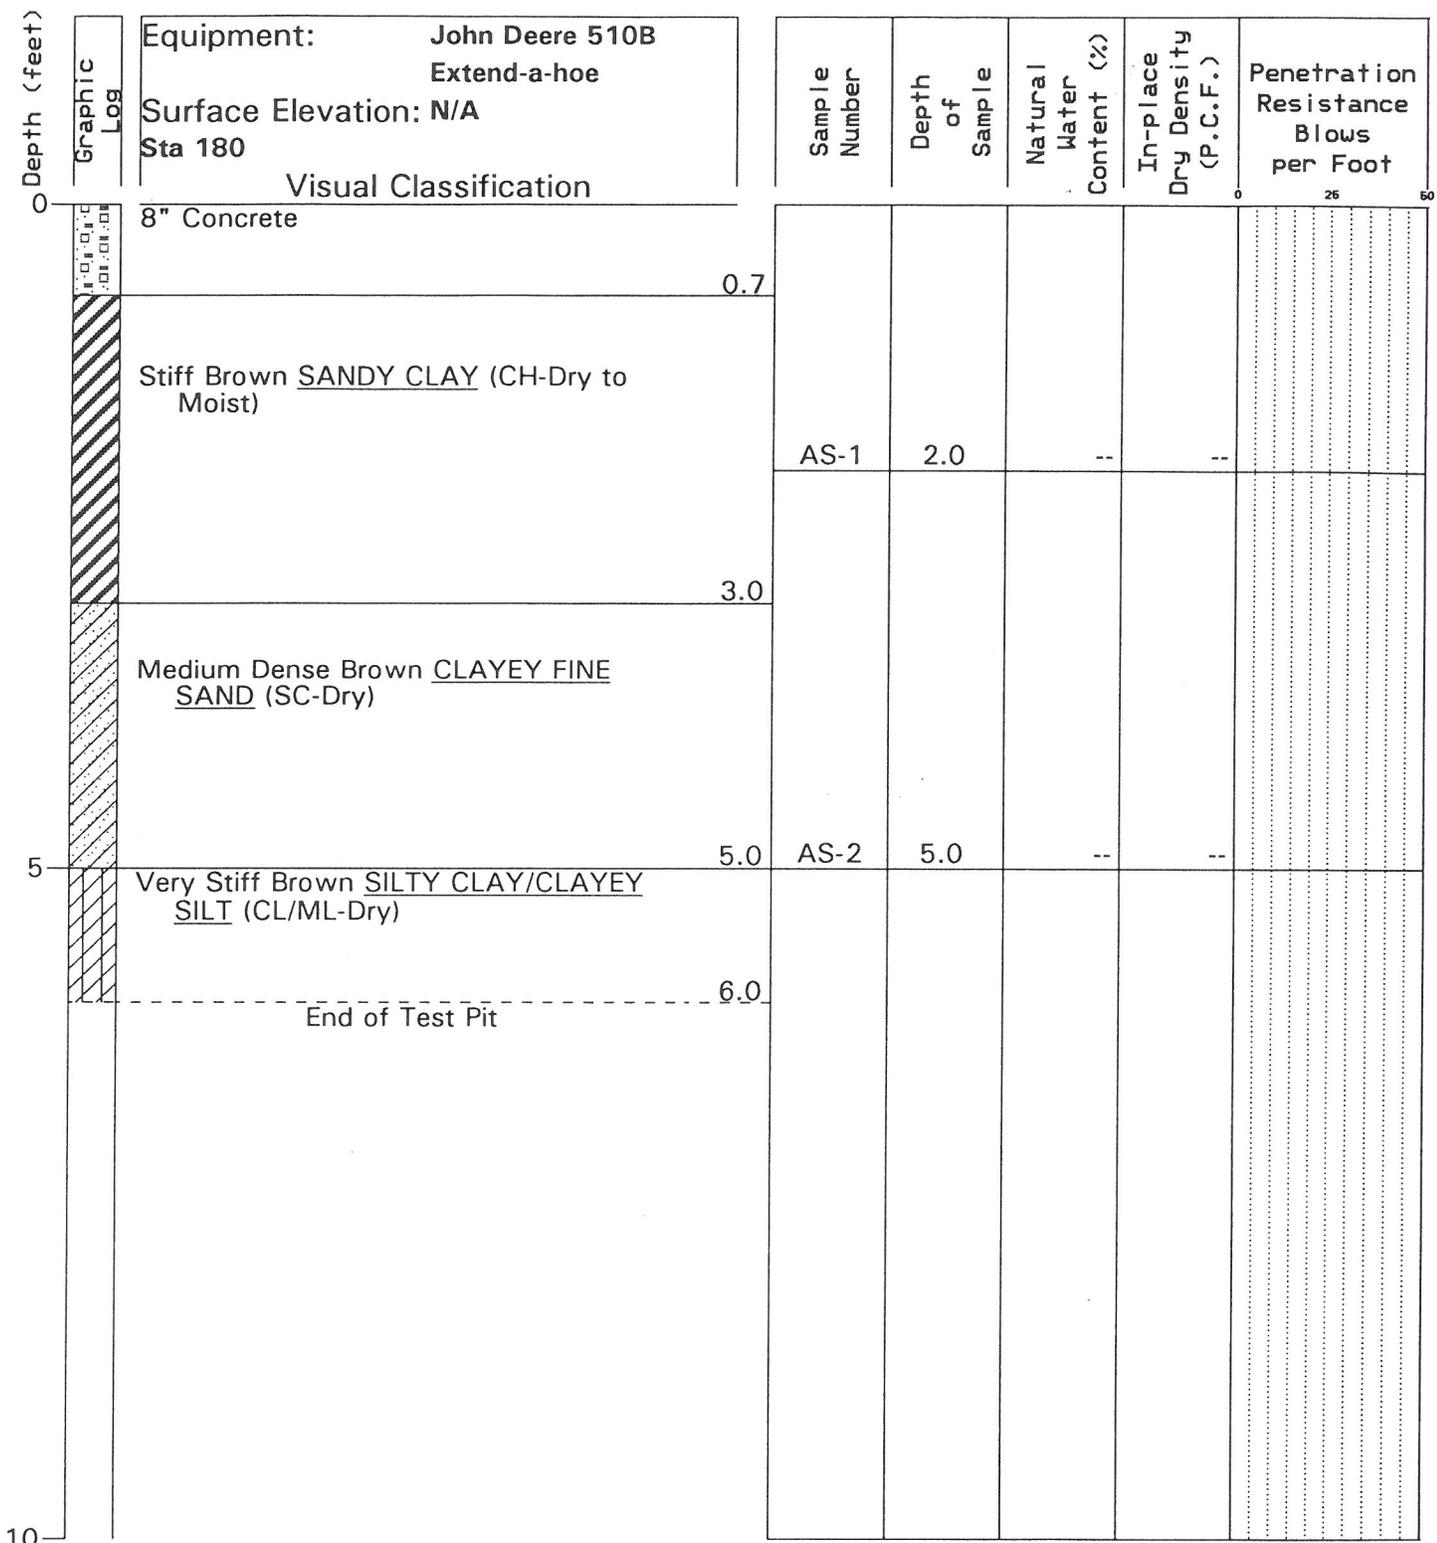
Excavation Date: 3-31-93
 Field Engineer/Technician: C. Spencer
 Operator: MCFC
 Contractor: MCFC

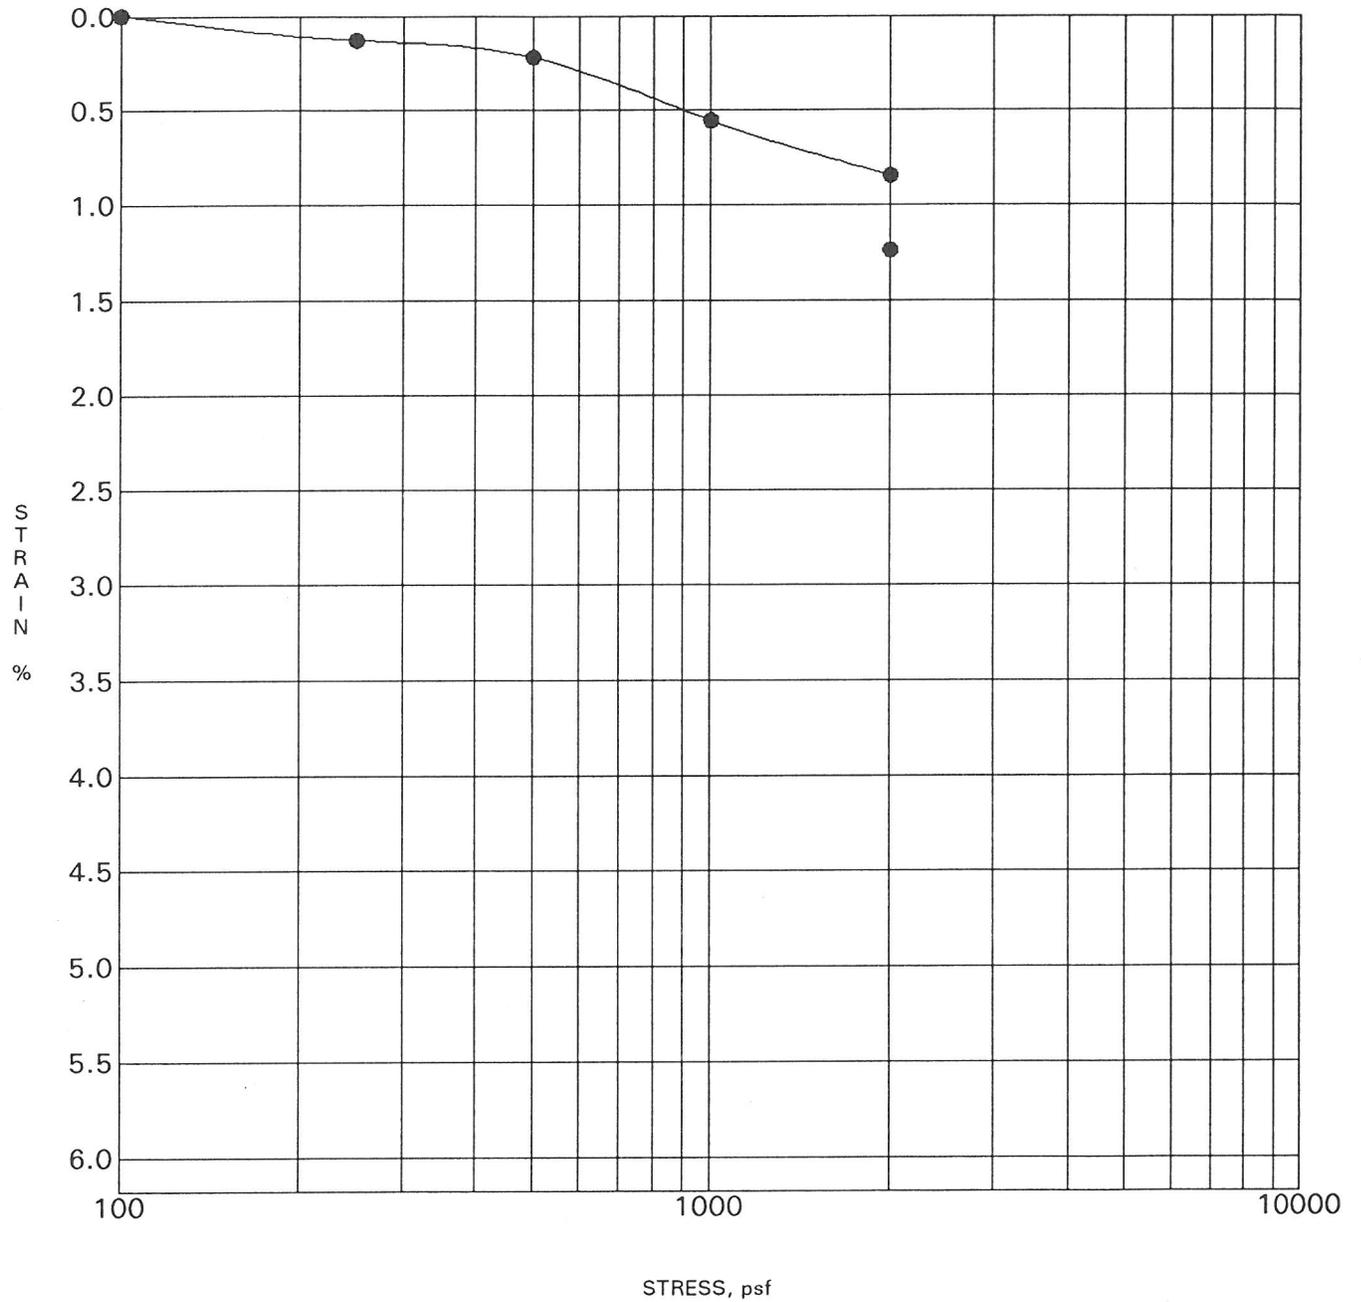
CONSOLIDATION TEST

BORING B-7

SAMPLE No. RS-1

Laboratory testing consisted of moisture content, dry density, grain-size distribution and plasticity (Atterberg Limits) tests for classification and design parameters. Direct Shear tests were performed on ring samples collected beneath the sidewalls in order to determine friction angle and cohesion values. Saturated direct shear tests were performed to determine soil strength parameters for bearing capacity calculations. Compression tests were performed on a selected ring sample in order to estimate settlements and determine effects of inundation. Remolded swell tests were performed on samples compacted to densities and moisture contents expected during construction. All field and laboratory data is presented in this Appendix.

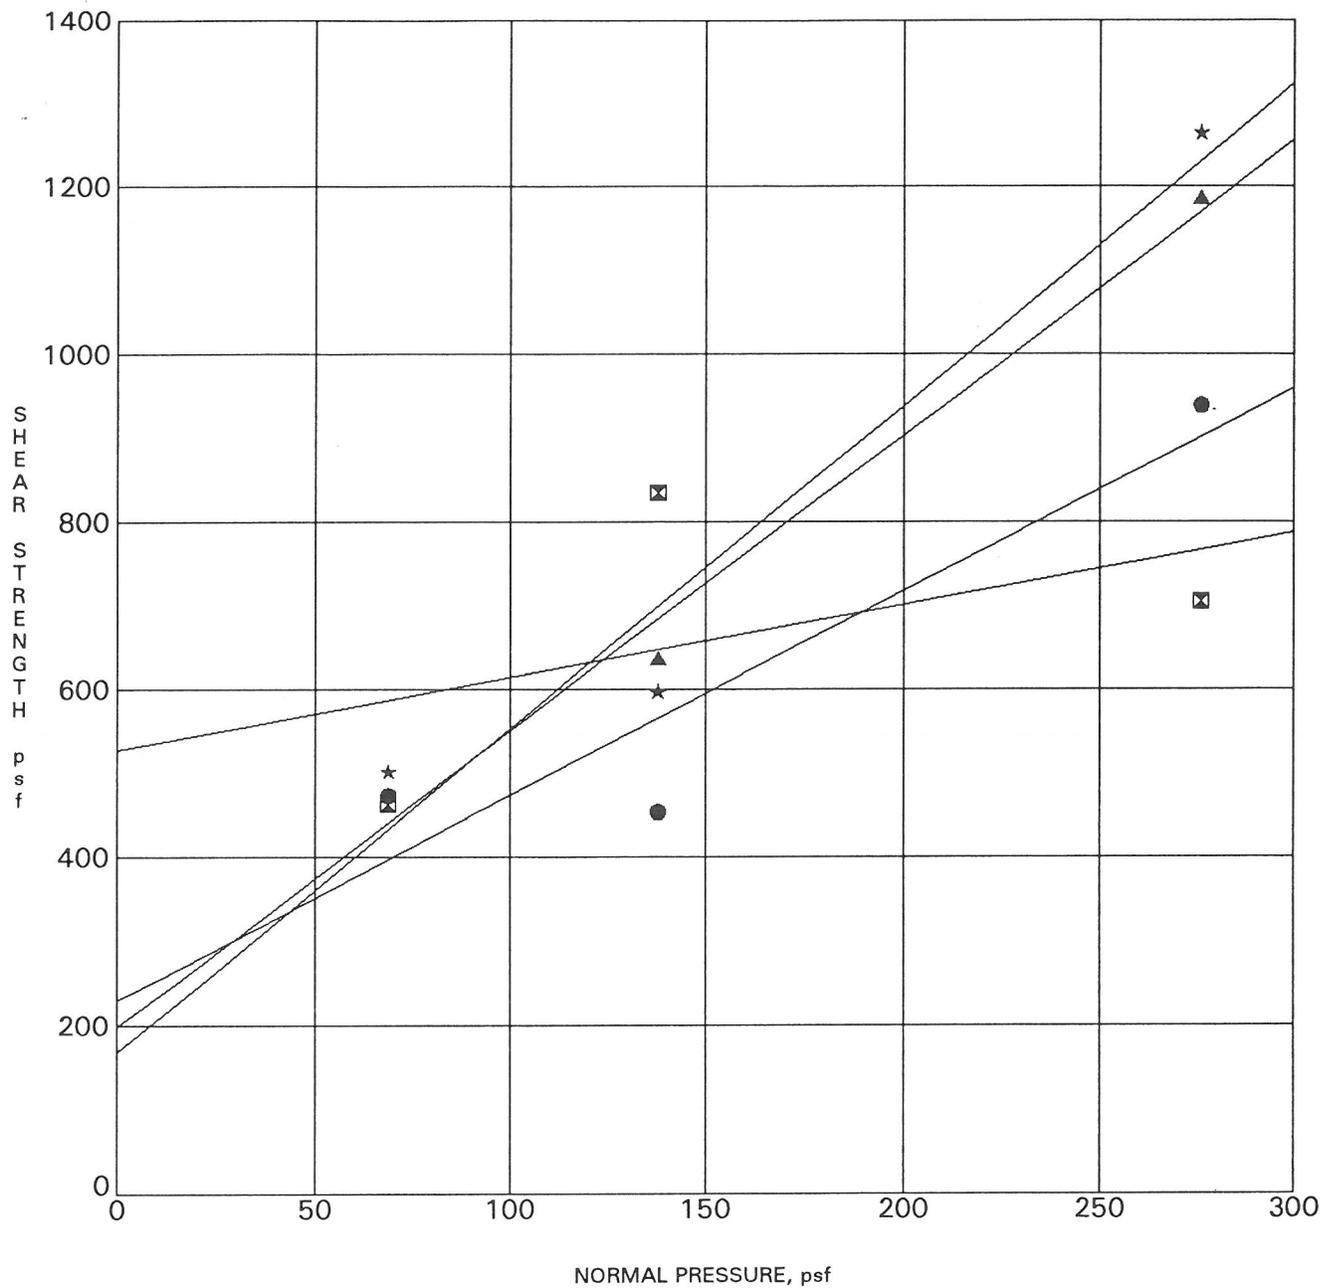
SHEAR TEST DIAGRAM

Specimen Identification	Classification	DD	MC%
● C- 1 1.5	SANDY LEAN CLAY CL	97	14
⊠ C- 2 1.5	LEAN CLAY with SAND CL	91	13
▲ C- 3 1.5	LEAN CLAY CL	100	15
★ C- 4 1.5	SANDY LEAN CLAY CL	100	13

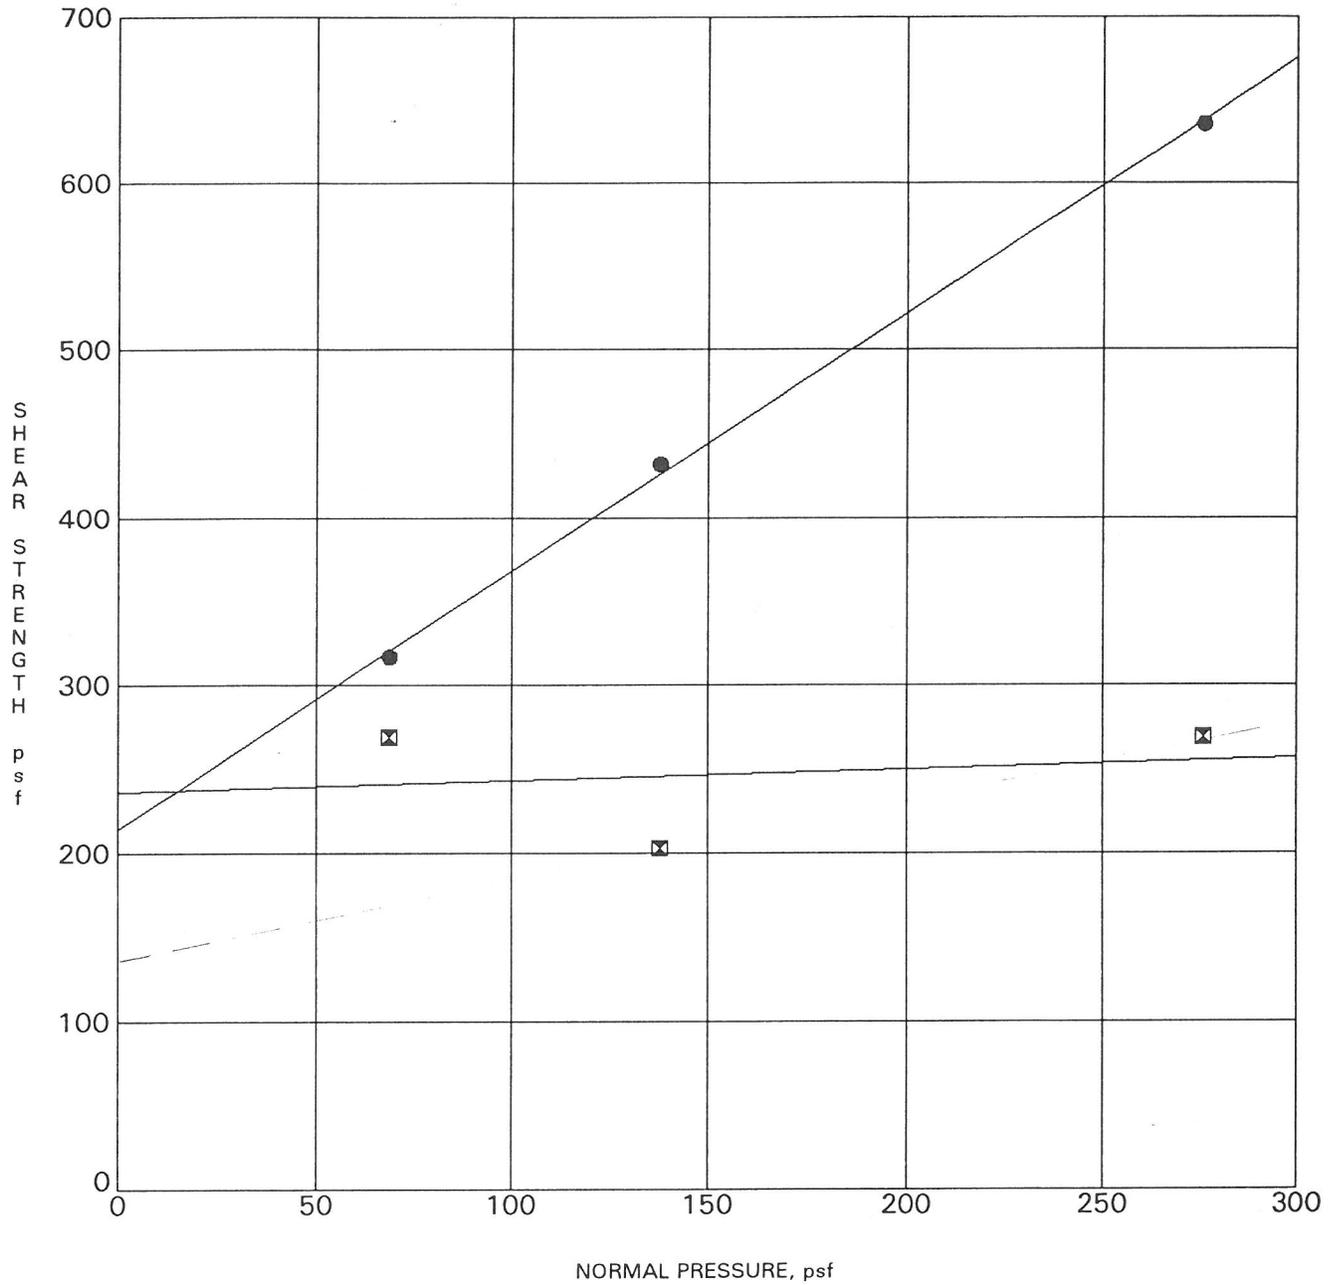
SHEAR TEST DIAGRAM

Specimen Identification	Classification	DD	MC%
● B- 6 2.5	SILT with SAND ML	109	13
⊠ B-10 2.5	SILTY CLAY with SAND CL-ML	97	16
