SPECIAL FLOOD HAZARD STUDY

LUKE AIR FORCE BASE--GLENDALE, ARIZONA

PERFORMED BY: LOS ANGELES DISTRICT, U.S. ARMY CORPS OF ENGINEERS

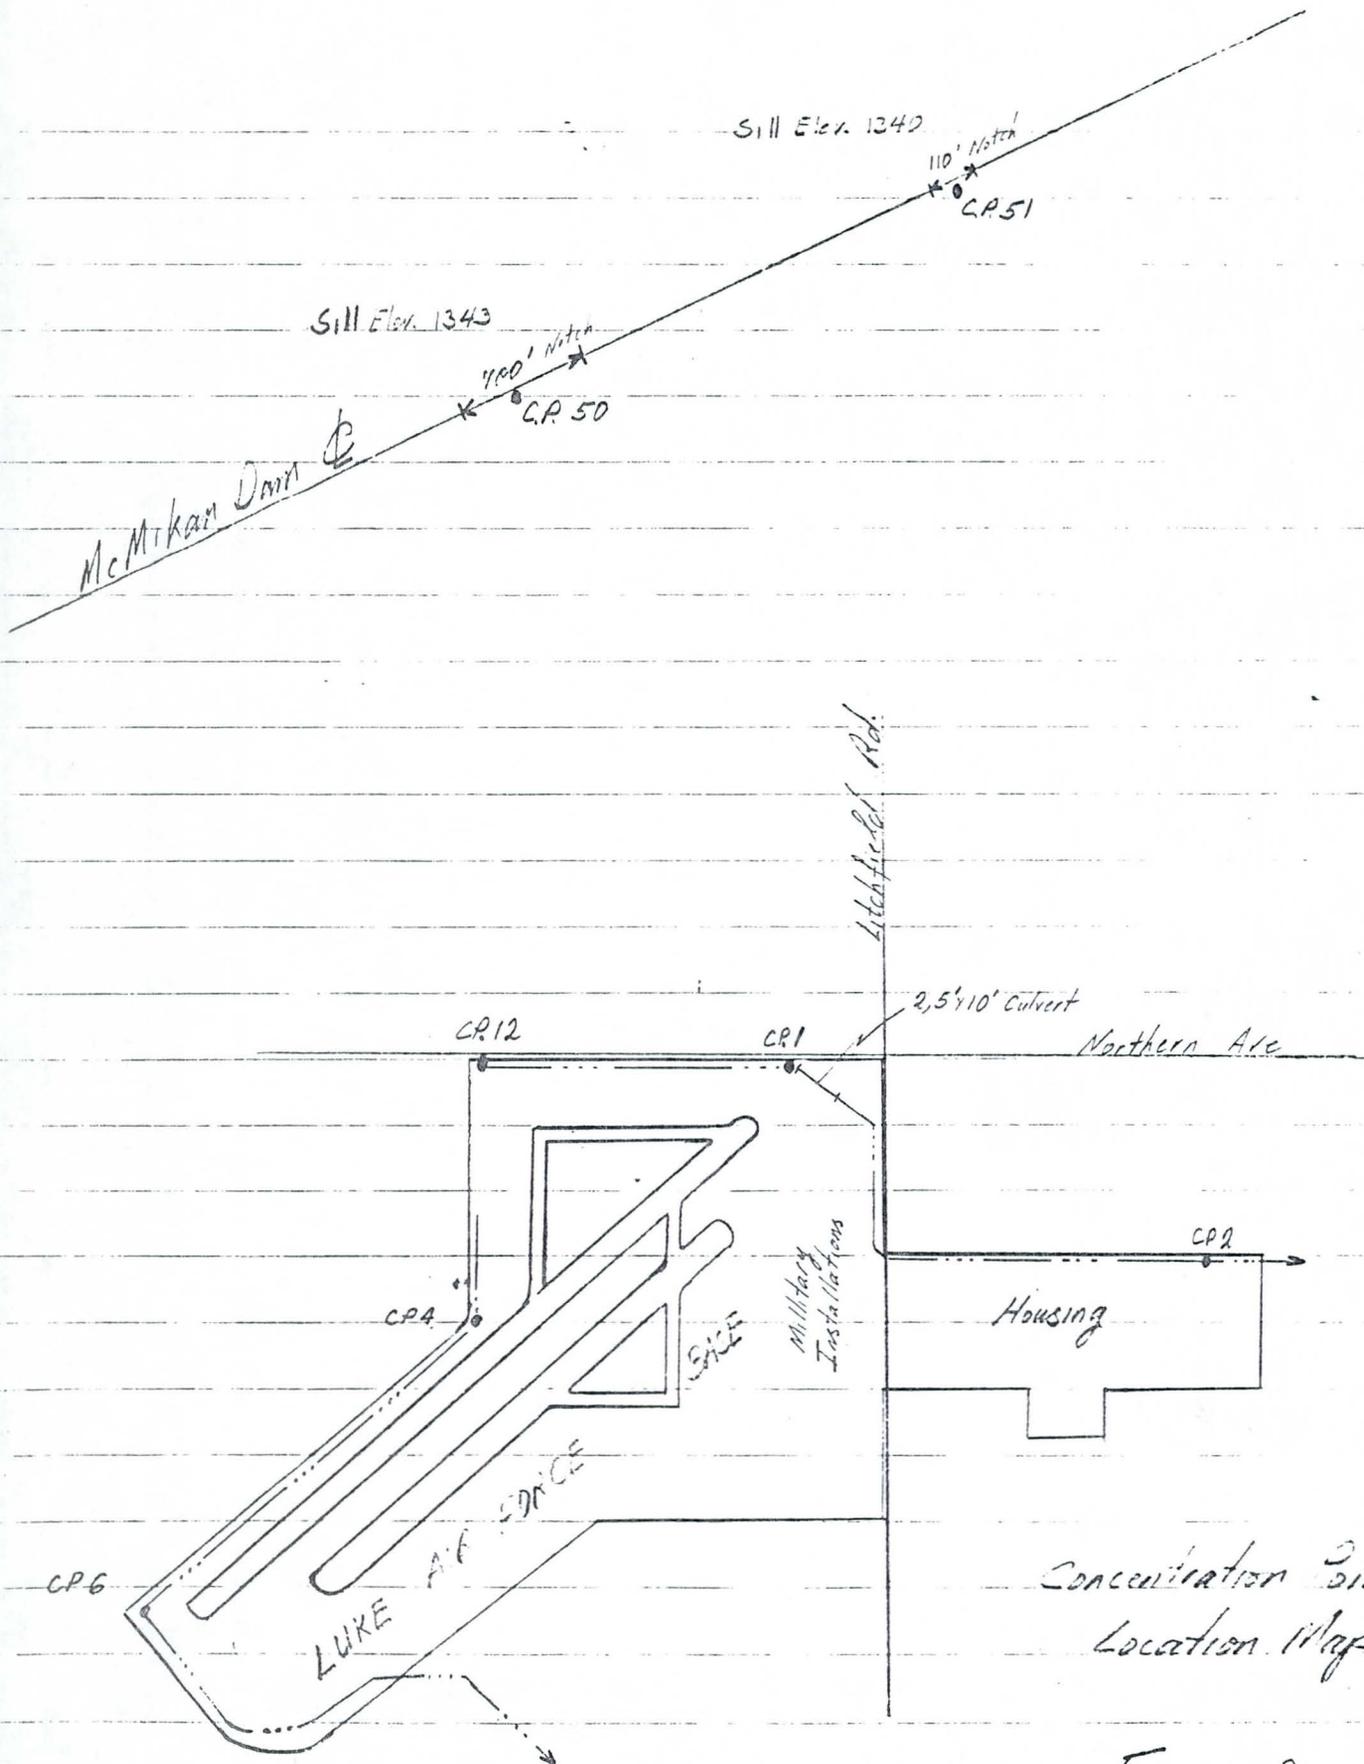
Fig. 2

Concentration Points
Location Map

Figure 2 shows the location of various concentration points. The discharge values at these concentration points are shown in table 3. For discharge values with the Dam breached, the values include contribution from the drainage area below the Dam.
