Geologic Hazards in the Phoenix Area, Arizona

by
Troy L Péwé
Department of Geology
Arizona State University
Tempe, Az., 85281

Reprinted from
Field Notes, 1978
Bureau of Geology and Mineral
Technology
Vol. 8, Nos 1-2 p.18-20

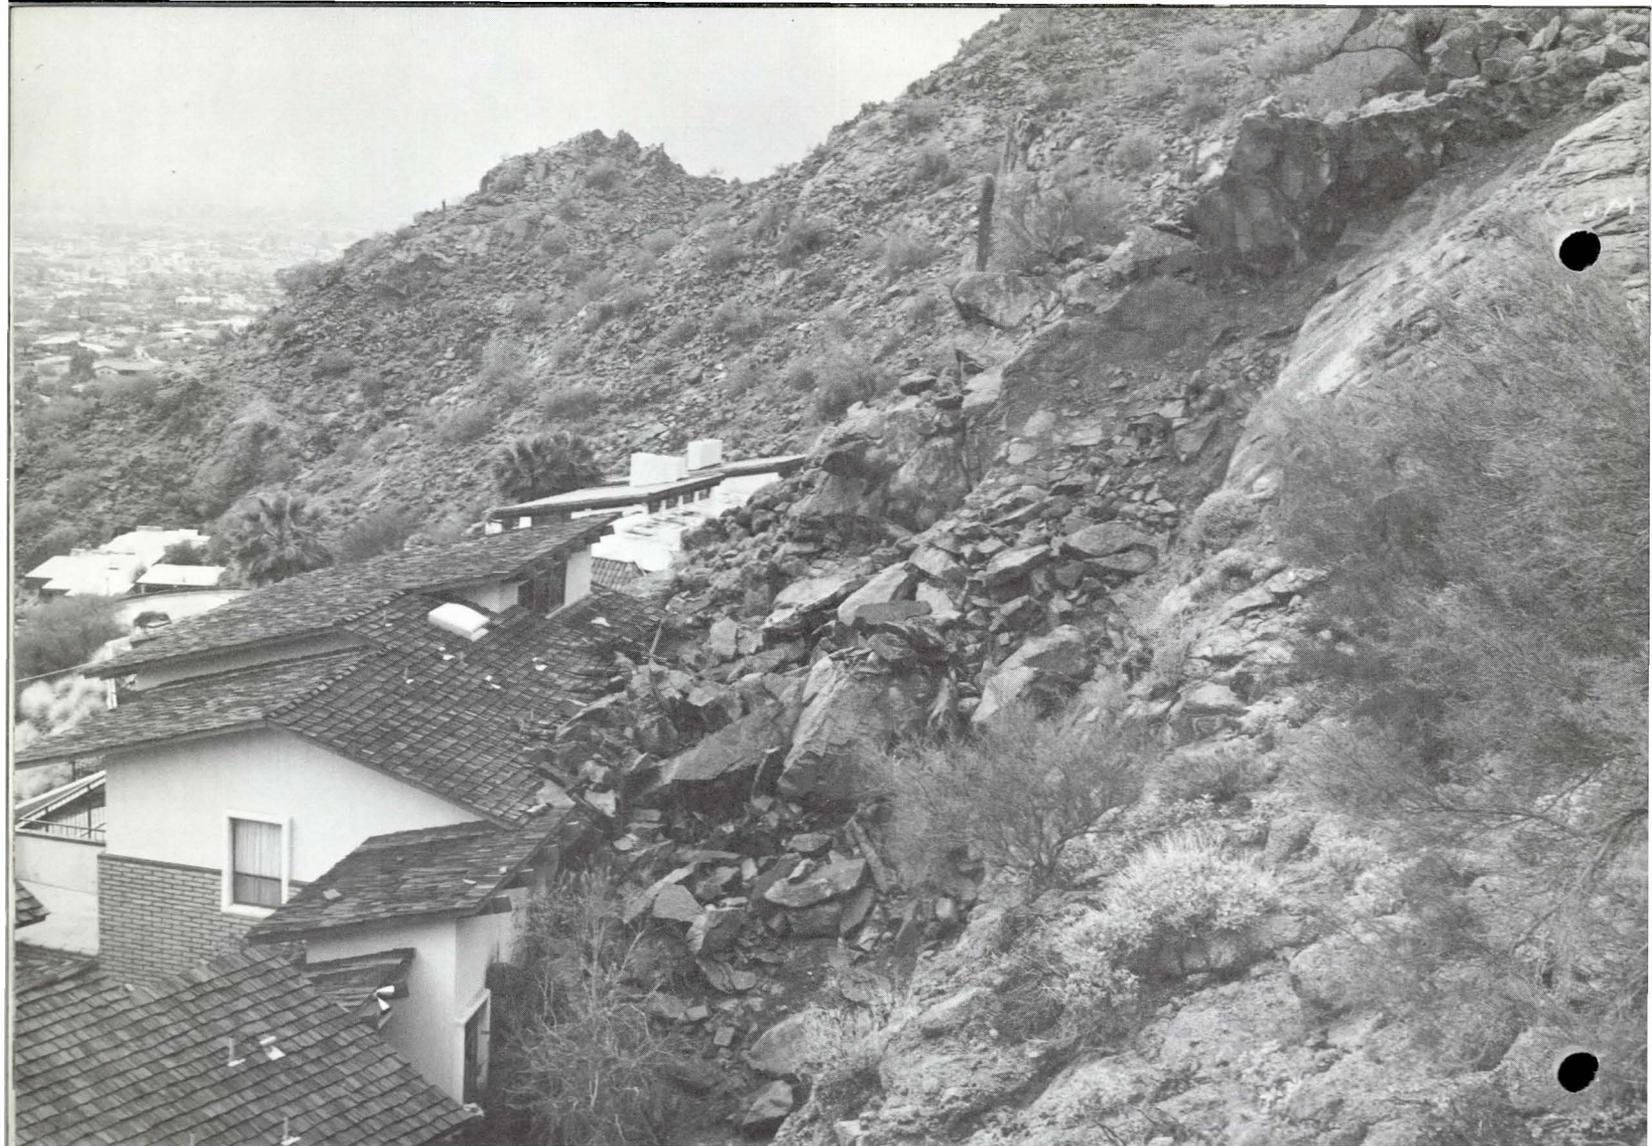
Above; Home on granite bedrock on south side of Camelback Mountain, Phoenix, Arizona, partially destroyed by rock slide after several weeks of above normal precipitation. (Photograph by T.L. Péwé March 2, 1978.) Right; Detail of above rock slide.

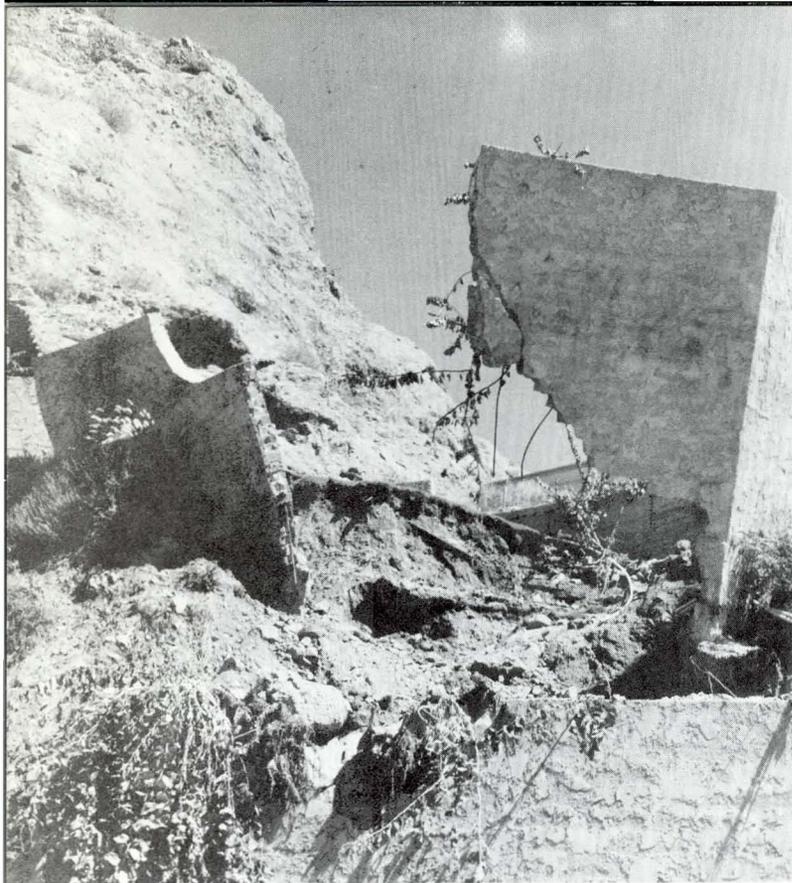
Left; Detail of mud slide below. (Photograph by T.L. Péwé, September 9, 1978.)

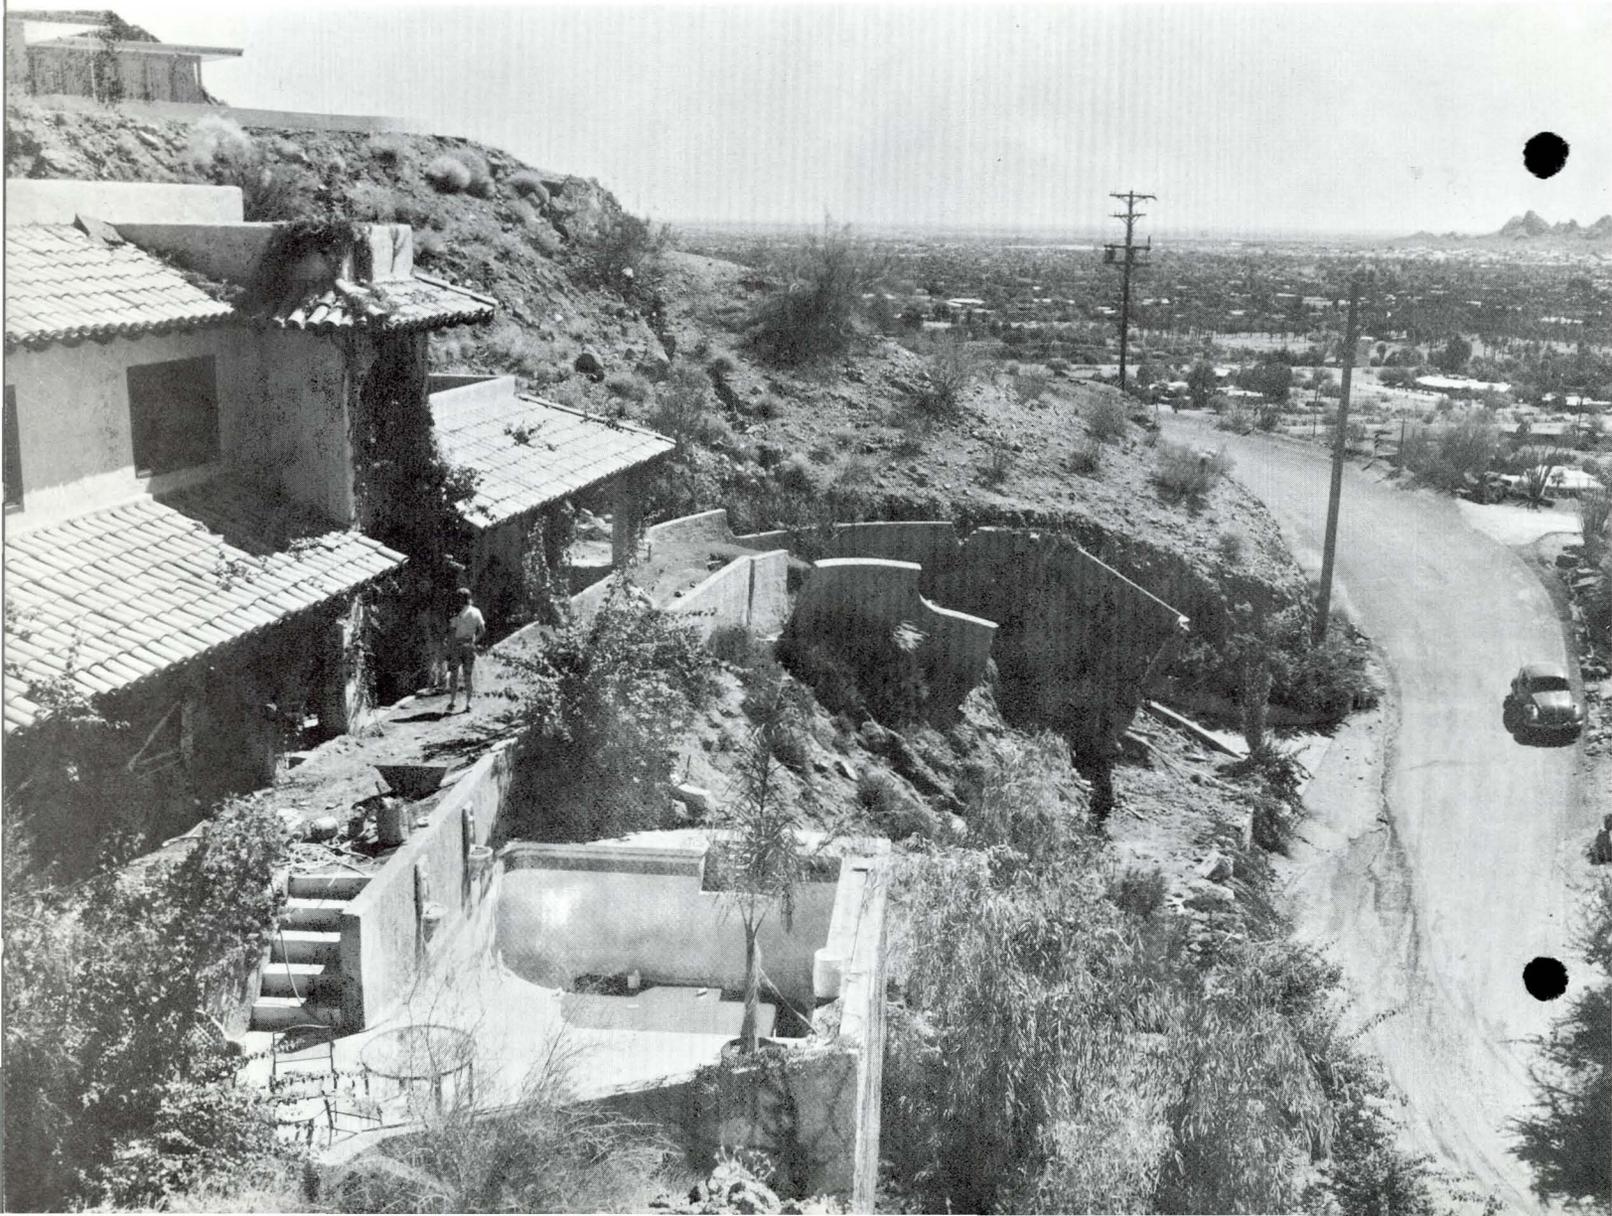
Below; Home of the south side of Camelback Mountain, Phoenix, Arizona, partially destroyed by mud slides during intense rainstorm. (Photography by T.L. Péwé, September 9, 1976.)
