FLOOD CONTROL DISTRICT OF MARICOPA COUNTY

APACHE JUNCTION FRS

F.C.D. CONTRACT NO. FCD 93-51

APACHE JUNCTION FRS
ELEVATION CAPACITY CURVE-AERIAL
TOPD'S BY McLain Harbers
FCD 93-51
320
McLain Harbers, Co. - Aerial Mapping Co.
Collins Pina Const. Engineers-Surveying Co.
Photo Date 5-18-95

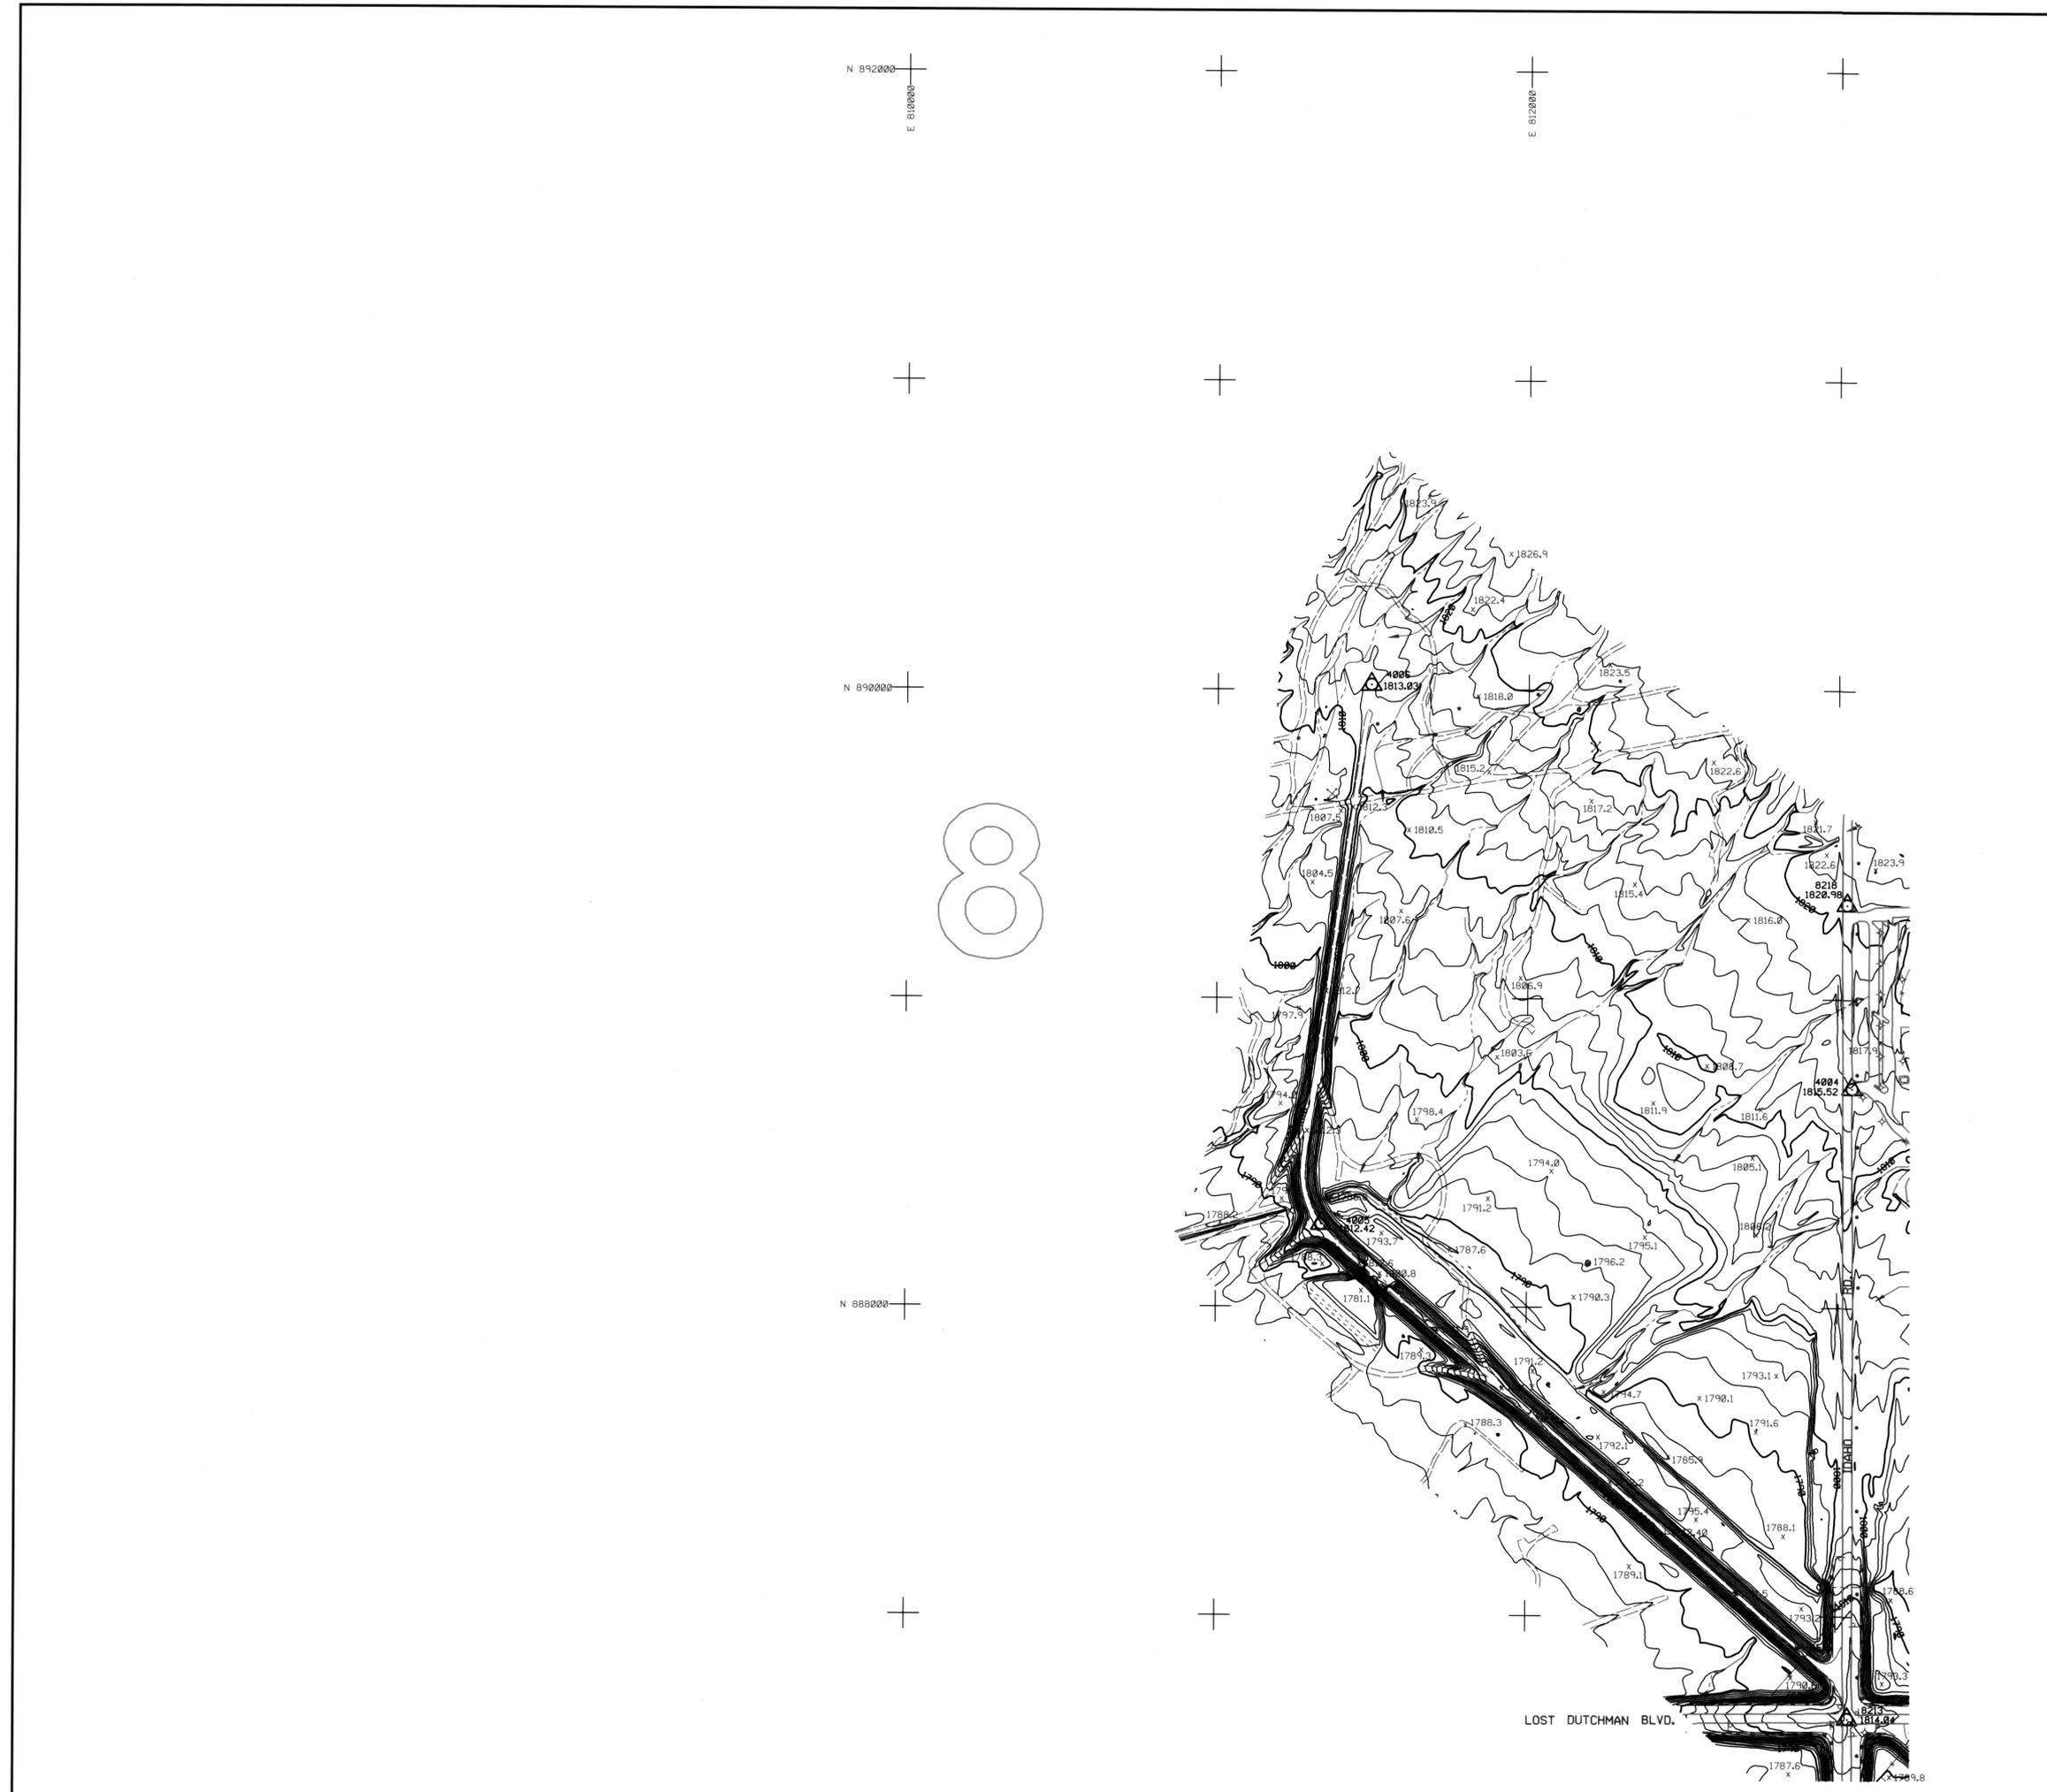
DESIGN	BY	DATE	FLOOD CONTROL DISTRICT OF MARICOPA COUNTY
DESIGN CHK.	-	-	
PLANS	-	-	RECOMMENDED BY: _____ DATE _____
PLANS CHK.	-	-	APPROVED BY: _____ DATE _____
SUBMITTED BY:	DATE		CHIEF ENGINEER AND GENERAL MANAGER
			SHEET 1 OF 3

Map Sheet 1 represents Section 8, T1N, R8E

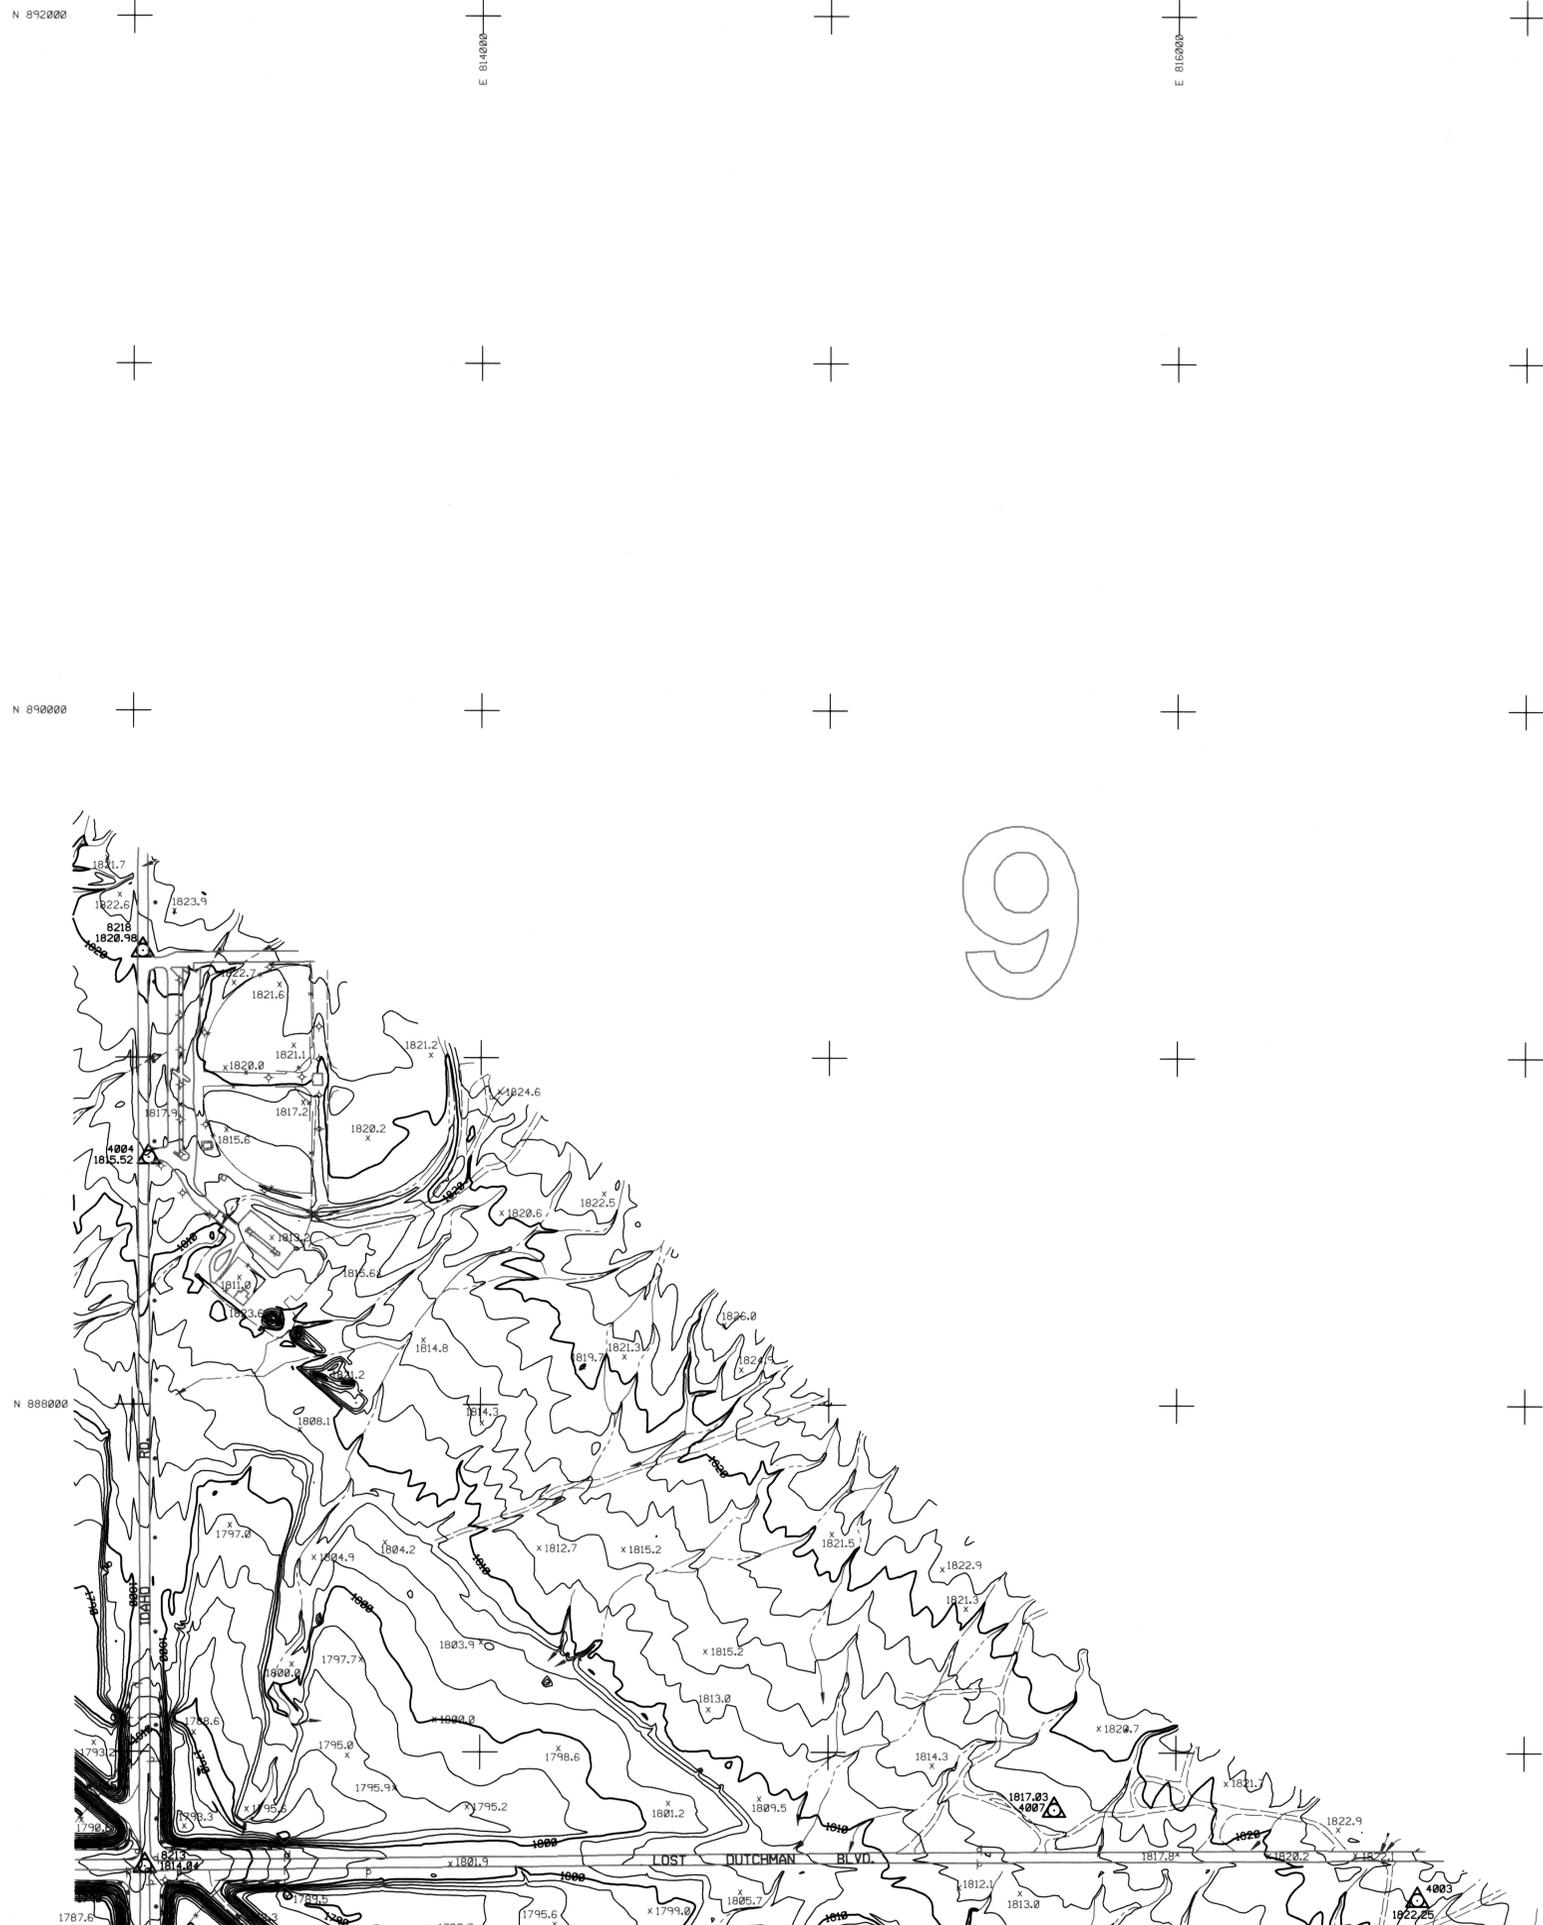
DESIGN	BY	DATE	FLOOD CONTROL DISTRICT OF MARICOPA COUNTY
DESIGN CHK.	-	-	RECOMMENDED BY: DATE
PLANS	-	-	APPROVED BY: DATE
PLANS CHK.	-	-	CHEF ENGINEER AND GENERAL MANAGER
SUBMITTED BY:	DATE:	SHEET	2 OF 3

Map Sheet 2 represents Section 9, TIN, RBE

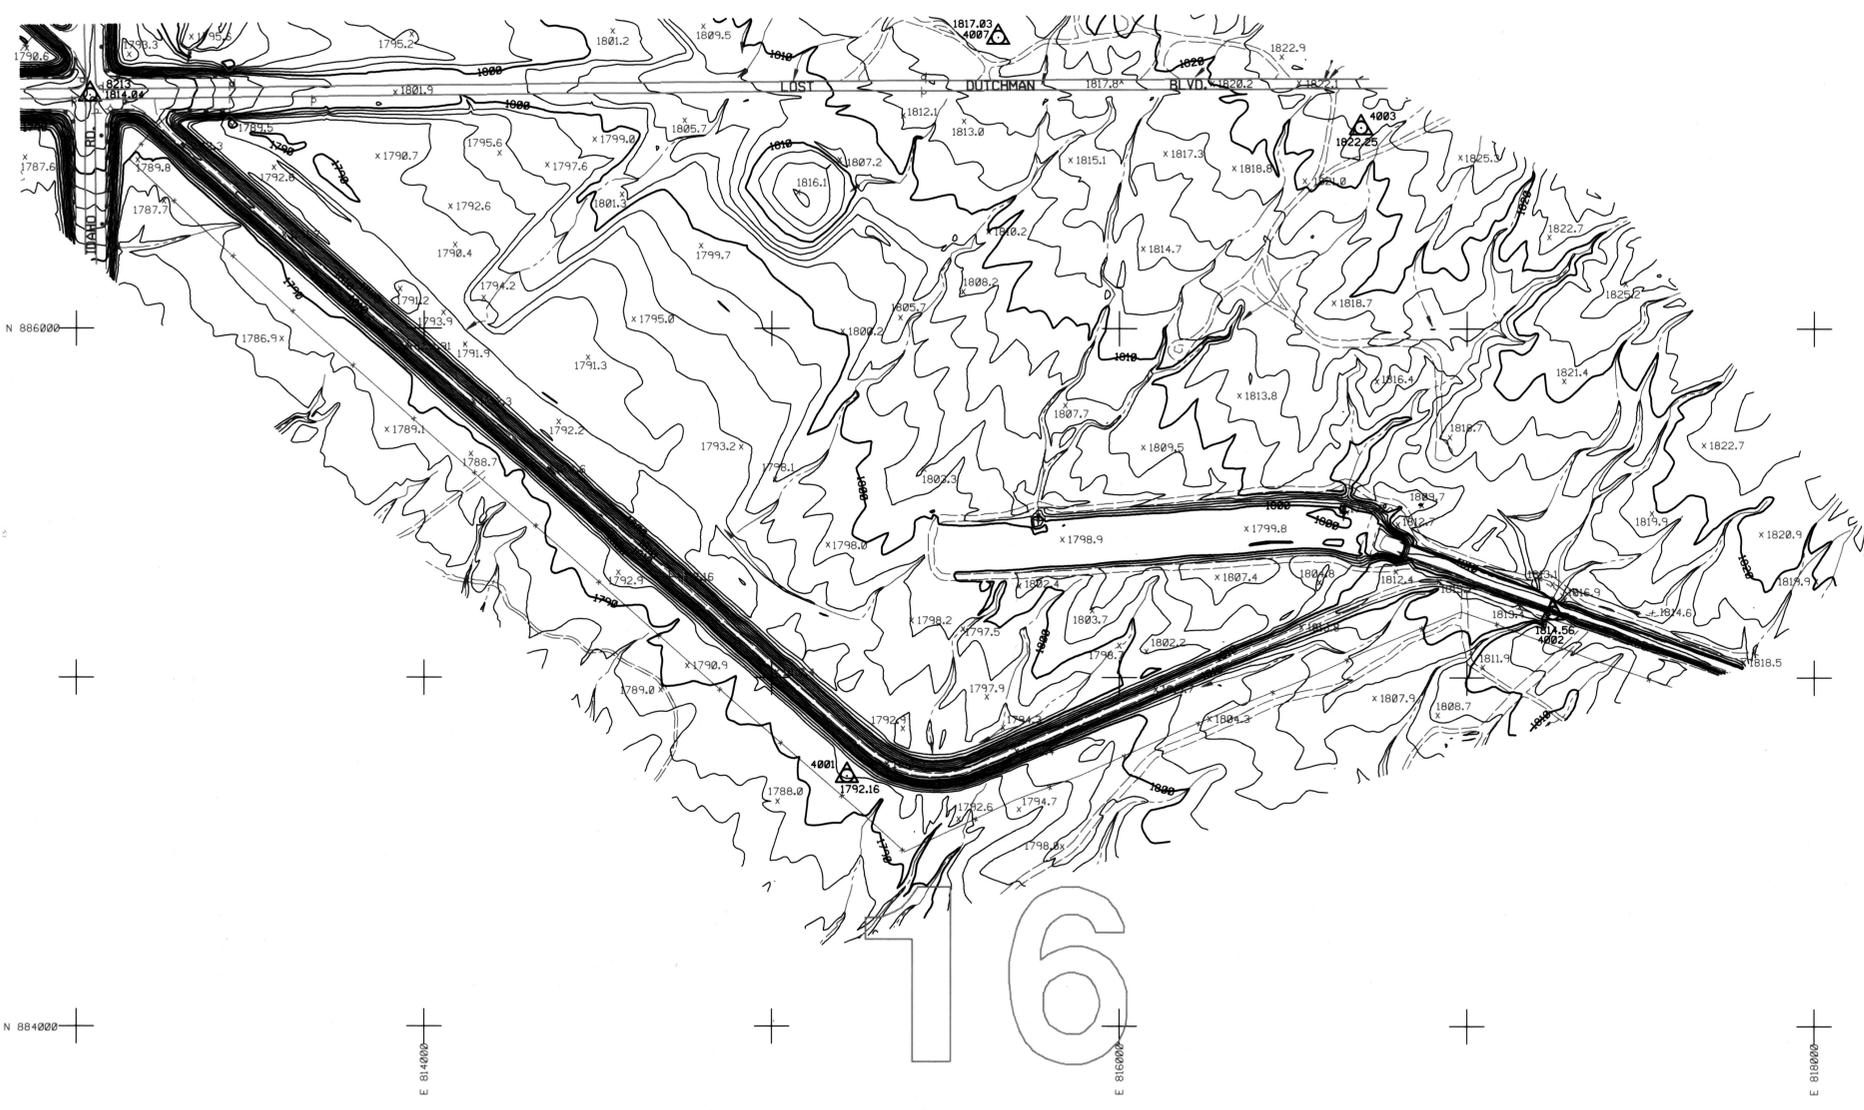
DESIGN	BY	DATE	FLOOD CONTROL DISTRICT OF MARICOPA COUNTY
DESIGN CHK.	-	-	
PLANS	-	-	RECOMMENDED BY: DATE
PLANS CHK.	-	-	APPROVED BY: DATE
SUBMITTED BY:			CHIEF ENGINEER AND GENERAL MANAGER
	DATE:		SHEET 3 OF 3

Map Sheet 3 represents Section 16, TIN, RBE
