WATERSHED WORK PLAN

GUADALUPE WATERSHED

MARICOPA COUNTY, ARIZONA

JANUARY 1971

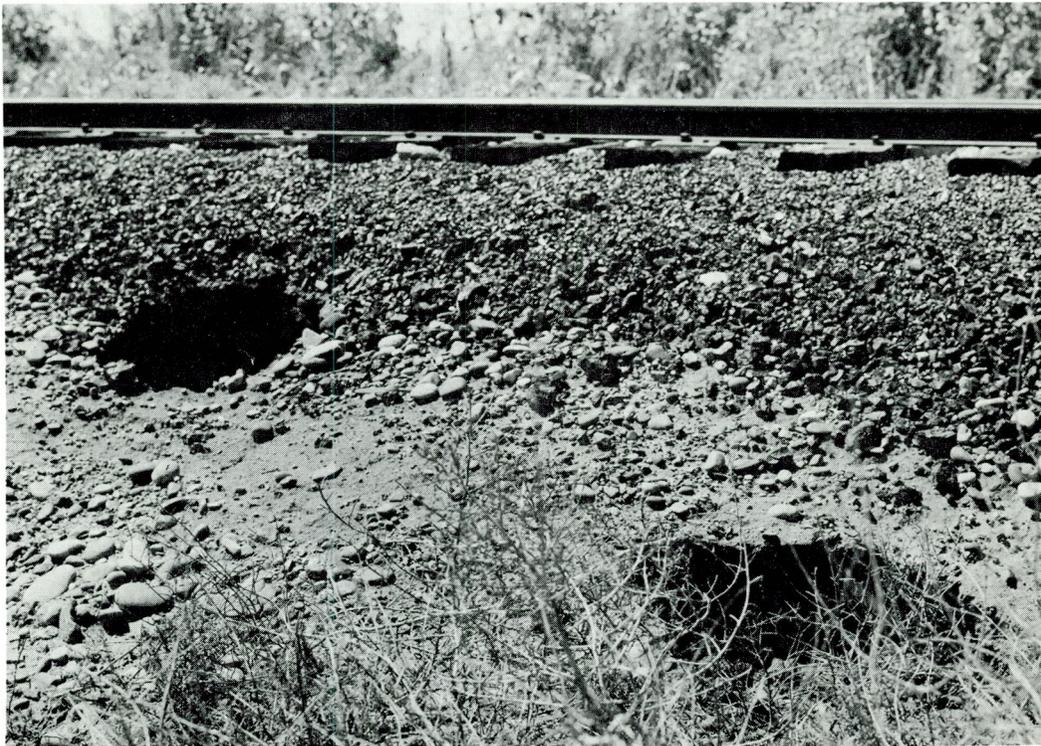
Damage resulting from floodwater and soil erosion.

The 1969 storm caused serious damage to agricultural properties by breaking about one-half mile of main canal lining, silting irrigation ditches and inundating over 600 acres of crops. This storm also damaged an estimated 137 homes and 18 commercial properties. Floodwater also damaged railroad and industrial properties.
