FLOOD CONTROL DISTRICT OF MARICOPA COUNTY

DAMBREAK ANALYSIS OF
SUNSET DAM ON SUNSET WASH
WICKENBURG, ARIZONA

February, 1987

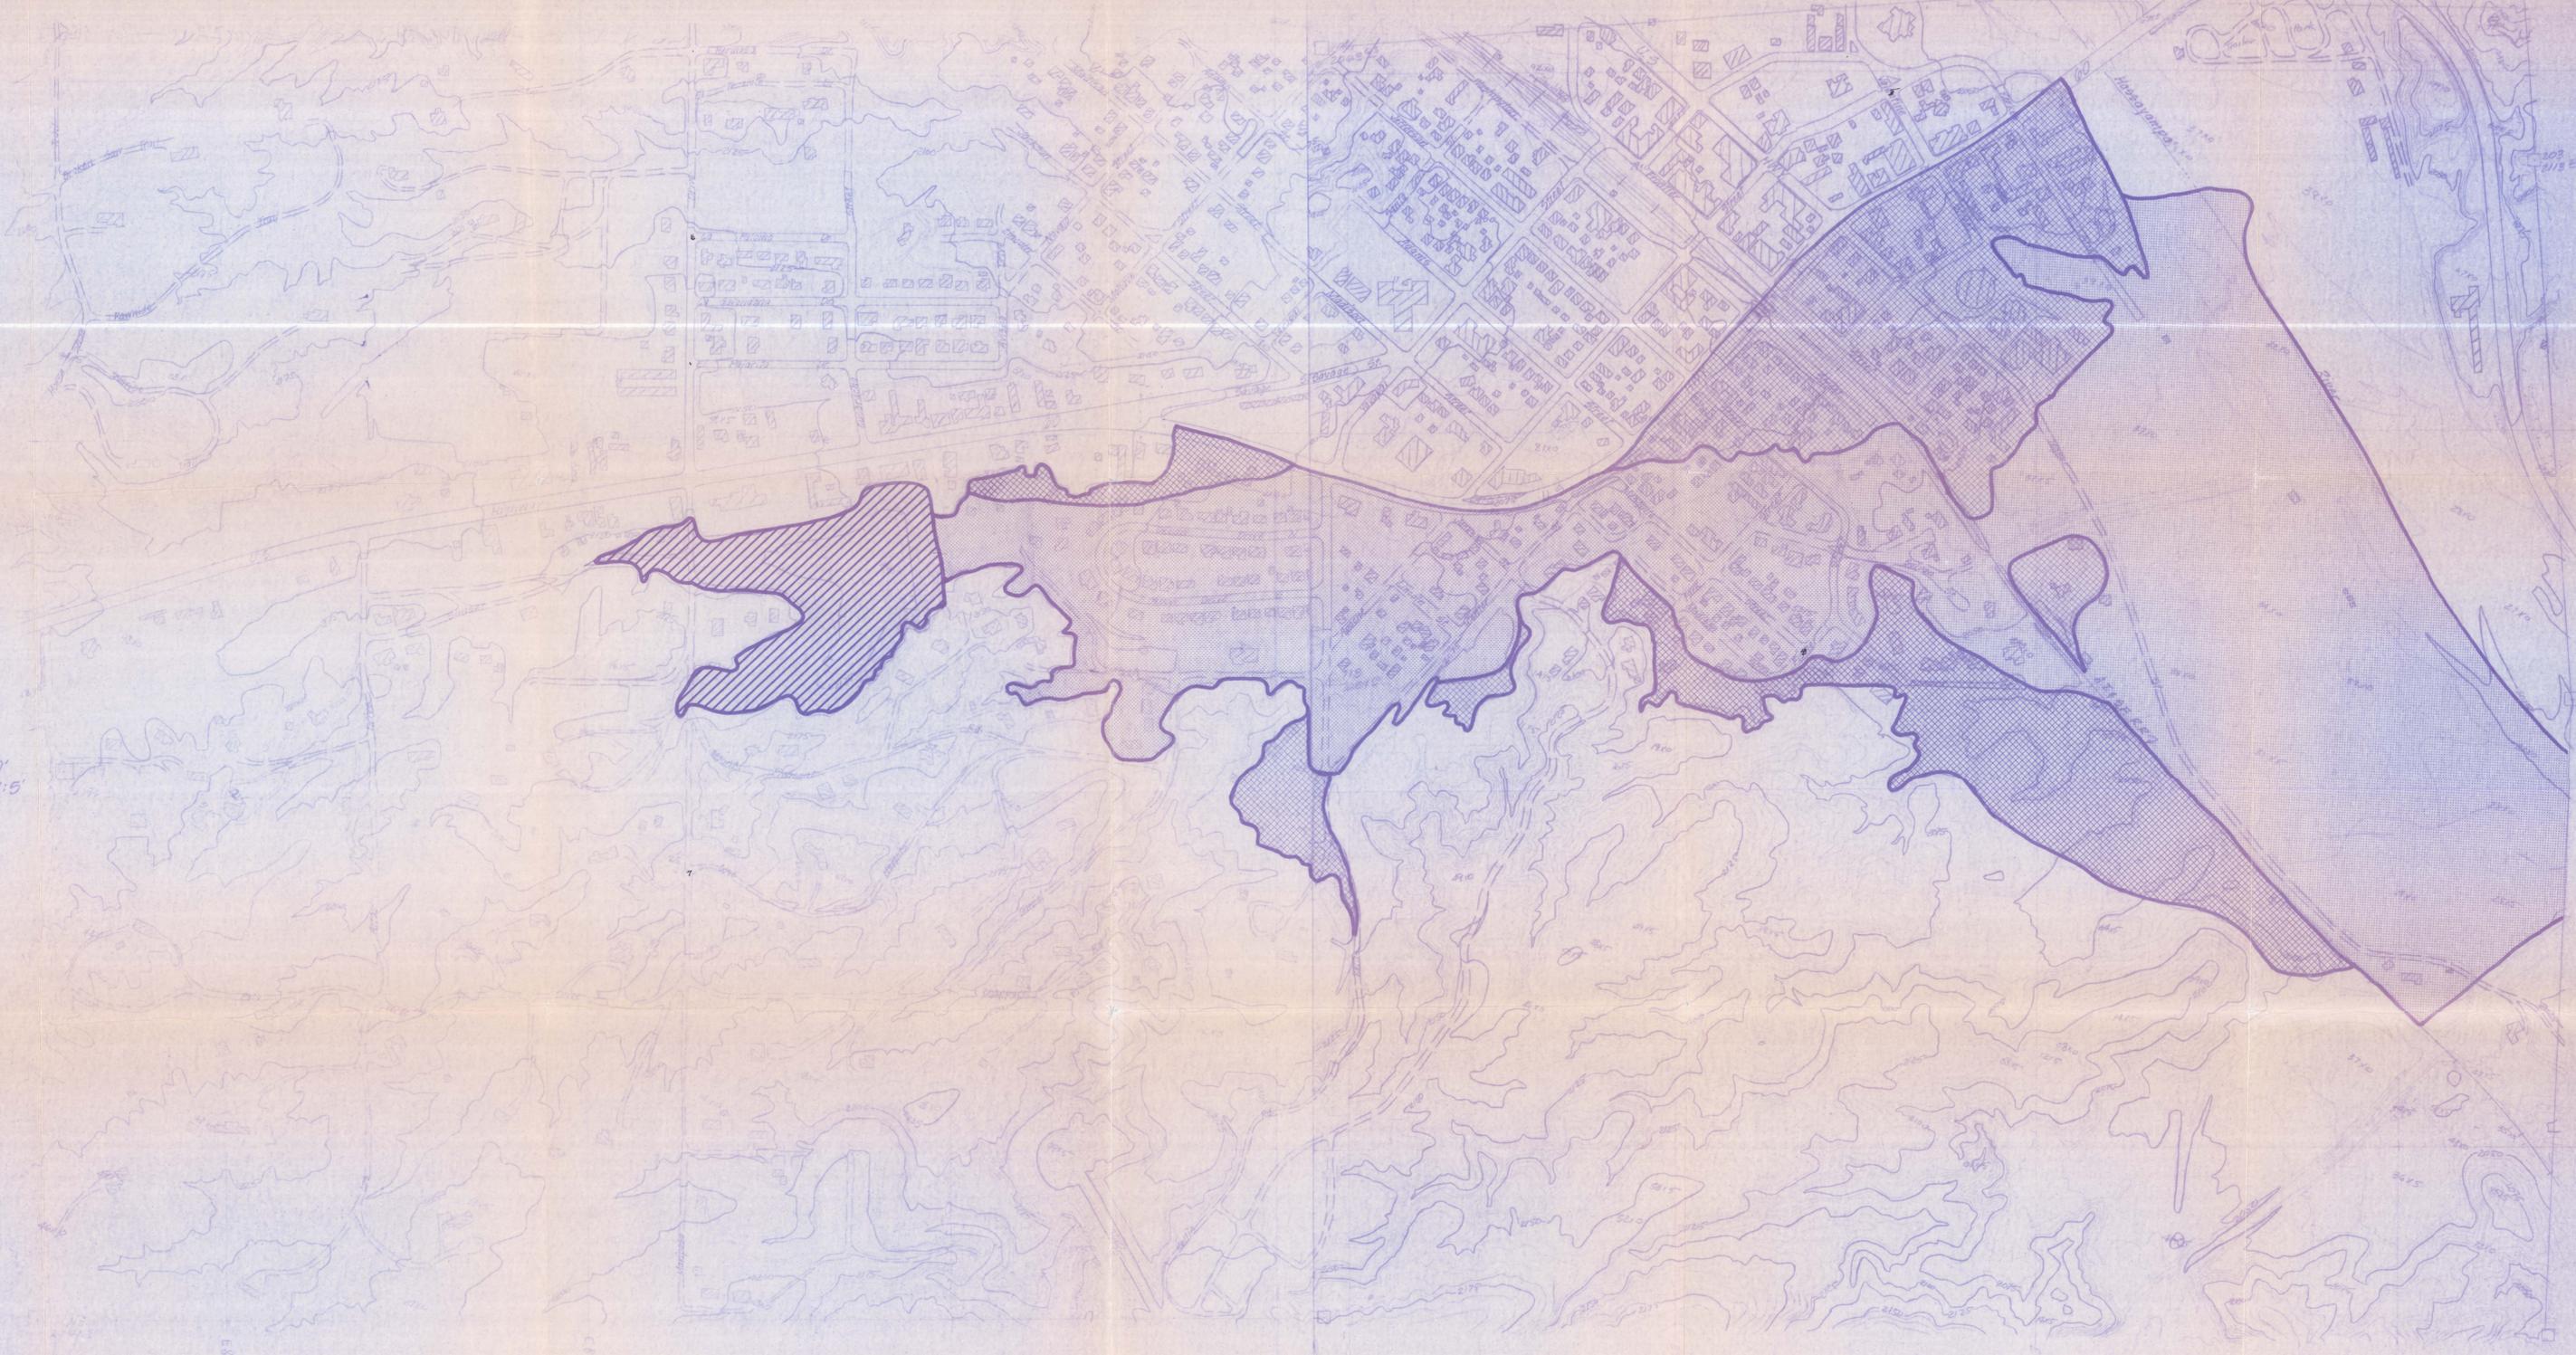
Scale: 1"=300'
 Contour Interval: 5'

FLOOD CONTROL DISTRICT OF MARICOPA COUNTY
 SUNSET DAM, WICKENBURG, ARIZONA
 DAMBREAK ANALYSIS ESTIMATED
 AREA OF INUNDATION
 FEBRUARY, 1987

The failure of Sunset Dam under the conditions modeled would result in downstream flooding of a magnitude not experienced in that area before. The peak discharge at the dam (8900 cfs) would exceed the Probable Maximum Flood (7100 cfs), that flood which would occur under the most severe hydrometeorological conditions possible. Figure 1 indicates the areas which would be inundated as a result of the failure of this structure.

The flood waters released through the breached dam would for the most part be confined to the area south of U.S. Highway 60. Output from the model indicates that the depths of flow in the severe hazard area would range from nearly 7 feet a short distance below the dam to nearly 3 feet at the downstream end of the routing reach. However, inasmuch as the SMPDBK model neglects the backwater effects caused by downstream bridges, and since the AT&SF RR embankment would in reality cause ponding to occur on its upstream side, depths approaching 5 feet could be expected at the lower end of the study area.

Within the area likely to be inundated (as indicated on Figure 1), velocities will not be as great as indicated above, and most of the property damage will be due to standing water rather than flowing water.
