**FINAL
REHABILITATION PLAN/
ENVIRONMENTAL ASSESSMENT
FOR THE**

**WHITE TANKS NO. 3
PROJECT PROJECT
Maricopa County, Arizona**

REHABILITATION PLAN – ENVIRONMENTAL ASSESSMENT

White Tanks No. 3 Project

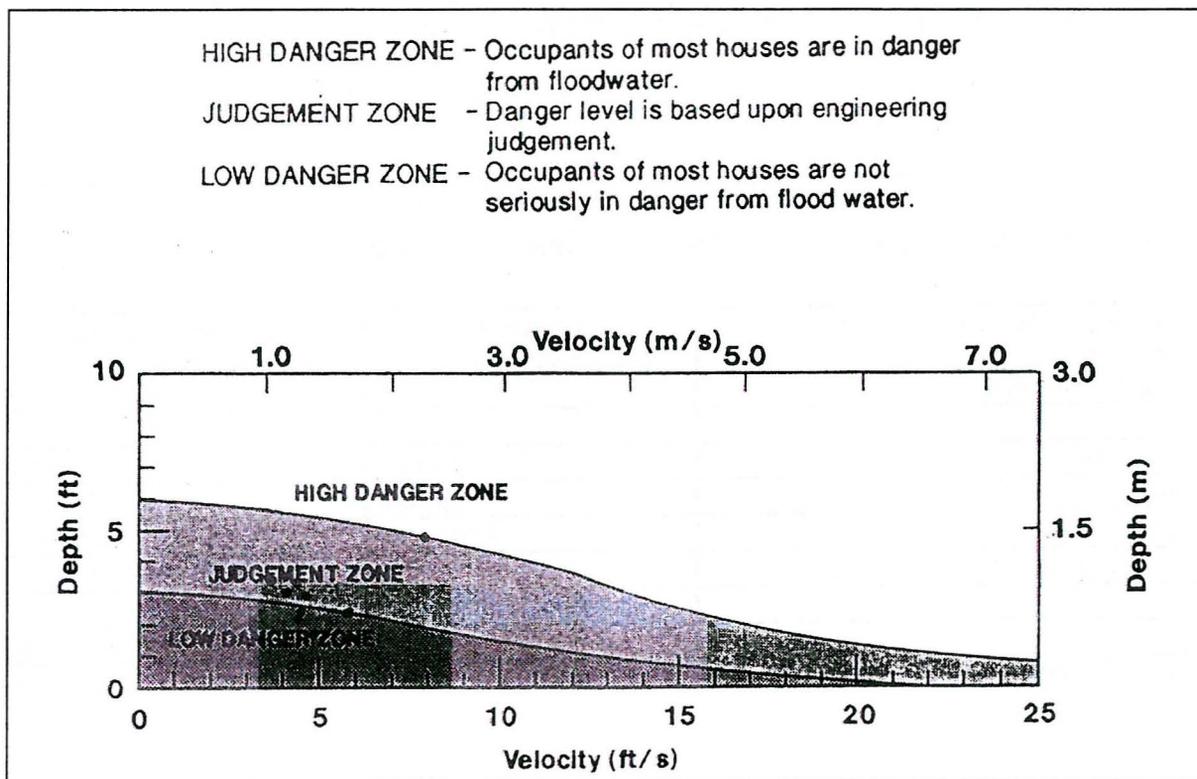
Figure 2: Depth-Velocity Flood Danger Level Relationship For Houses Built On Foundations.

An additional measure of the threat is in a reference, cited in the Dam Break Analysis for White Tanks No. 3 and No. 4 Flood Retarding Structures, January 1991. This figure, shown below, computes a danger factor based on a combination of water depth and velocity.

Plotting depth and damage for cross-sections utilized in the Dambreak Analysis shows that most locations in the White Tanks No. 3 FRS downstream area would result in a High or Judgment danger zone for structures and certainly for people downstream. A High Danger Zone is one where occupants of most houses are in danger from floodwater. A “Judgment Zone” is one where the danger level is based upon engineering judgment. Under a sudden and rapid dam failure scenario, a threat to life and property exists due to insufficient warning time.

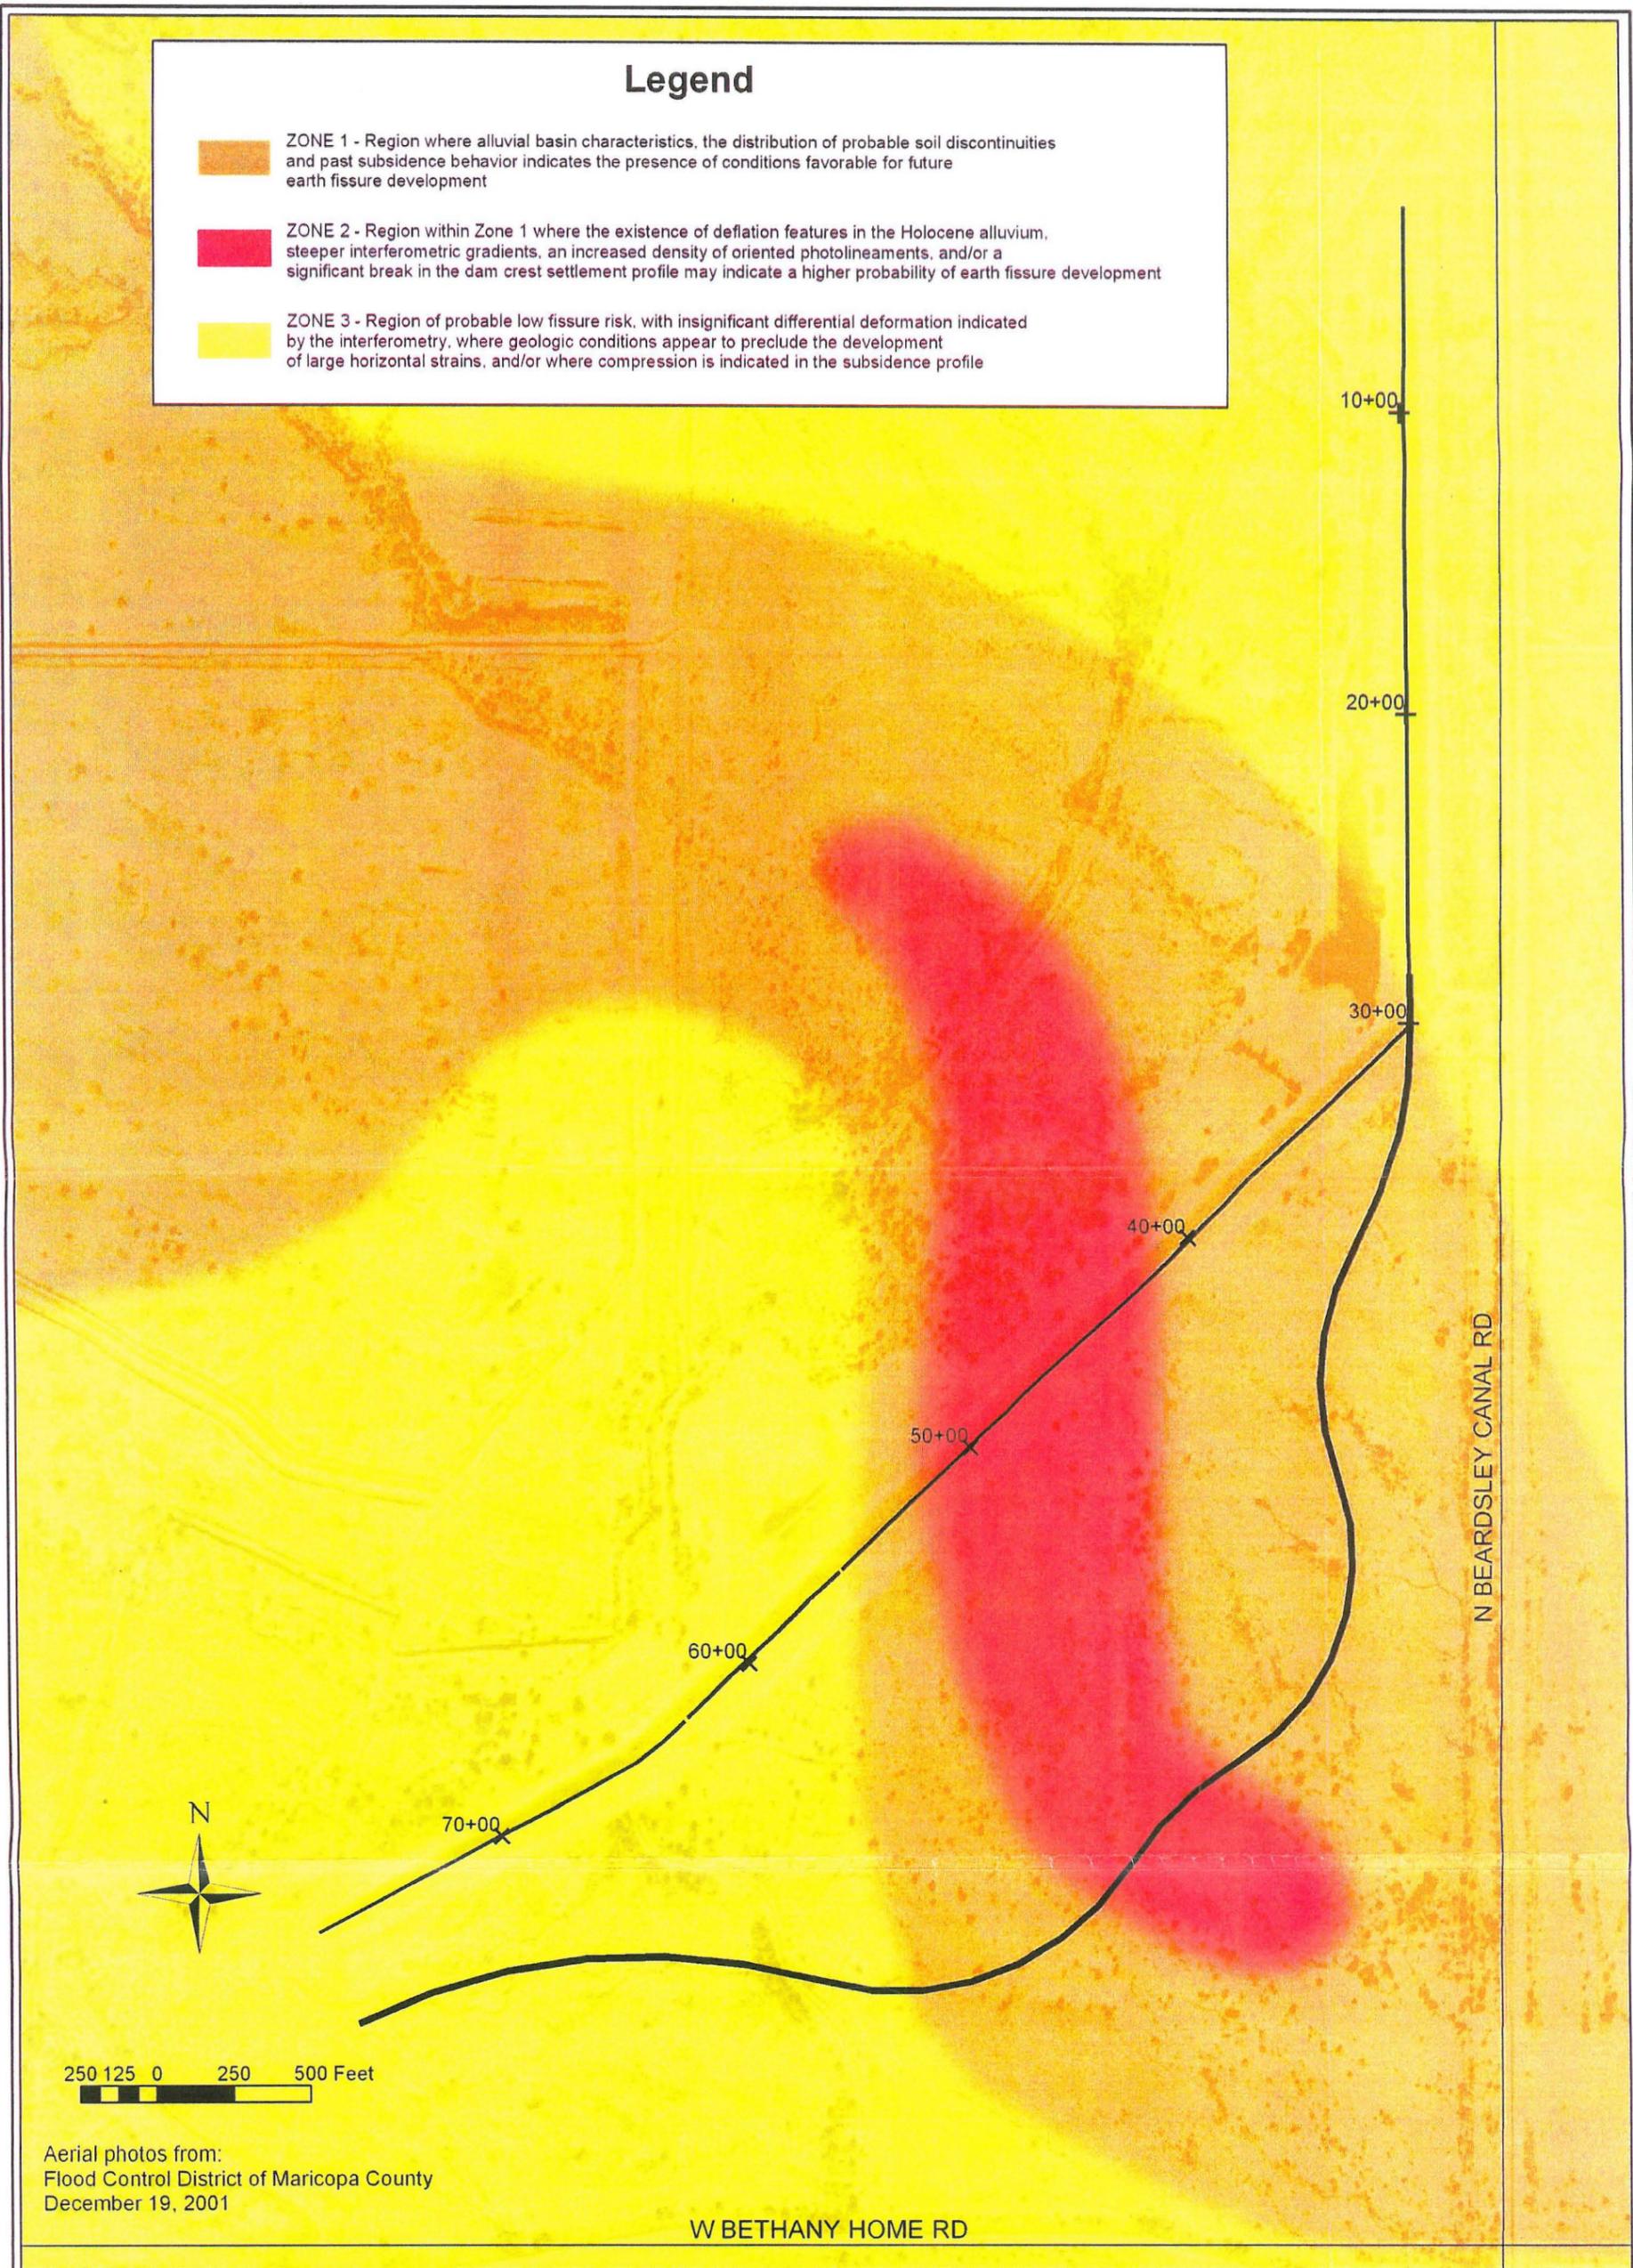
- ZONE 1 - Region where alluvial basin characteristics, the distribution of probable soil discontinuities and past subsidence behavior indicates the presence of conditions favorable for future earth fissure development
- ZONE 2 - Region within Zone 1 where the existence of deflation features in the Holocene alluvium, steeper interferometric gradients, an increased density of oriented photolineaments, and/or a significant break in the dam crest settlement profile may indicate a higher probability of earth fissure development
- ZONE 3 - Region of probable low fissure risk, with insignificant differential deformation indicated by the interferometry, where geologic conditions appear to preclude the development of large horizontal strains, and/or where compression is indicated in the subsidence profile

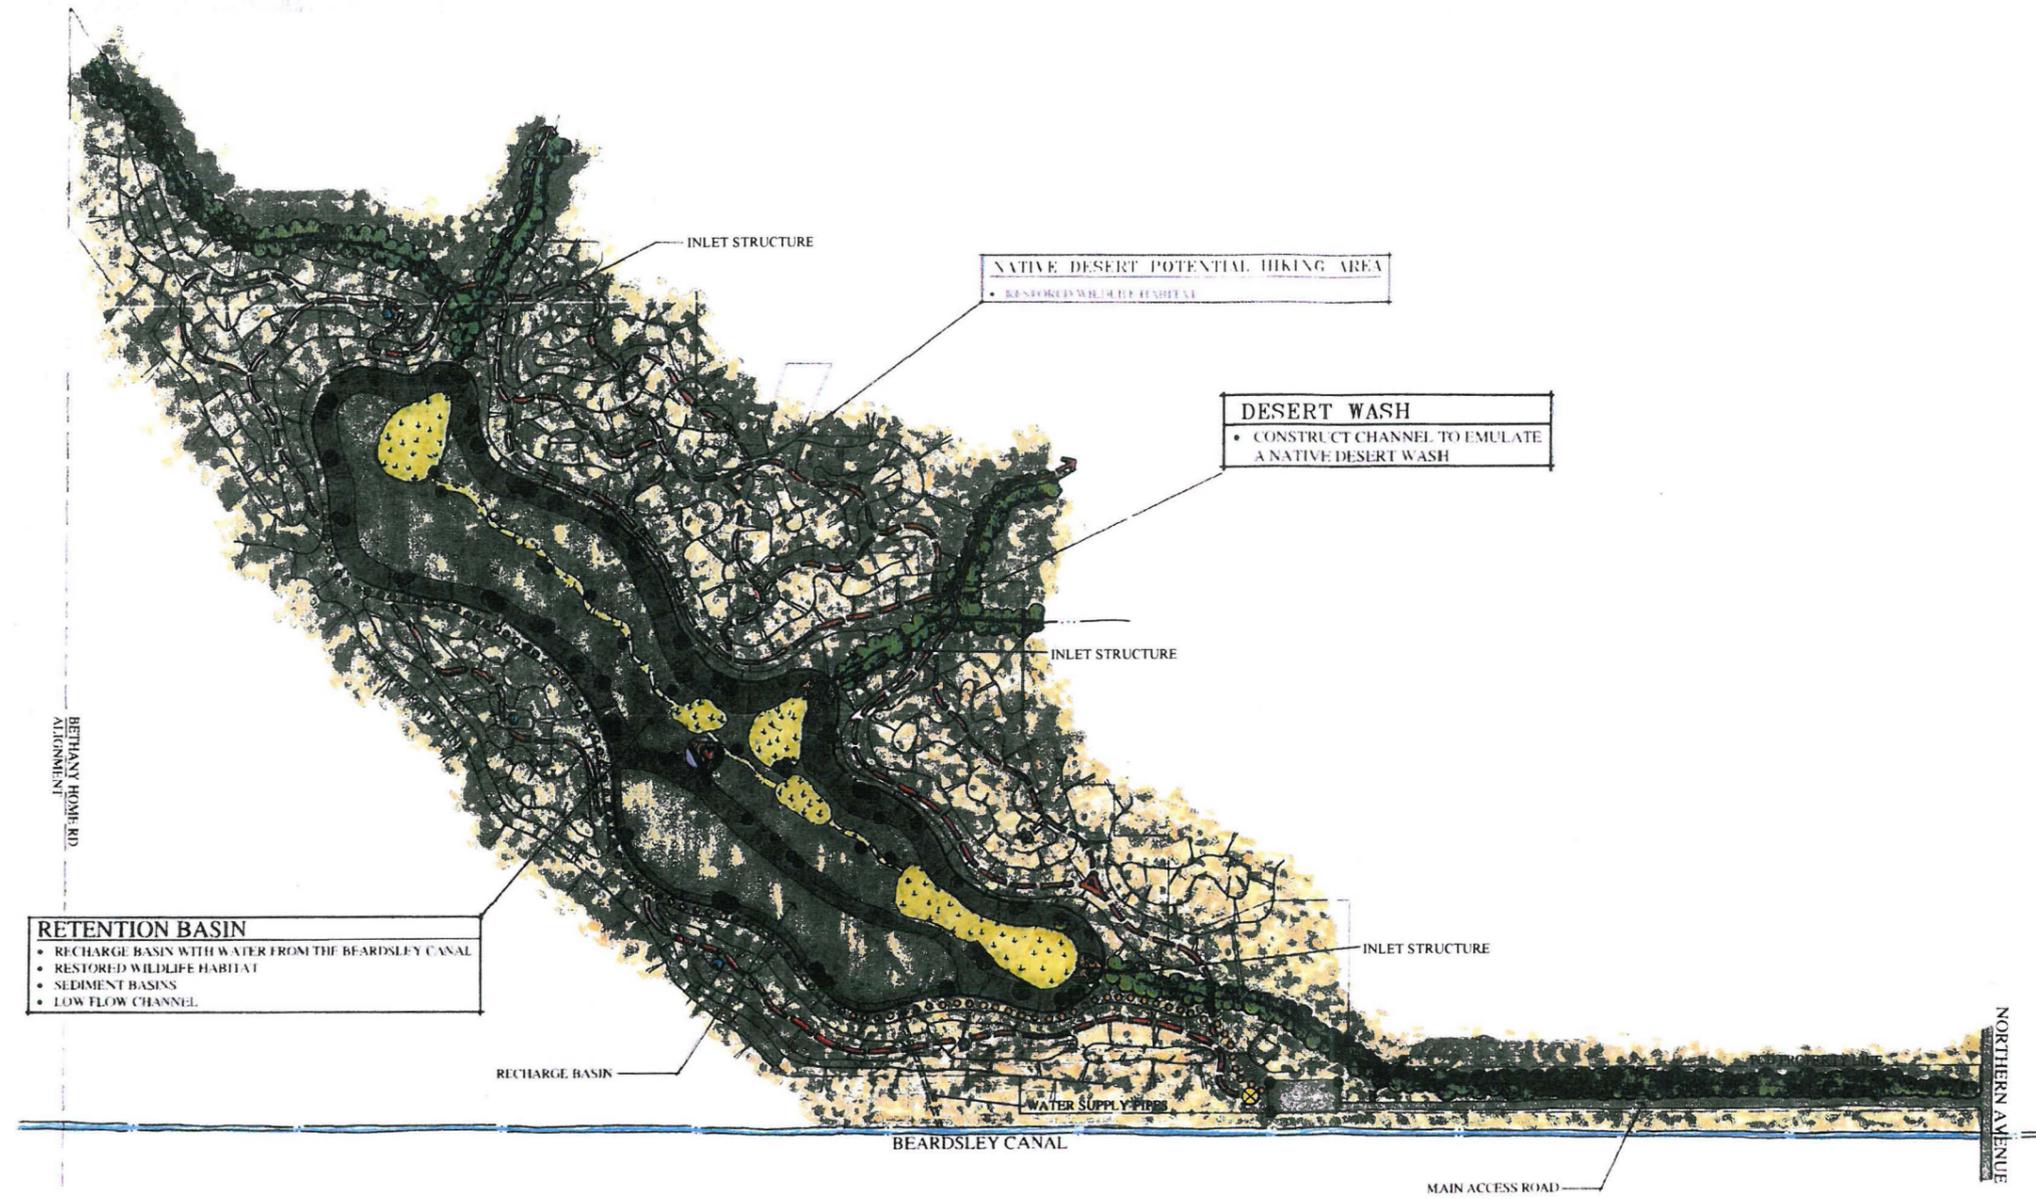
Figure 5

PLAN VIEW OF SINGLE BASIN

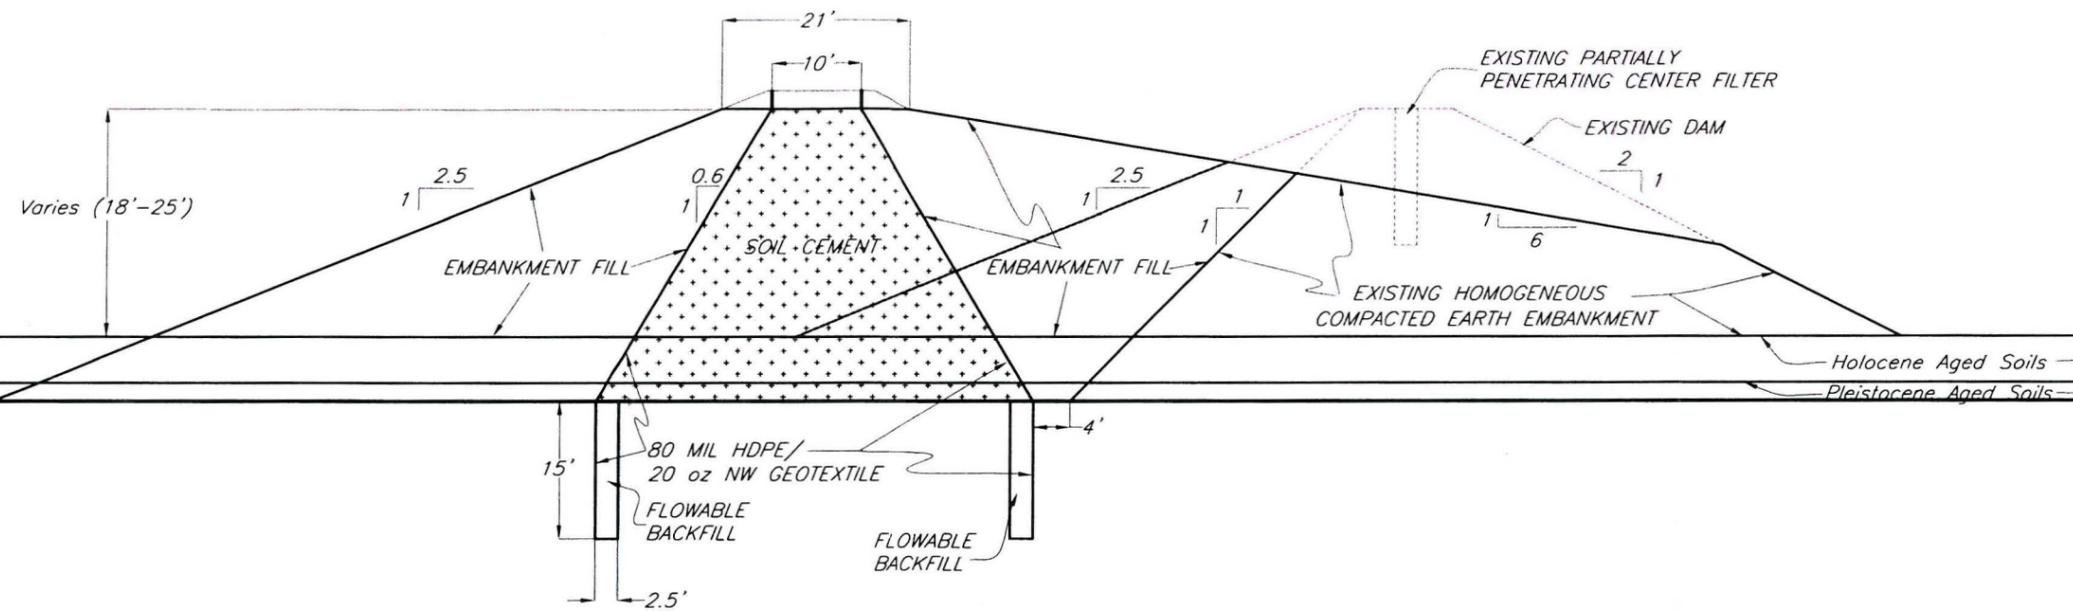
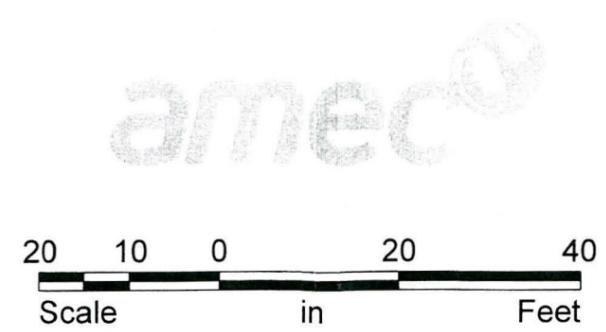
Figure: 6

EARTH FISSURE RISK ZONE

TYPICAL SECTION
STATION 30+00 to 55+00

DAM CROSS SECTIONS STA. 30+00 TO STA. 55+00
WHITE TANKS NO. 3
DAM MODIFICATION ALTERNATIVE
 MARICOPA COUNTY, ARIZONA

The final configuration includes the installation of a concrete cut-off wall across the 800 foot-wide earthen spillway crest. The wall would be 3 feet wide and extend down approximately 15 feet vertically into the Pleistocene soils. For protection, a riprap launch apron would be constructed that would extend for 40 feet downstream of the cut-off wall. The riprap would be covered with soil for safety and aesthetic reasons.

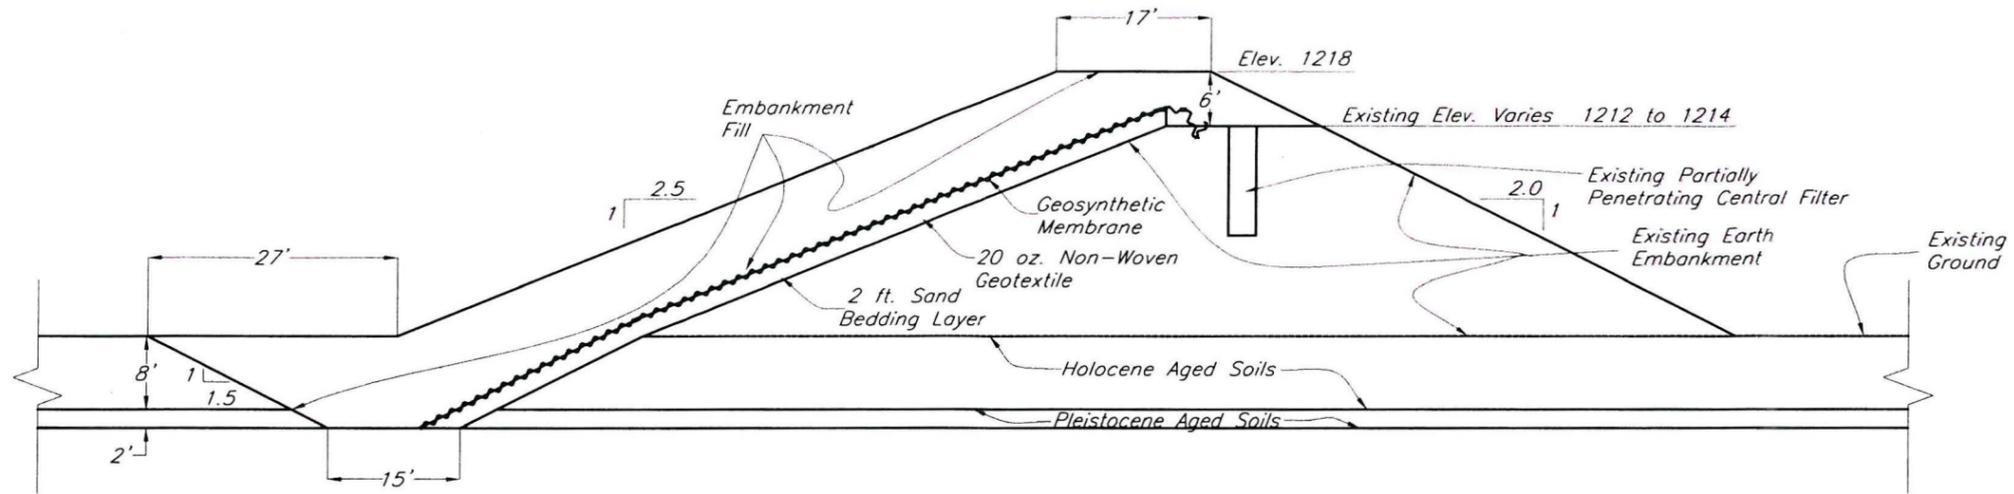
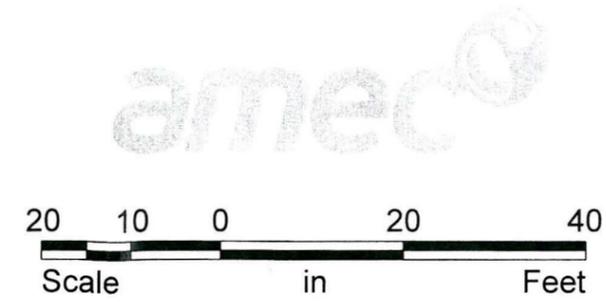
Figure: 7

EMBANKMENT CRACKING ZONE

TYPICAL SECTION

STATION -3+80 to 30+00 & 55+00 to 76+96

DAM CROSS SECTIONS -3+80 to STA. 30+00 and STA. 55+00 to 76+96
WHITE TANKS NO. 3
DAM MODIFICATION ALTERNATIVE
 MARICOPA COUNTY, ARIZONA

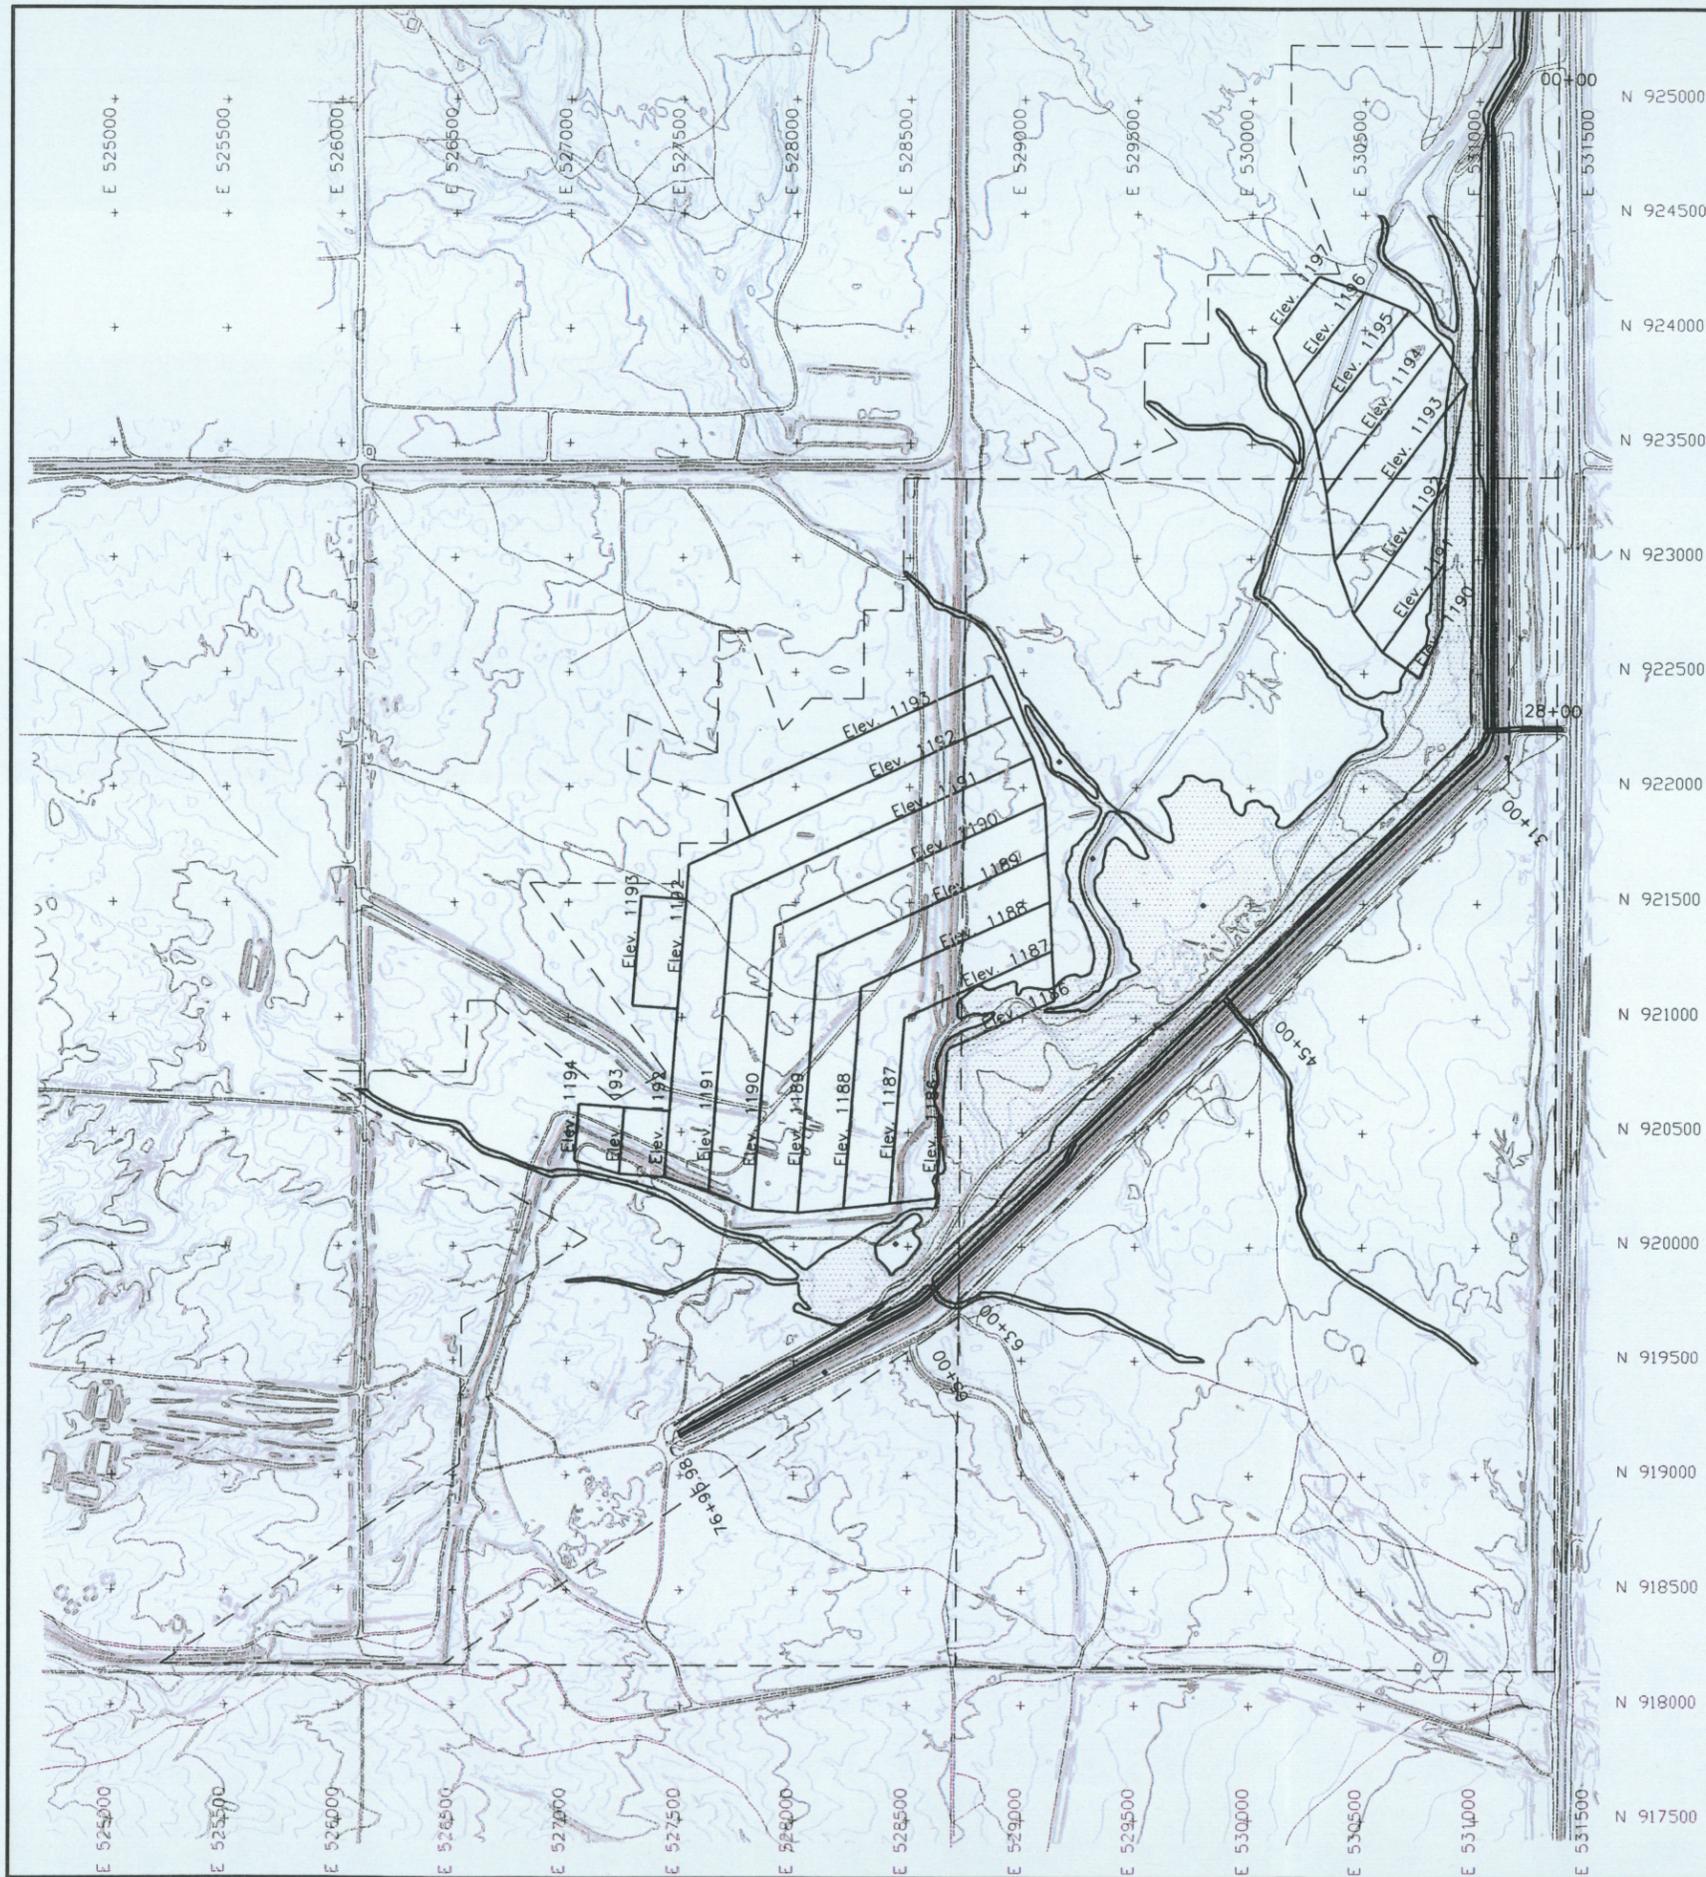
Figure: 9

The former borrow area has been disturbed and is sparsely vegetated with low value habitat. The proposed borrow areas consist of approximately 90 acres of previously disturbed barren land and areas of low to moderate value desert habitat adjacent to some unnamed washes (see Figure 9).

Following construction of the dam, excavated areas will be revegetated and graded to blend into the surrounding terrain and will include drainages to convey flows into the impoundment behind the dam. Habitat loss resulting from construction will be mitigated by applying a hydroseed mix of native desert plants. Areas within the impoundment disturbed by construction will be hydroseeded with a mix of native forbs, grasses and shrubs, including globemallow, Indian wheat, purple three-awn, triangleleaf bursage, and brittle bush. The borrow areas and other disturbed areas will be hydroseeded with a mix of desert shrubs and trees, including velvet mesquite, palo verde, acacia, ironwood, creosote bush and brittle bush. The embankment will be hydroseeded with native grasses, forbs, and other non-deep rooting shrubs. The vegetation will be seeded during the fall after completion of construction. The compacted ground will be scarified and graded to promote passive water collection and to improve soil moisture.

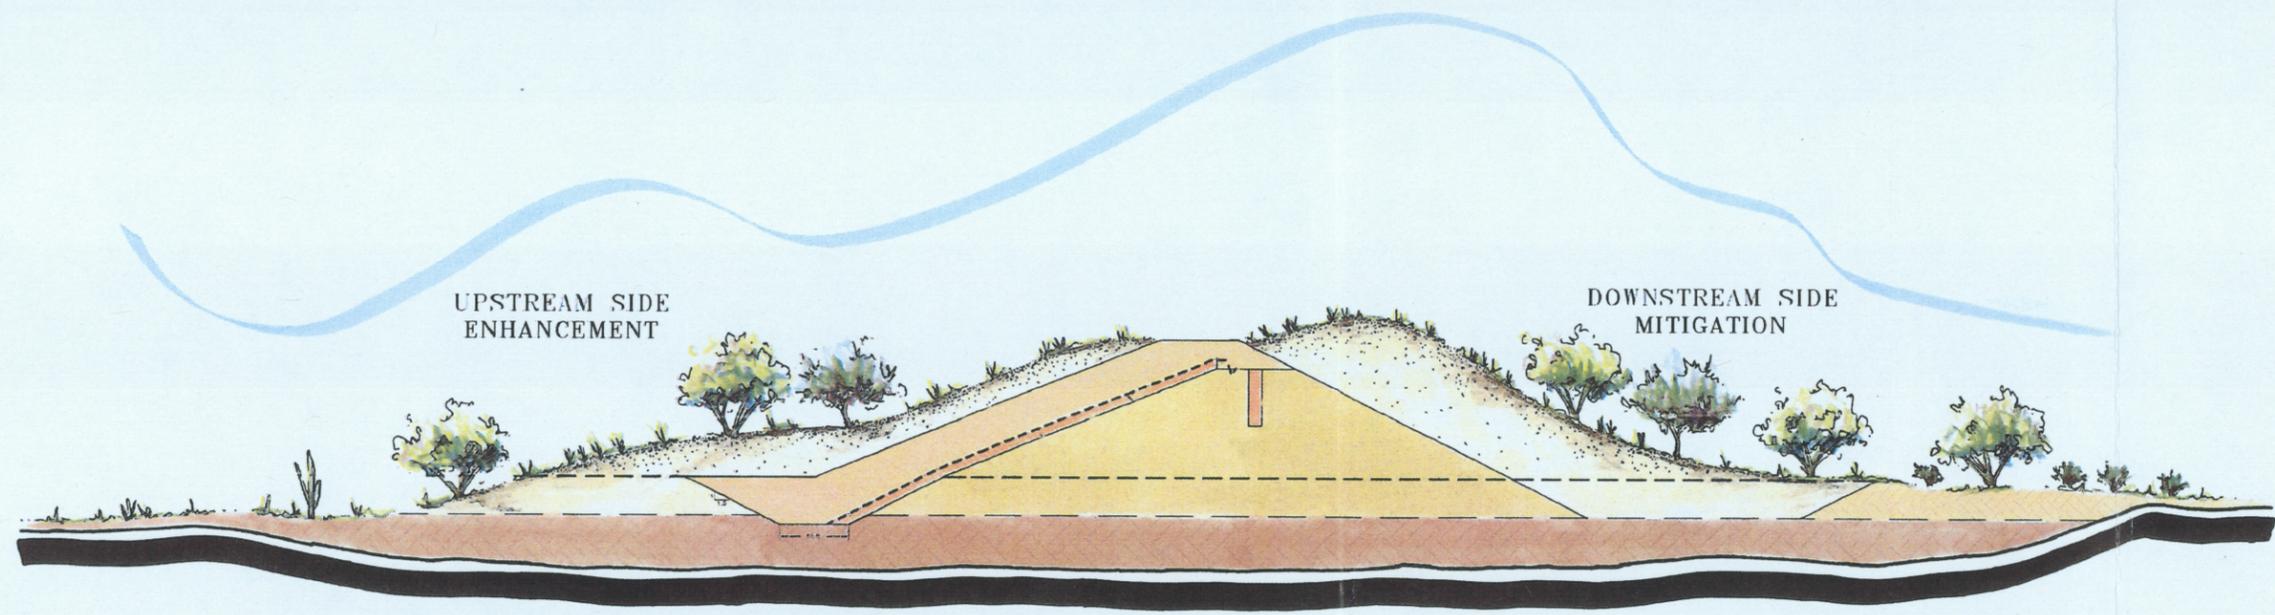
Figure 10
 MODIFIED DAM
 ALTERNATIVE
 SECTIONS

(A) EMBANKMENT CRACKING ZONE SECTION (Station 3+80 to 30+00 & 55+00 to 76+96)

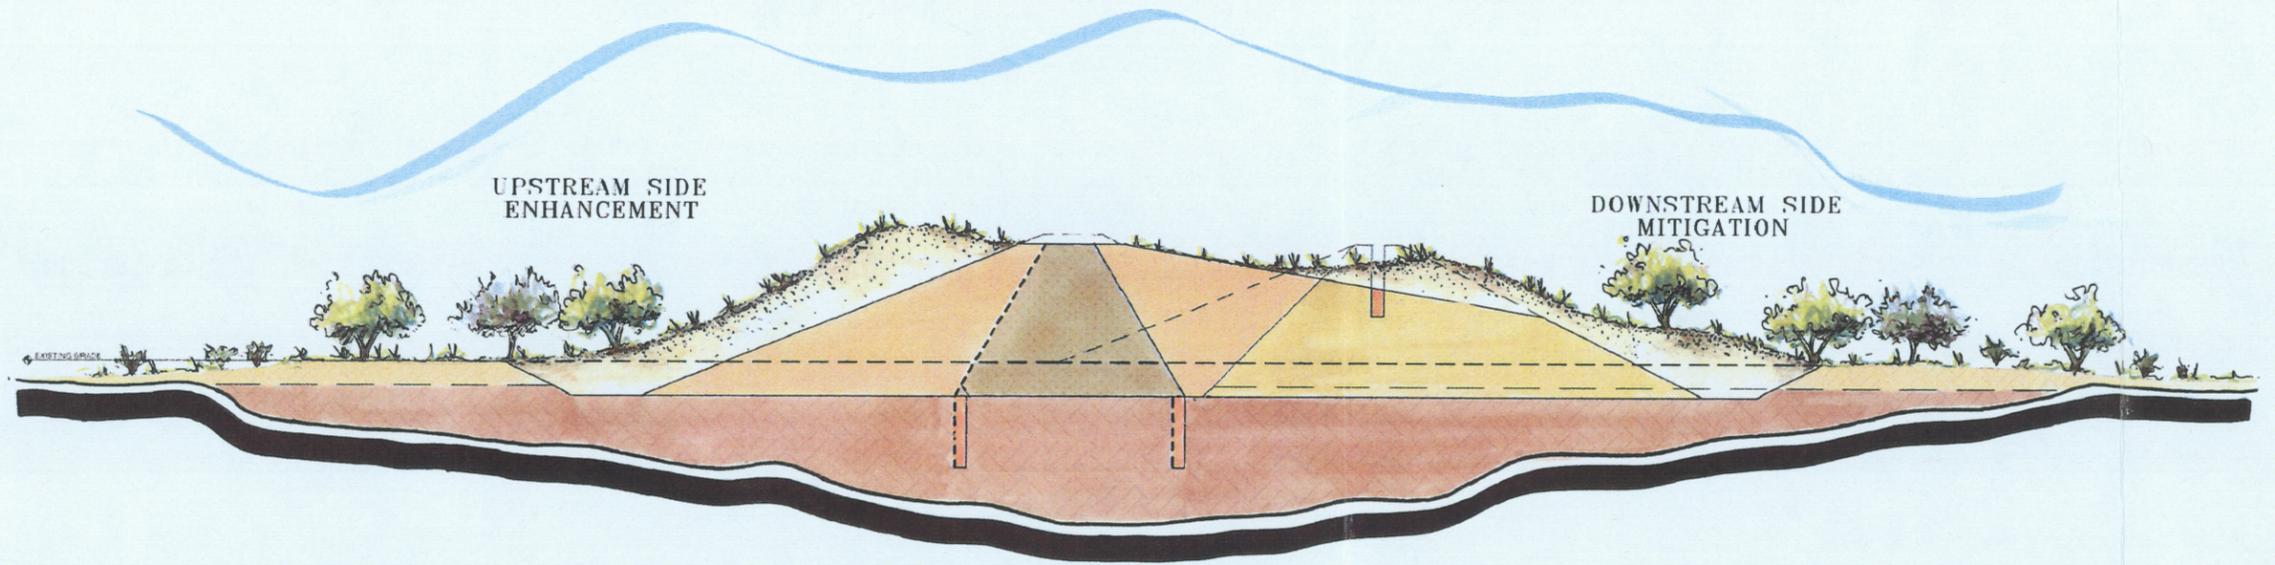
(B) EARTH FISSURE RISK ZONE SECTION (Station 30+00 to 55+00)

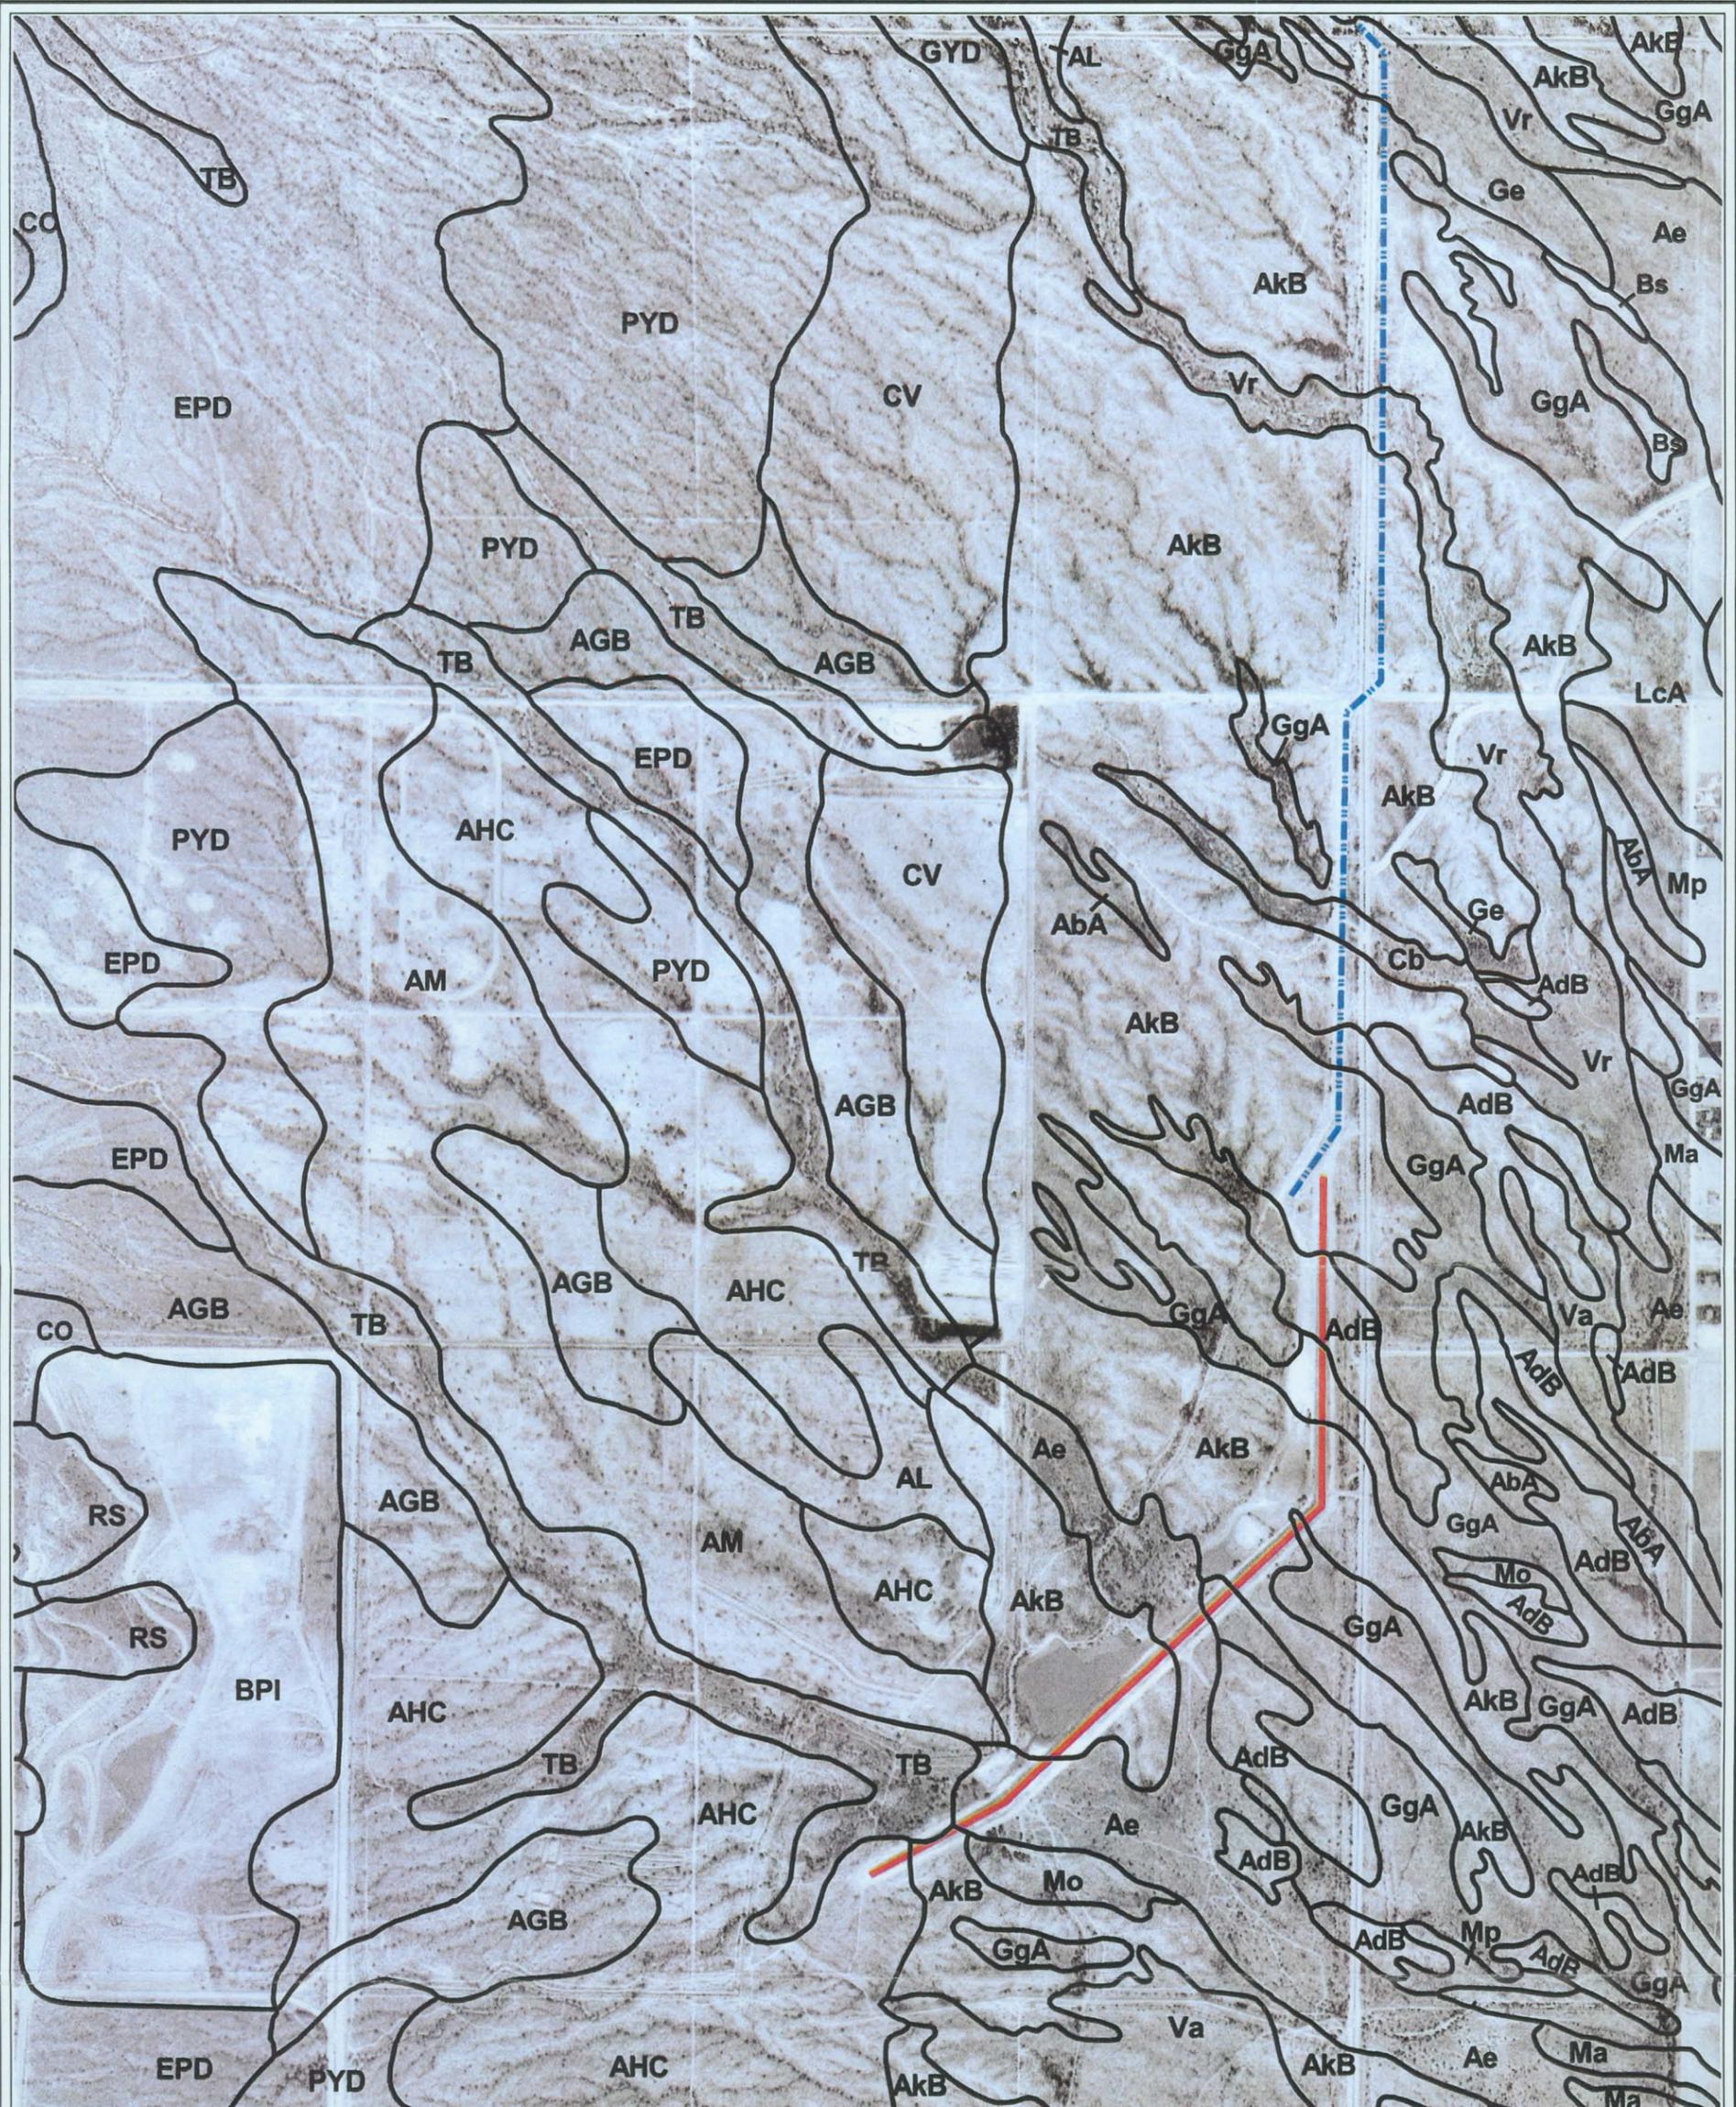
White Tanks Flood Retarding Structure #3 Detailed Soils

Base Map Source: USGS Digital Orthophoto Quadrangle, 1992.
Soil Data: USDA/NRCS SSURGO, 2002, Field Mapped at 1:24,000 scale.

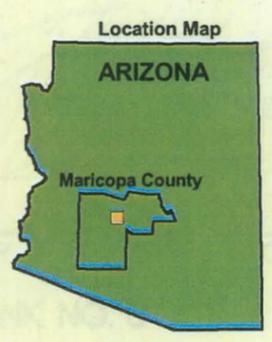
Soil Map Units

SYMBOL	SOIL MAP UNIT NAME
AGB	ANTHO-CARRIZO COMPLEX, 0 TO 3 PERCENT
AHC	ANTHO-TREMANT COMPLEX, 1 TO 5 PERCENT SLOPES
AL	ANTHO ASSOCIATION
AM	ANTHO-VALENCIA ASSOCIATION
AbA	ANTHO SANDY LOAM, 0 TO 1 PERCENT SLOPES
AdA	ANTHO GRAVELLY SANDY LOAM, 0 TO 1 PERCENT SLOPES
AdB	ANTHO GRAVELLY SANDY LOAM, 1 TO 3 PERCENT SLOPES
Ae	ANTHO-BRIOS SANDY LOAMS
AkB	ANTHO-TREMANT-MOHALL COMPLEX, 1 TO 5 PERCENT SLOPES
BPI	BORROW PIT
Bs	BRIOS SANDY LOAM
CO	CHERIONI-ROCK OUTCROP COMPLEX
CV	COOLIDGE-LAVEN ASSOCIATION
Cb	CARRIZO GRAVELLY SANDY LOAM
EPD	EBON-PINAMT COMPLEX, 0 TO 10 PERCENT SLOPES
GYD	GUNSIGHT-RILLITO COMPLEX, 0 TO 10 PERCENT SLOPES
Ge	GILMAN FINE SANDY LOAM
GgA	GILMAN LOAM, 0 TO 1 PERCENT SLOPES
LcA	LAVEN LOAM, 0 TO 1 PERCENT SLOPES
Ma	MARIPO SANDY LOAM
Mo	MOHALL SANDY LOAM
Mp	MOHALL LOAM
PYD	PINAMT-TREMANT COMPLEX, 1 TO 10 PERCENT SLOPES
RS	ROCK OUTCROP-CHERIONI COMPLEX
TB	TORRIFLUVENTS
Va	VALENCIA SANDY LOAM
Vr	VINT-CARRIZO COMPLEX

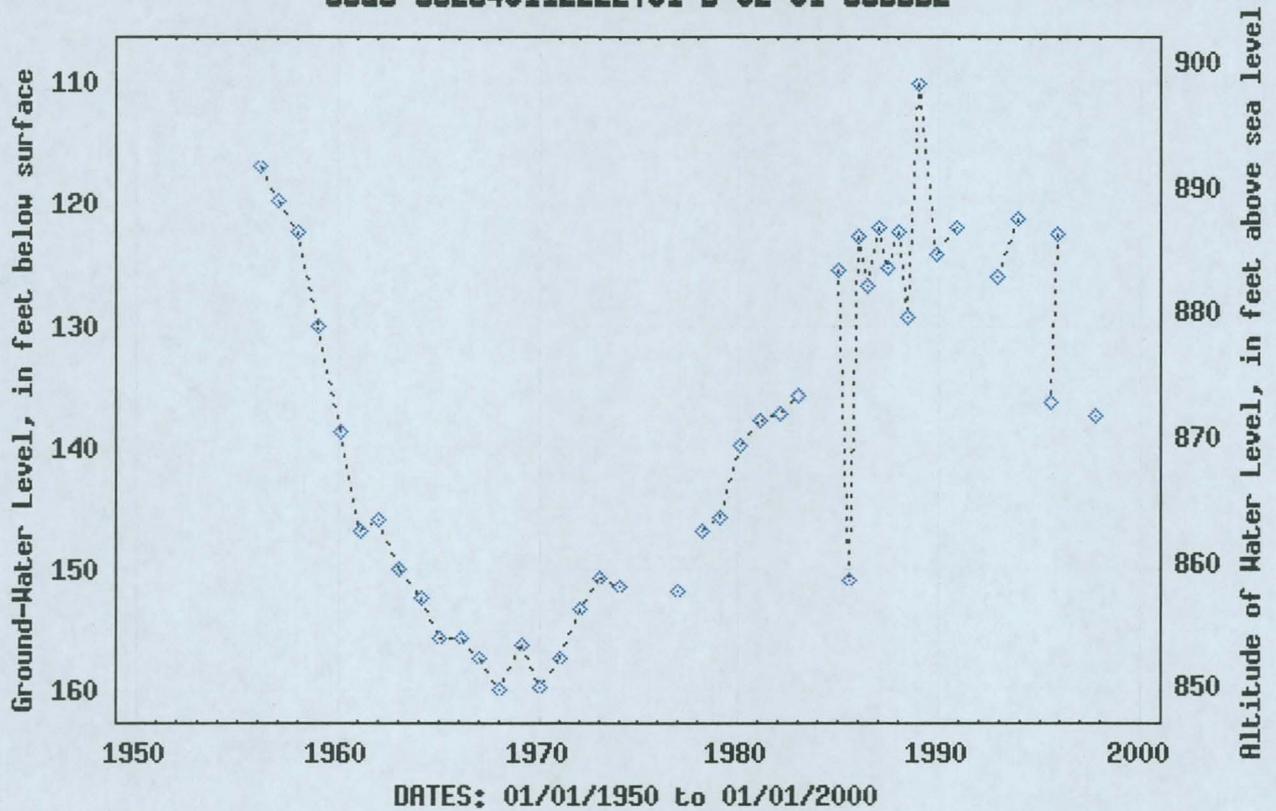
USGS 332840112222701 B-02-01 338882

Provisional Data Subject to Revision
