**FINAL GEOTECHNICAL INVESTIGATION
SUPPLEMENTAL INVESTIGATION OF TRANSVERSE CRACKS
BUCKEYE FLOOD RETARDING STRUCTURE NO. 1
FLOOD CONTROL DISTRICT OF MARICOPA COUNTY
CONTRACT FCD 2003C014
WORK ASSIGNMENT NO. 2**

**JANUARY 7, 2005
AMEC JOB NO. 4-117-001021**

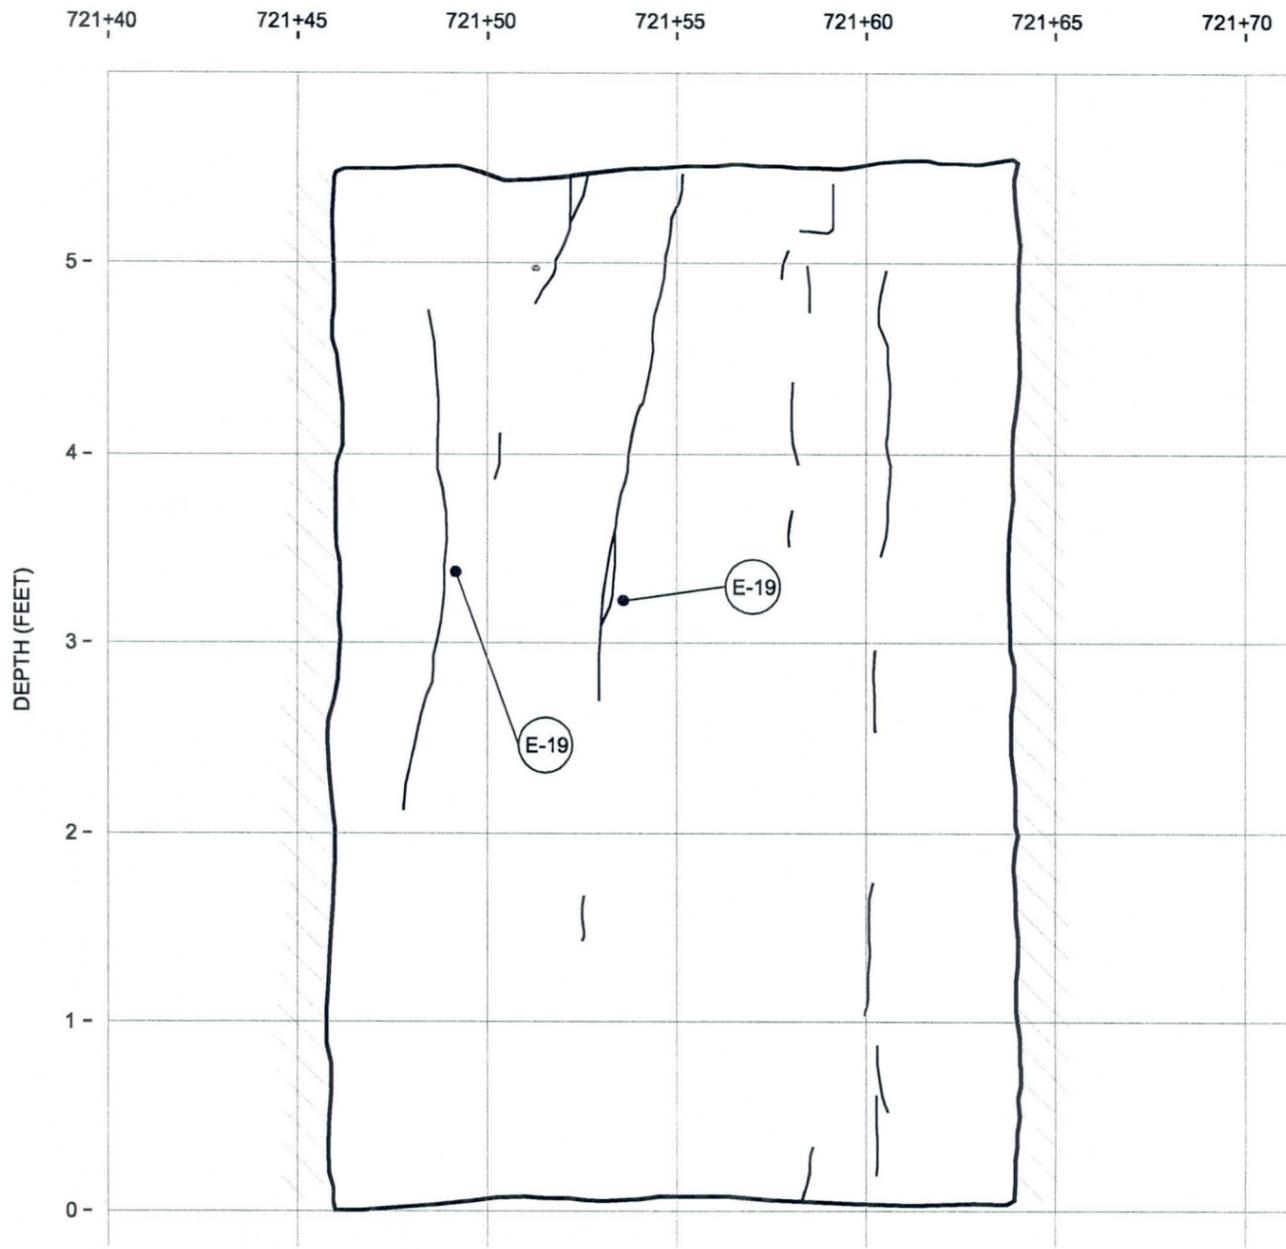
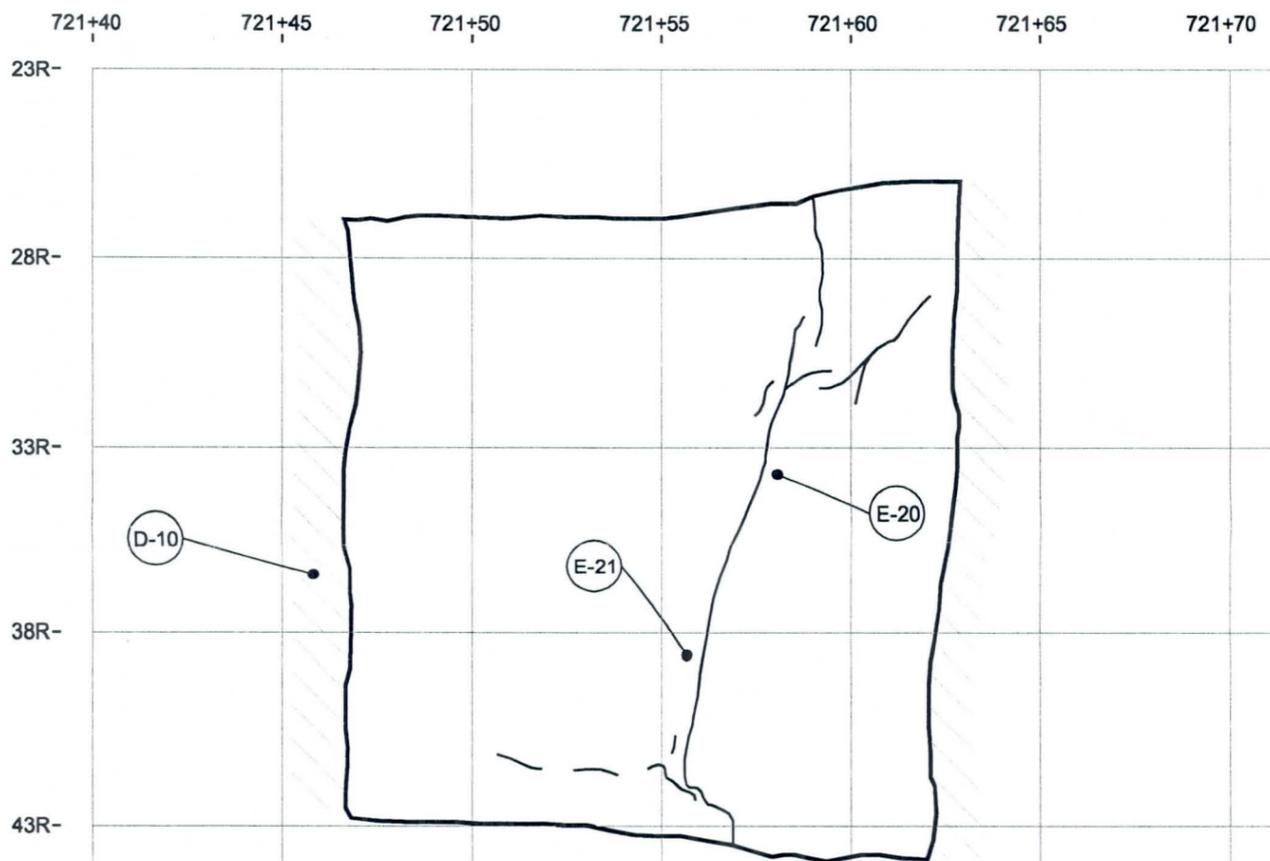
MAP VIEW 3D

E-18 CRACK <1/16" OPEN, 1 PHOTO

E-19 CRACK <1/16" OPEN, 1 PHOTO

E-20 OPEN CRACK UP TO 0.5" OPEN, 1 PHOTO

E-21 OPEN CRACK TO PARTIALLY FILLED UP TO 1.0" OPEN, 2 PHOTOS

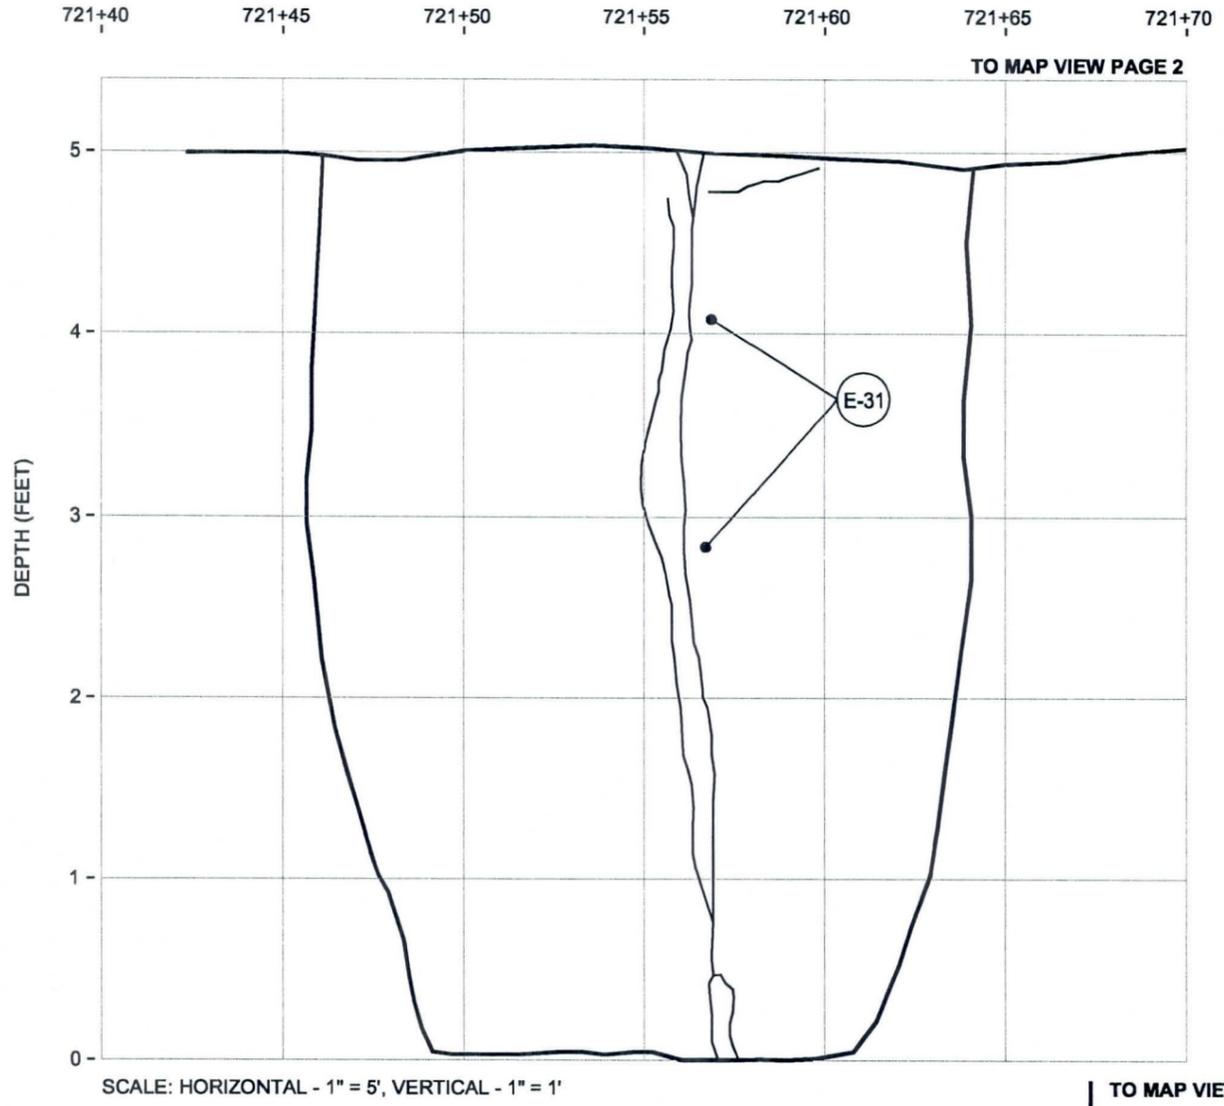
MAP VIEW 3F

| | LIMIT OF DEEPER EXCAVATION OR SPOILS PILE | | MAJOR CRACK TYP. OPEN 0.2" TO 0.5" UP TO 2"+ OPEN, 2 PHOTOS |
| | FILLED CRACK | | MAJOR PARTIALLY FILLED CRACK UP TO 2" WIDE, 1 PHOTO |
| | DISTINCT CRACK | | MAJOR PARTIALLY FILLED CRACK AND SAND FROM PREVIOUS INVESTIGATION, 4 PHOTOS |

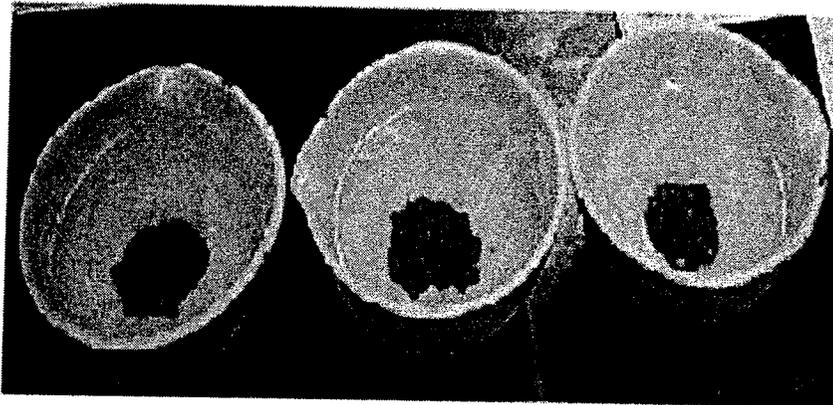
Lab 171
F-4B

Soil Crumb Specimen after 24 hours
Grade 1 - Nondispersive

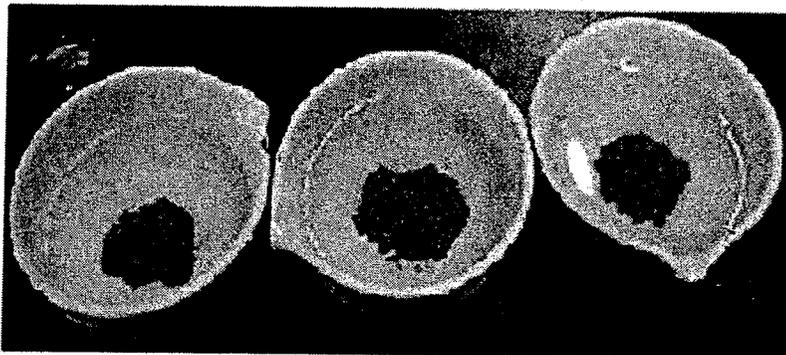
Lab 175
F-6B

Soil Crumb Specimen after 24 hours
Grade 1 - Nondispersive

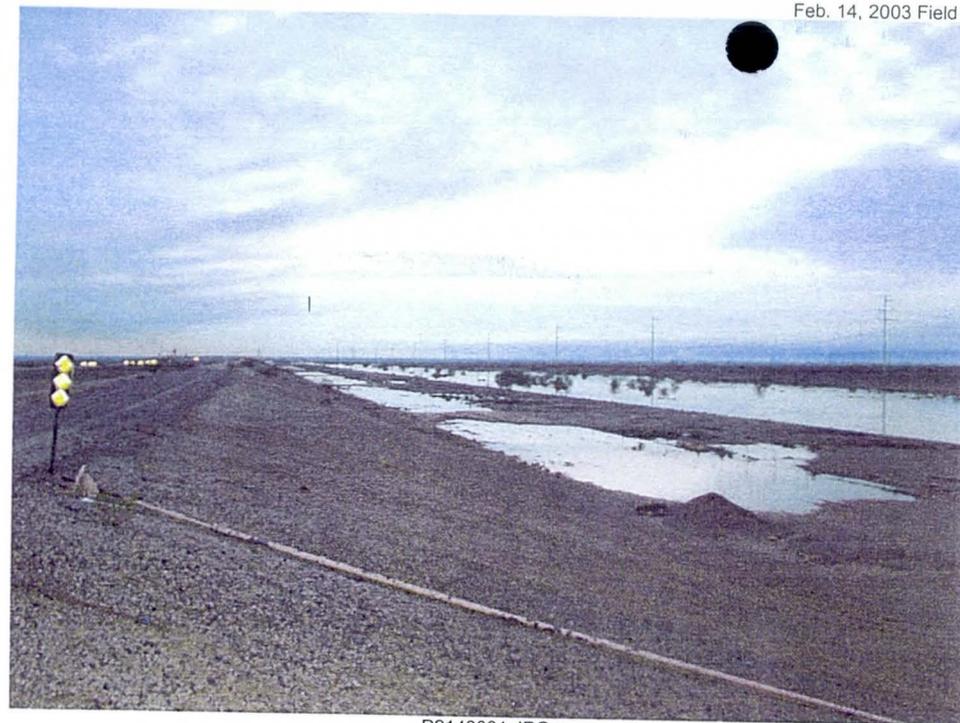
P2140061.JPG

Looking west at ponding adjacent to the embankment from Sta. 710+00.

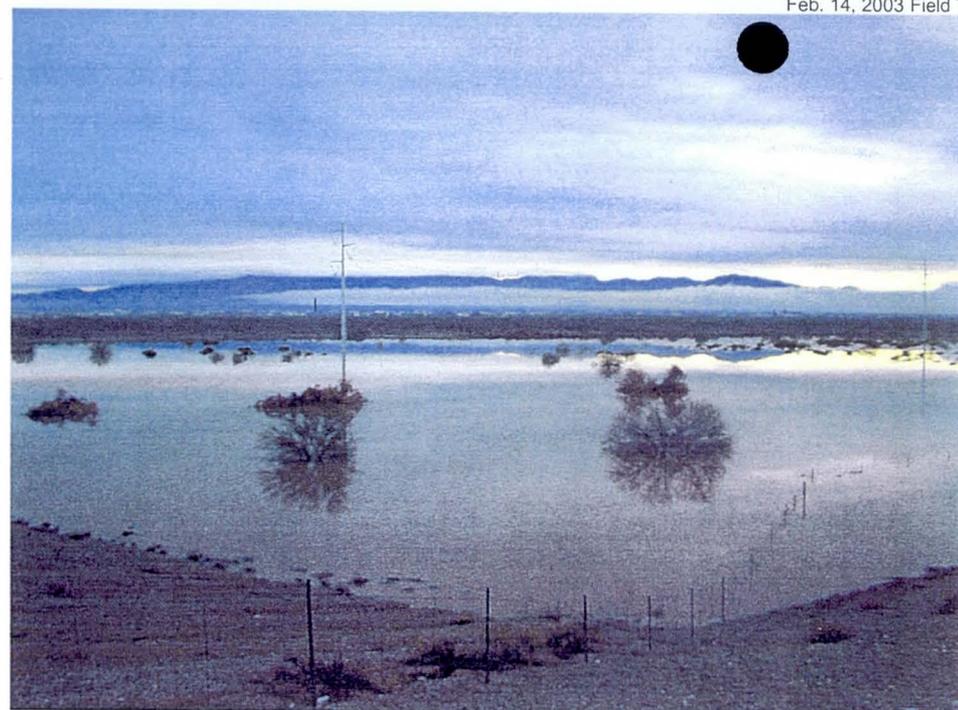
P2140068.JPG

View of ponding at the NE intersection of Johnson Camp Road and Buckeye FRS #1.

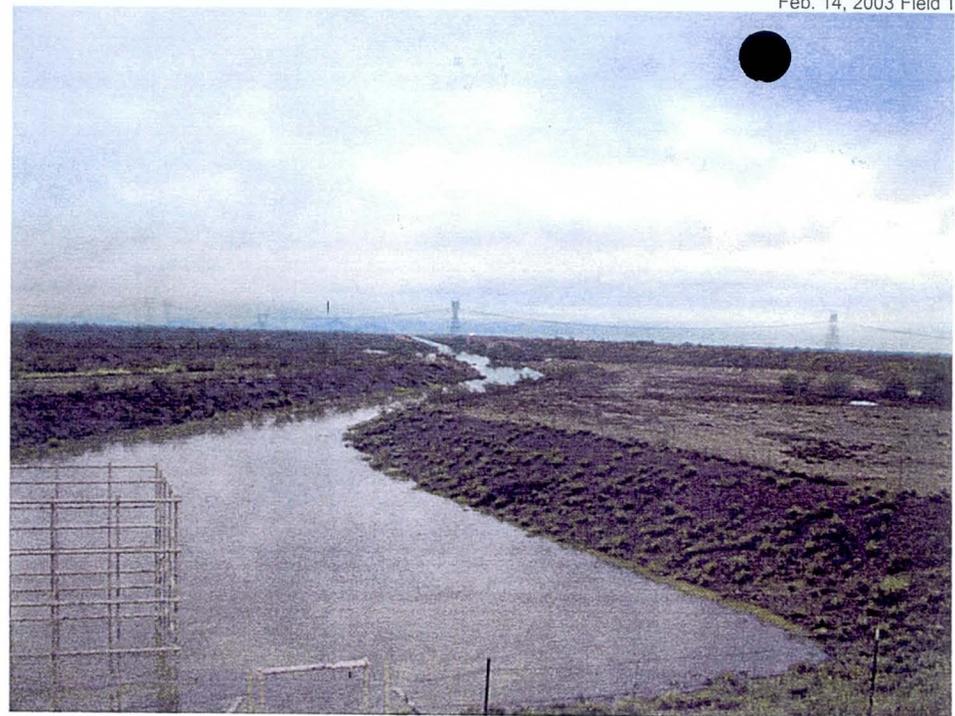
P2140080.JPG

Looking west at the principal outlet approach channel.

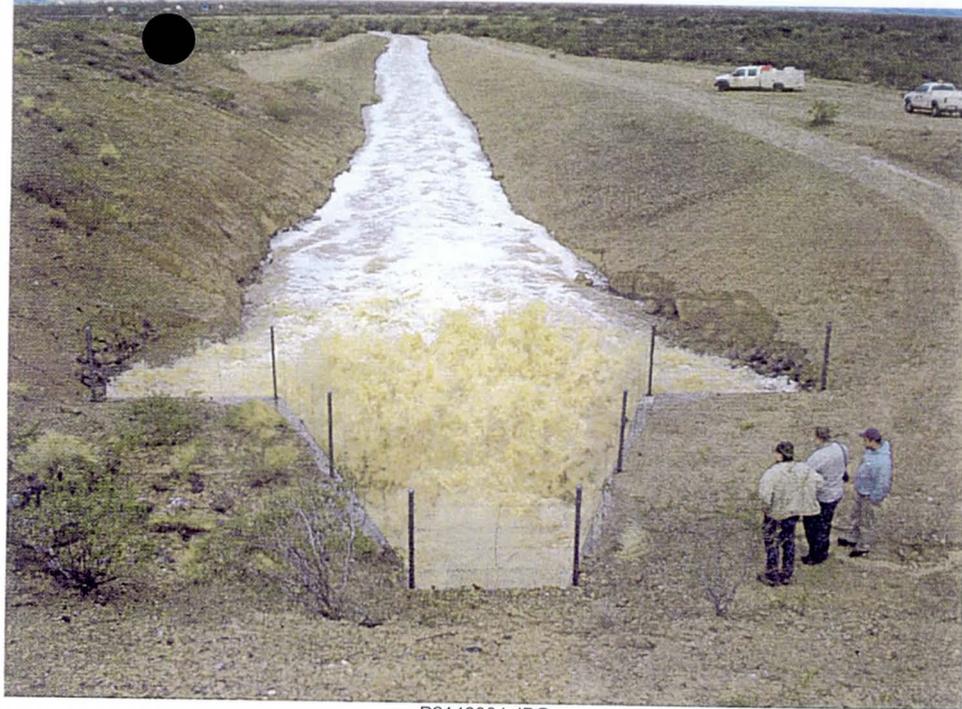
P2140084.JPG

Looking west at the principal outlet channel. Note erosion to the sides of the channel.

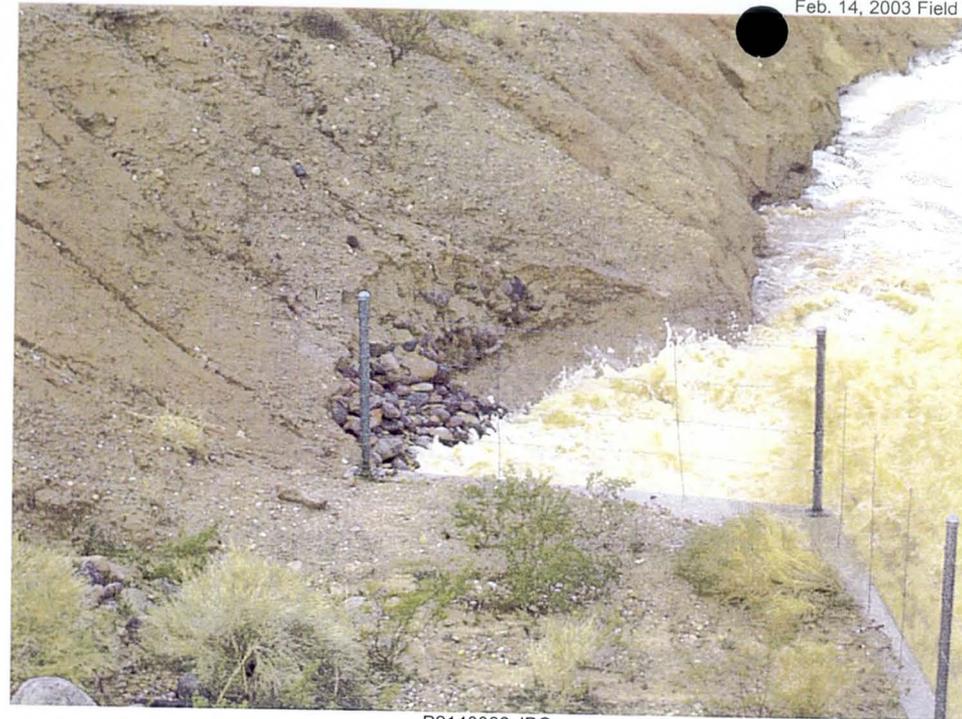
P2140086.JPG

View of erosion to the left bank of the principal outlet channel. Note the high bank above the erosion.

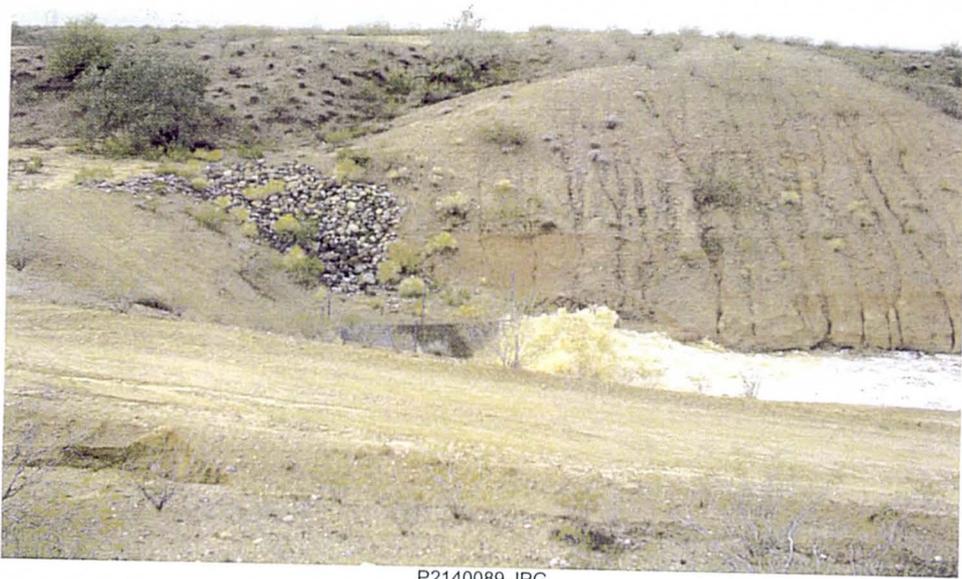
P2140089.JPG

Looking south at the principal outlet channel. Note erosion at the toe of the left high bank.

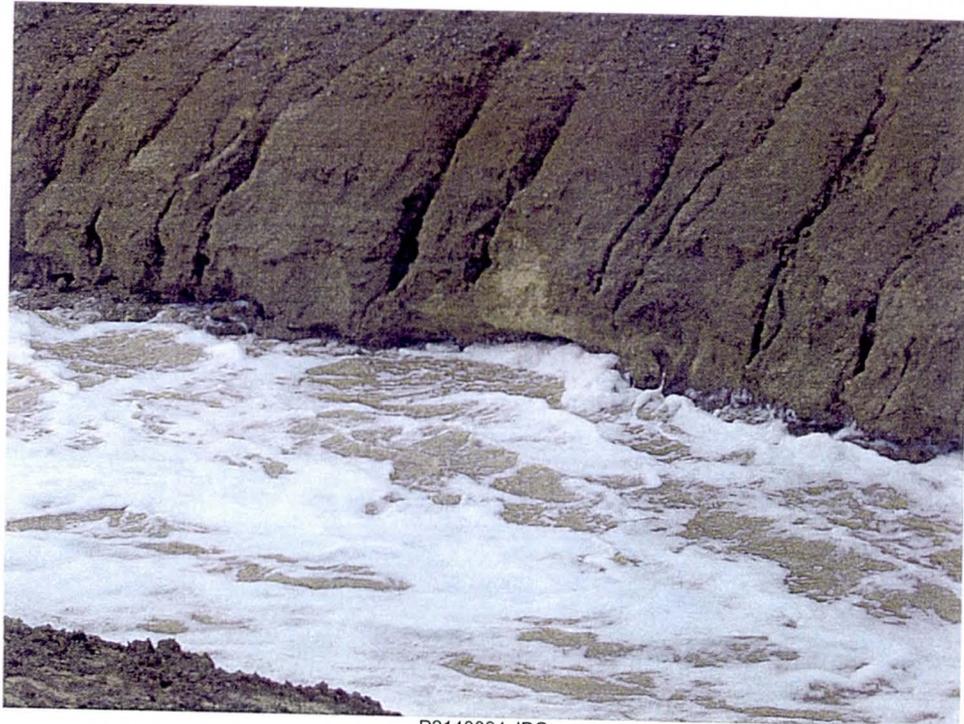
P2140092.JPG

Looking southeast at the principal outlet channel. Note erosion at the toe of the left high bank.
