**ADOBE
DAM/DESERT
HILLS**

AREA DRAINAGE MASTER PLAN

**Sedimentation Engineering and
Geomorphology Evaluation**

September 2003

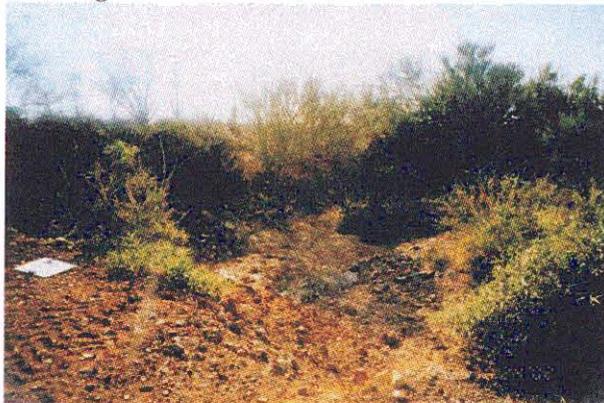
Figure 2-2. Minor incision and bank erosion on Desert Lake Wash.

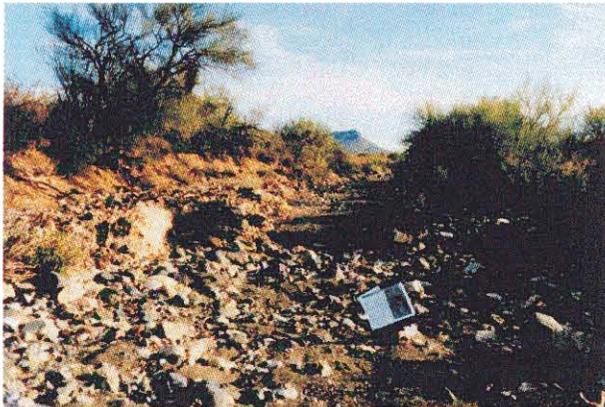
Figure 2-10. Actively eroding cutbank on Upper Skunk Creek.

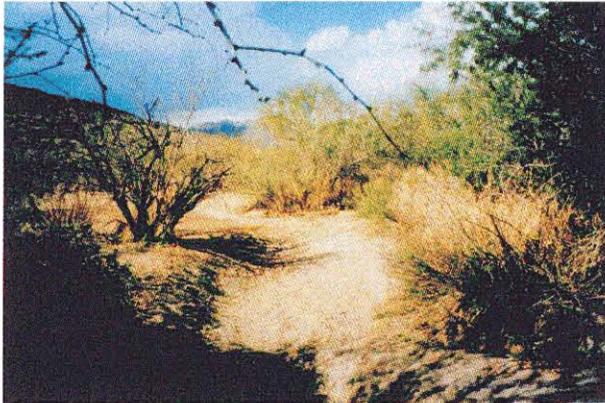
Figure 2-15. Avulsive channel formation in the left overbank floodplain of Cline Creek Tributary C6.

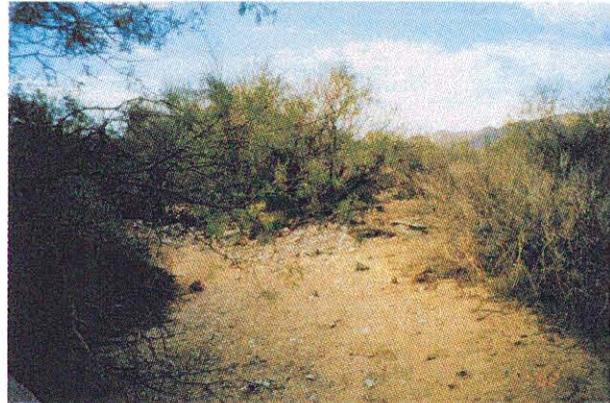
Figure 2-17. Avulsive channel split on Skunk Creek Tributary 12.

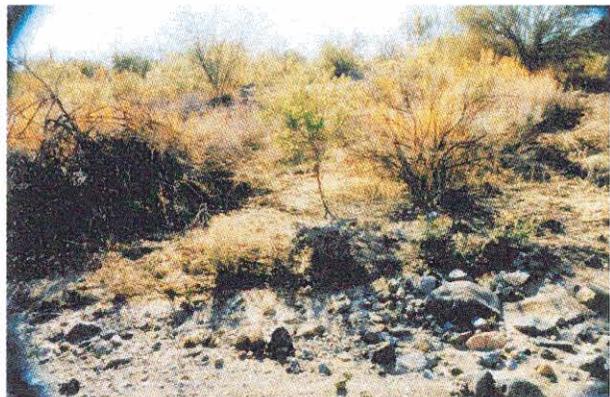
Figure 2-18. Low avulsive floodplain on Shoemaker Spring Wash.

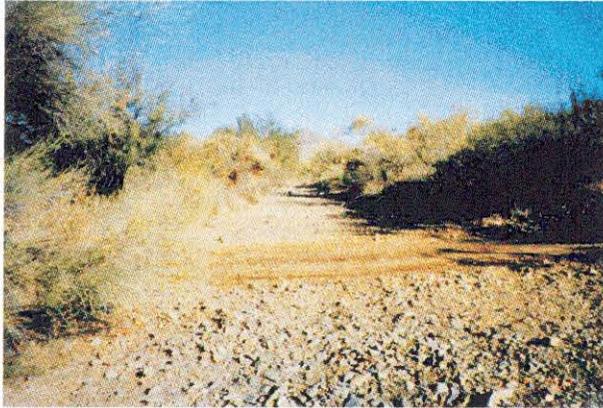
Figure 2-23. Minimal impact on channel from unpaved dip section road crossing on Apache Wash.

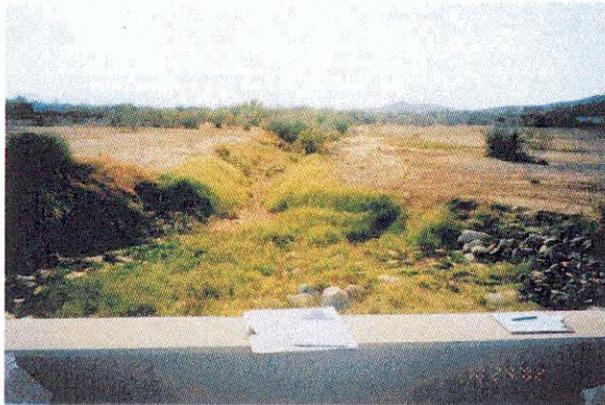
Figure 2-29. Overwidened channel at culvert crossing on Desert Lake Wash. Sediment deposition is expected in overwidened sections.

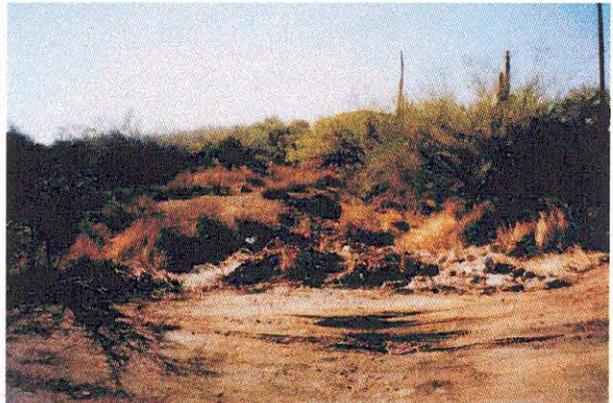
Figure 2-48. Ungrazed floodplain and channel vegetation on Desert Hills Wash Tributary 6.

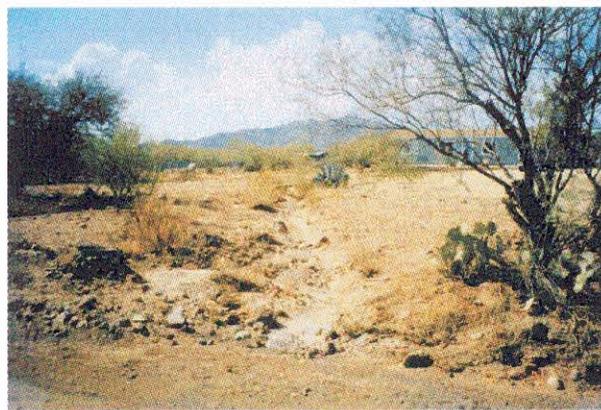
Figure 3-14. Cline Creek Tributary X4b typical channel with floodplain grading and removal of bank vegetation.

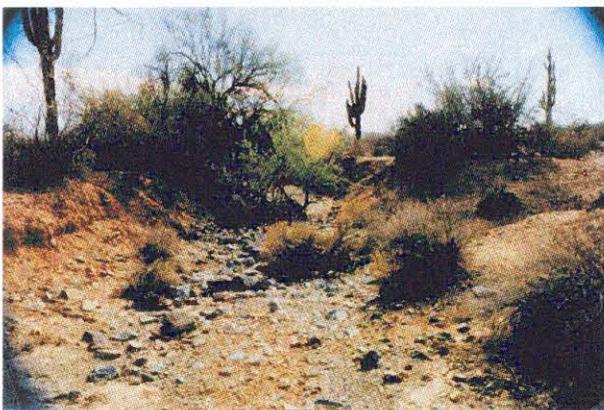
Figure 3-17. Apache Wash Tributary 1 typical channel with minor cut bank and channel vegetation.

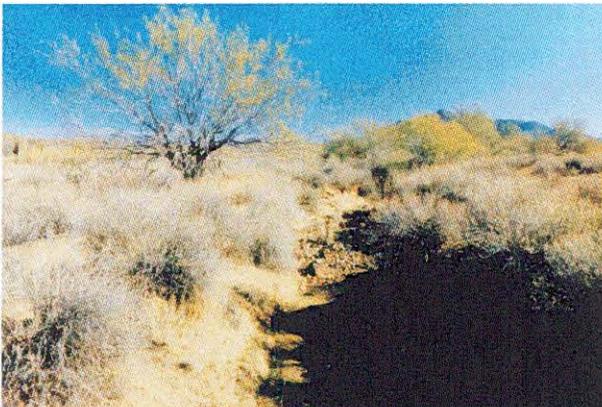
Figure 3-27. Ranieri Tank Wash typical channel. Note small channel and minimal floodplain topographic containment.

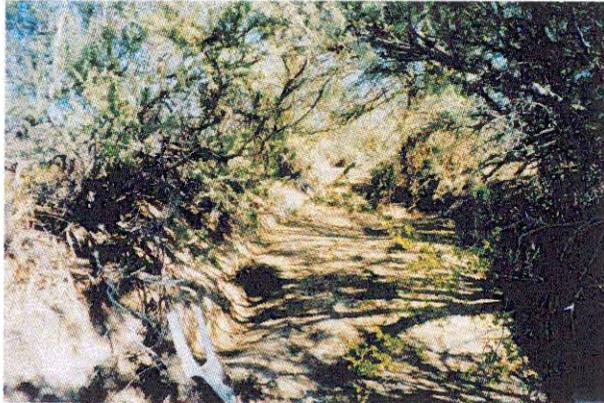
Figure 3-30. Desert Hills Wash typical channel with minor (~1 ft.) incision.

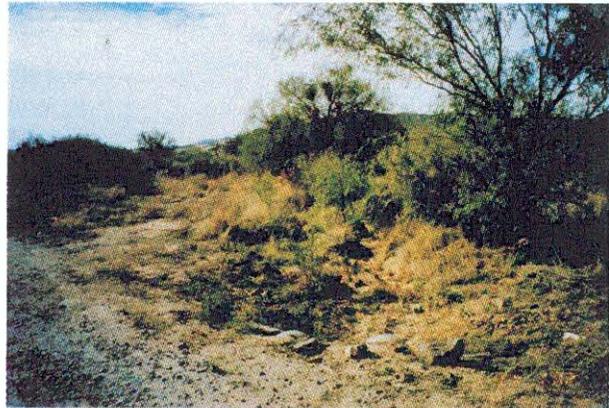
Figure 3-33. Desert Hills Wash Tributary 2 typical channel.

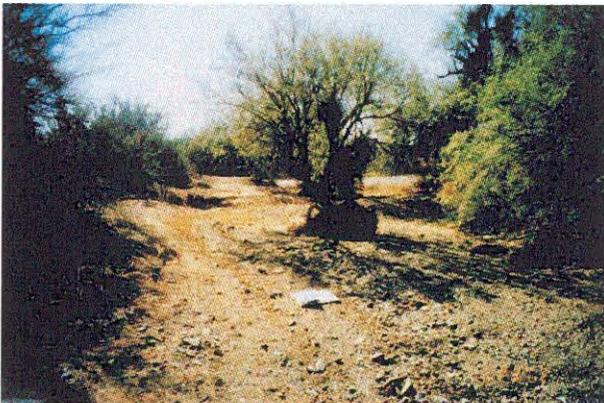
Figure 3-31. Desert Hills Wash typical channel north of Carefree Highway. Mid-channel vegetation suggests recent lateral movement.

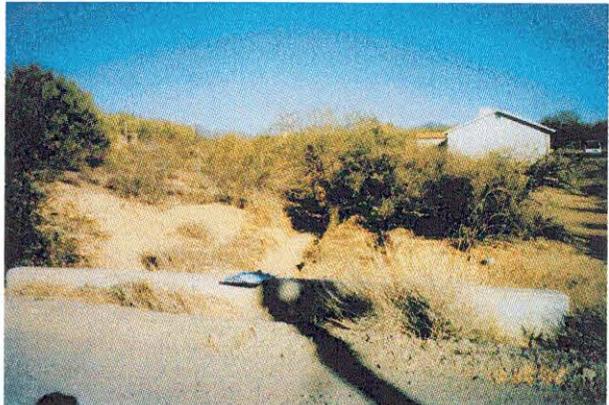
Figure 3-34. Desert Hills Wash Tributary 3 typical channel with home in floodplain adjacent to main channel.

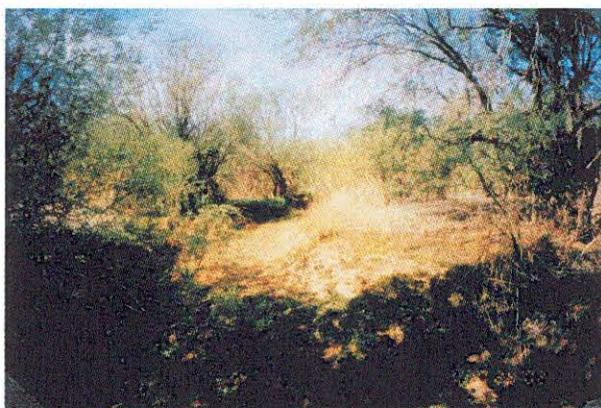
Figure 3-39. Desert Lake Wash typical channel in reach of dense floodplain vegetation.

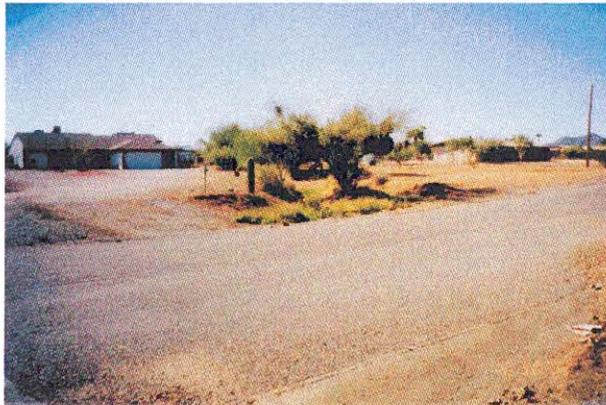
Figure 3-41. Desert Lake Wash East Fork typical channel with extensive floodplain development.

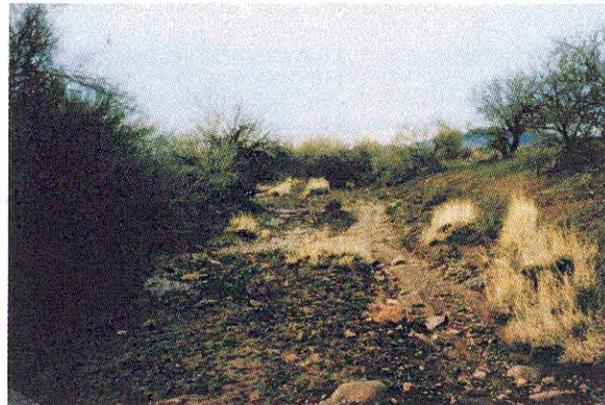
Figure 3-44. CAP Wash East Branch typical channel.

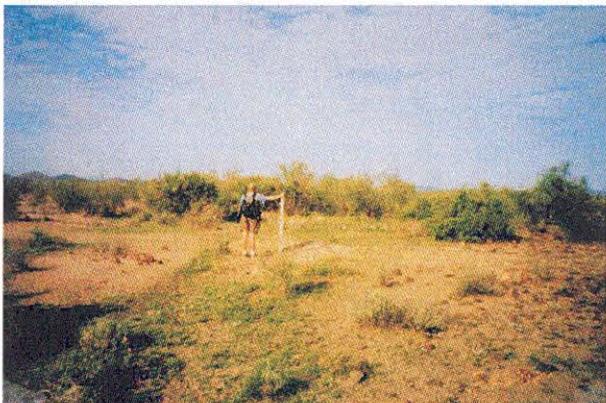
Figure 3-42. Buchanan Wash typical channel section in non-incised reach upstream of the CAP.

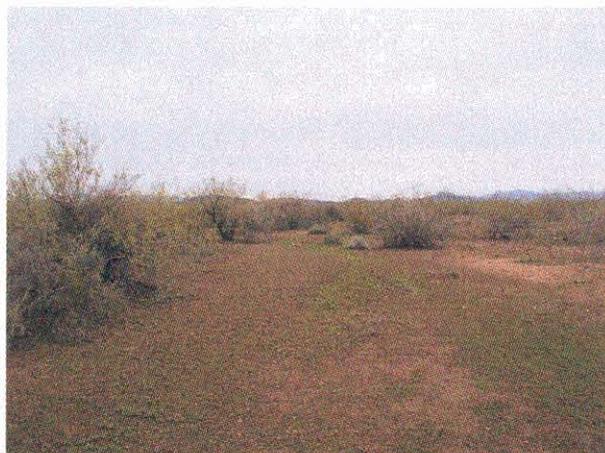
Figure 3-45. CAP Wash West Branch typical channel.
