Hassayampa River Post-Flood Study Final Report

June 17, 2005

Prepared For:
Flood Control District of Maricopa County
FCD 2002030

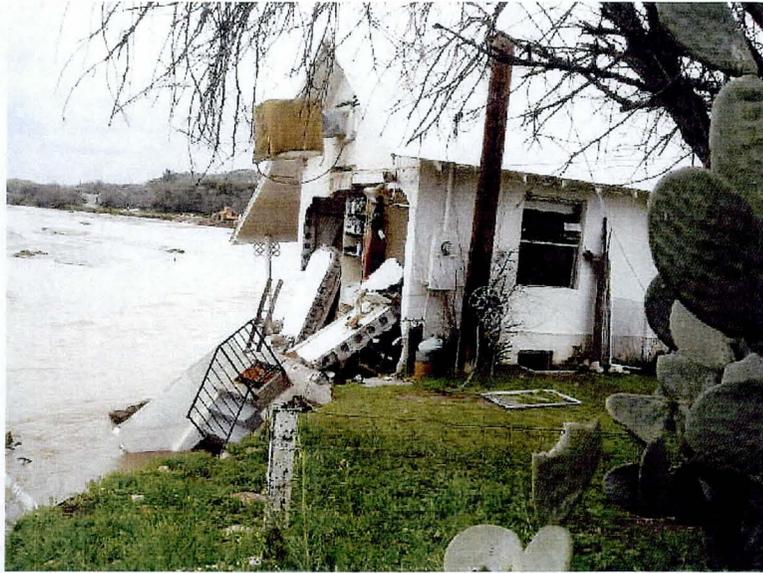
Photo 1: Residence on eastern bank of the Hassayampa River looking north just upstream of the US 60/ 93 Bridge. (February, 2005)

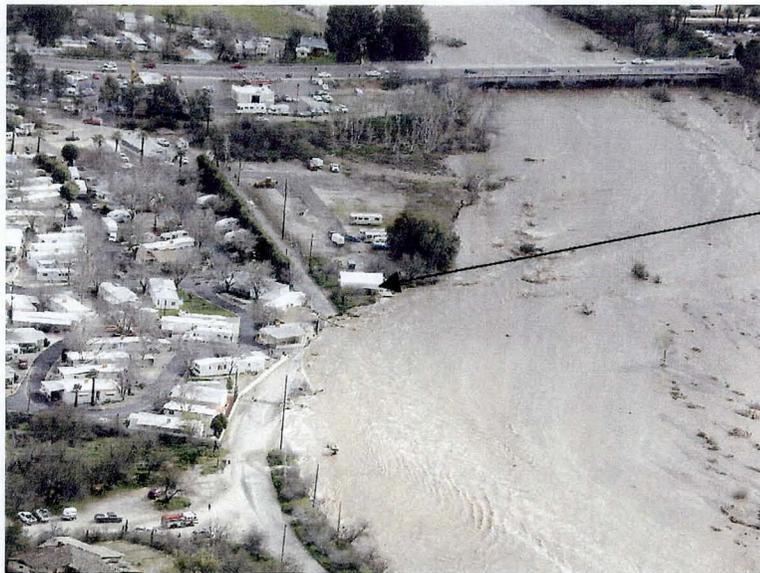
Residence
in Photo 1

Photo 2: Aerial view along the eastern bank of the Hassayampa River just upstream of the US 60/93 Bridge courtesy of Flying M Air Photos. (February 2005)

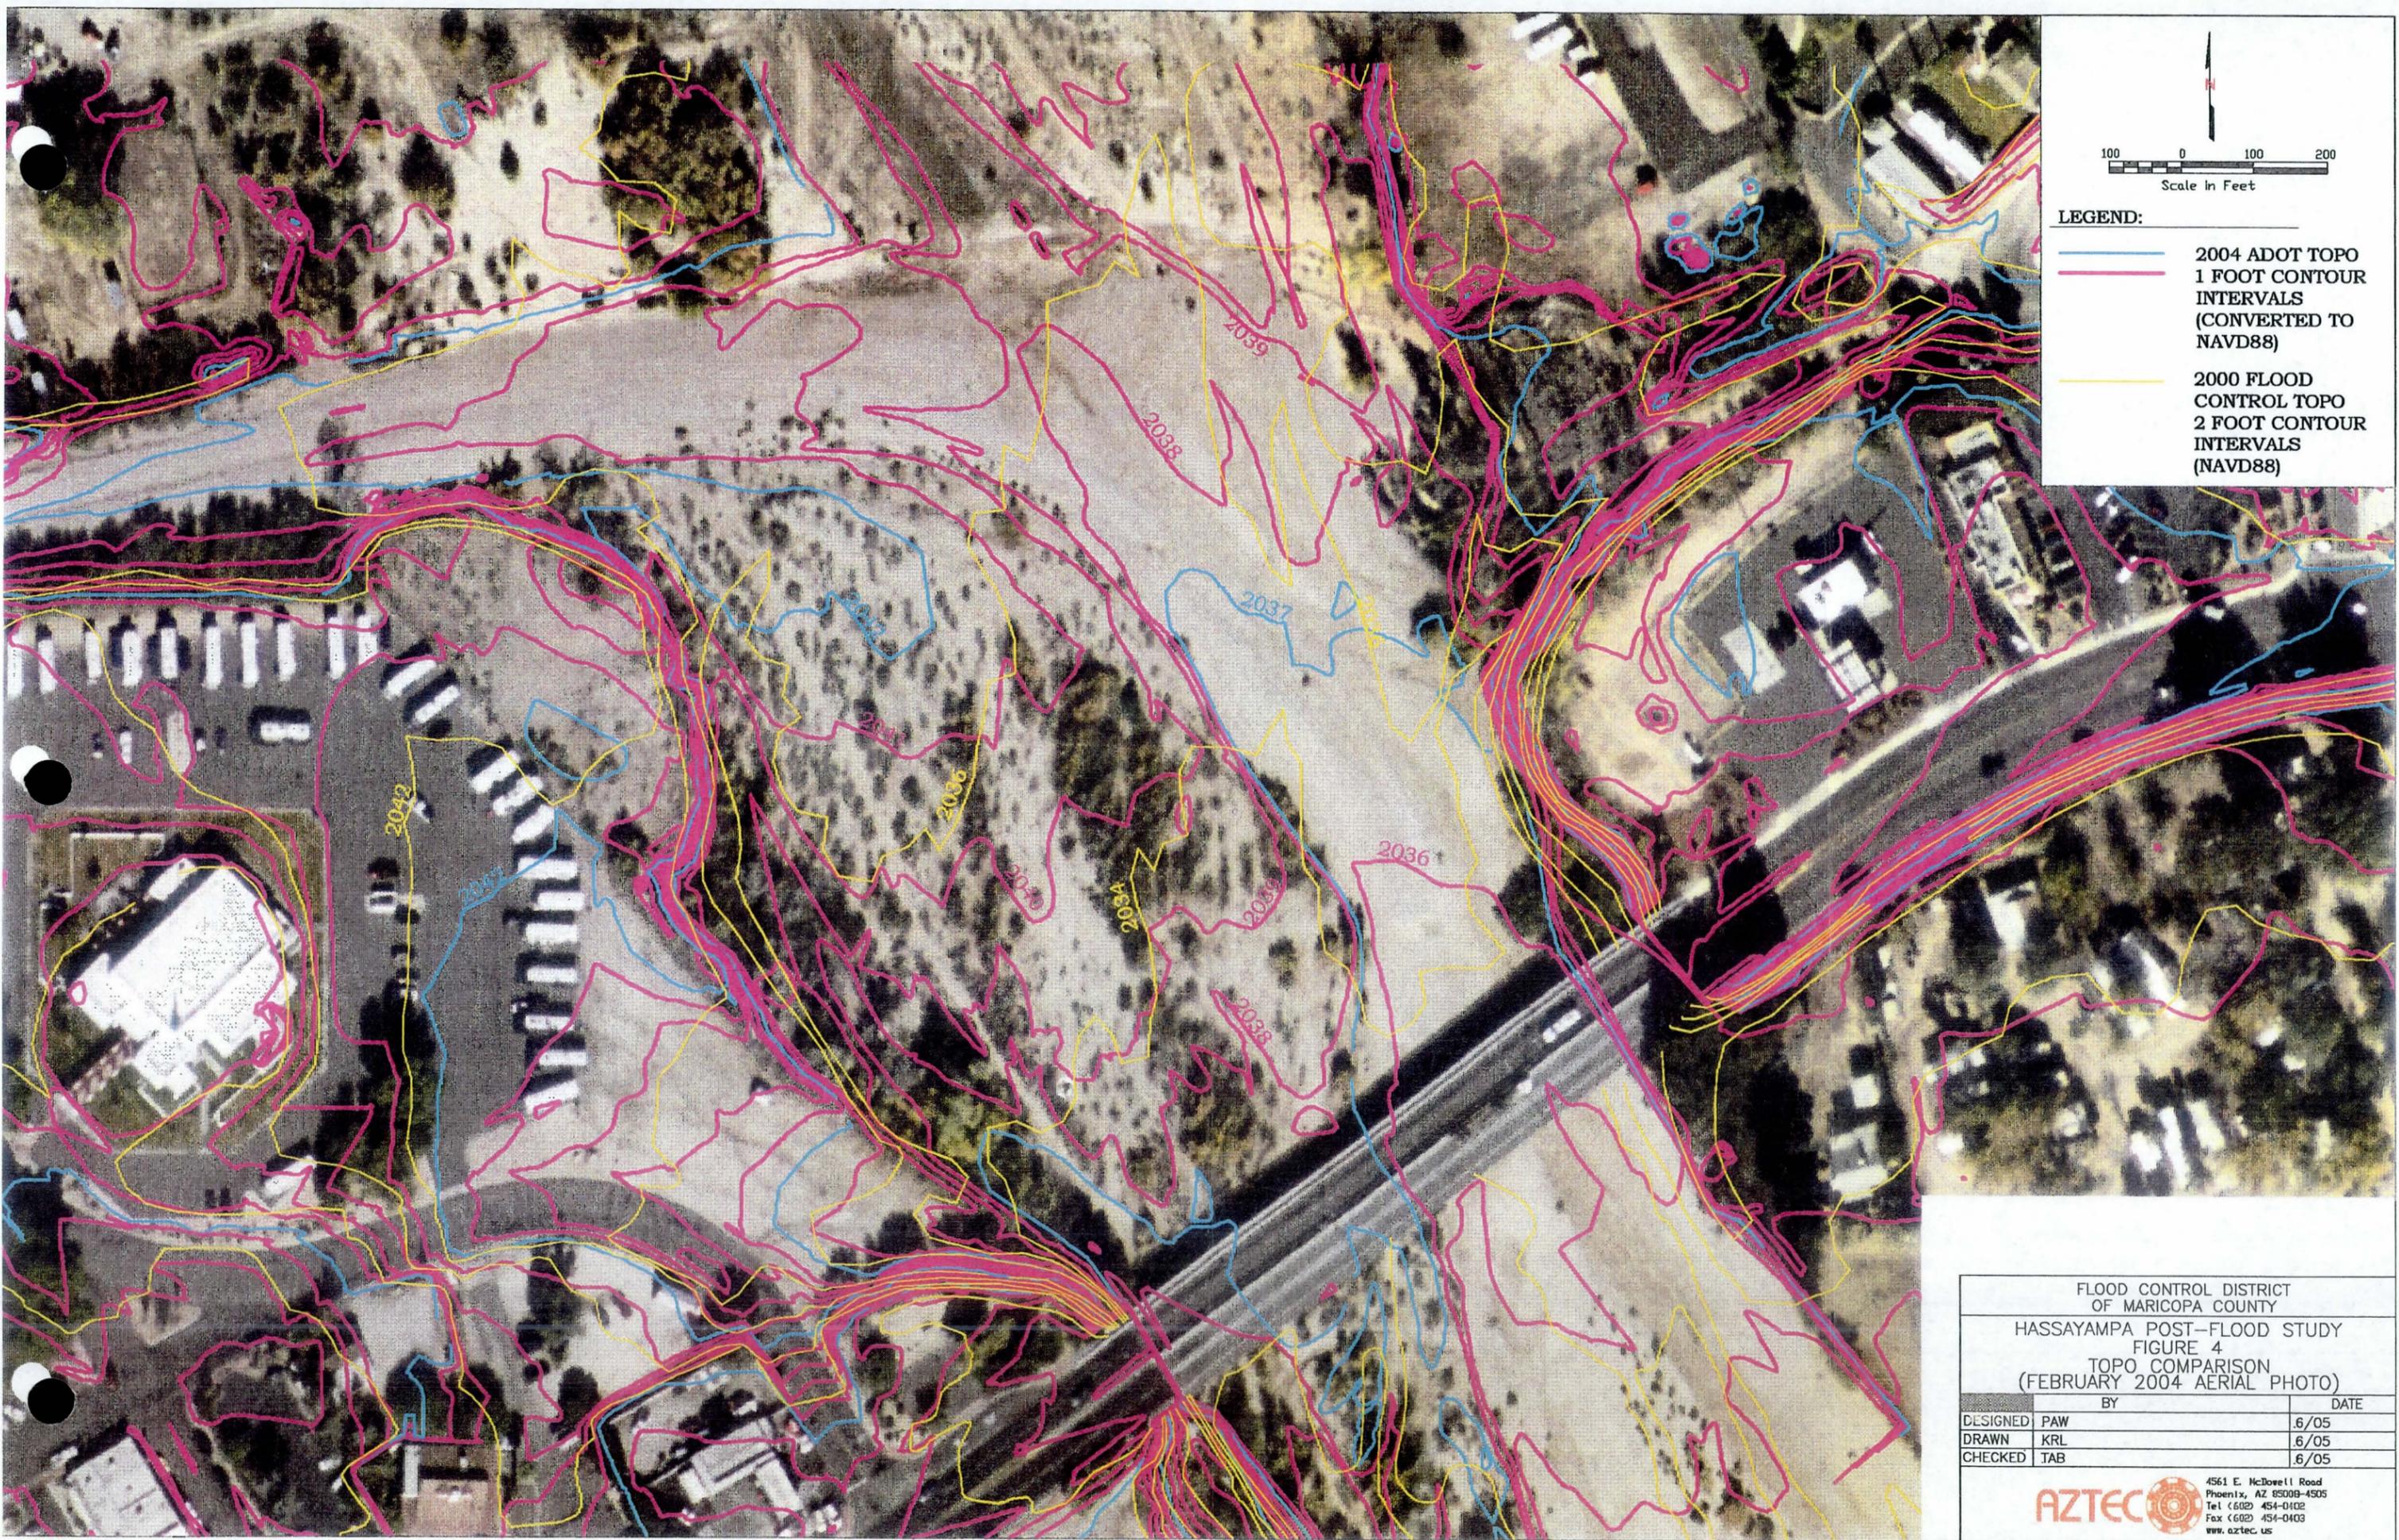
HASSAYAMPA POST-FLOOD STUDY
FIGURE 4
TOPO COMPARISON
(FEBRUARY 2004 AERIAL PHOTO)

Sols Wash flows frequently flows independently from the Hassayampa River. This type of independent flow event occurred October 21, 2000. The District's stream gage 7043 located in Sols Wash approximately one mile west of Vulture Mine Road indicated a peak flow of 10,800 cfs for that event. A great deal of sediment was transported in that flow event, much of which settled at the southern portion of the confluence to the Hassayampa River. Two digital topographic maps were collected as part of this study; the first map was created in 2000 just prior to the Sols Wash flood event. The second topographic map was created in 2004 as part of the US 93 bypass project for ADOT. A comparison between these two topographic maps shows the west portion of the Hassayampa aggraded up to four feet after the October 2000 Sols Wash flow event (See Figure 4).

As discussed in Section 3.2, Figure 4 shows the aggradation along the western bank due to the October 2000 Sols Wash flood. It also shows the western portion of the Hassayampa River at the US 60/93 Bridge has aggraded over the last four years.

According to the scour analysis prepared by the Sols Wash Candidate Assessment Report (Reference 6), Sols Wash is degrading in its upstream segment. It conveys a large amount of sediment towards the confluence with the Hassayampa River, as shown in Photo 5. Additionally, the confluence of Sols Wash is nearly perpendicular to the Hassayampa River, which causes flow in Sols Wash to slow as it transitions into the Hassayampa River. This causes the sediment in the wash to settle with this portion of the wash aggrading, as shown in Figure 4.

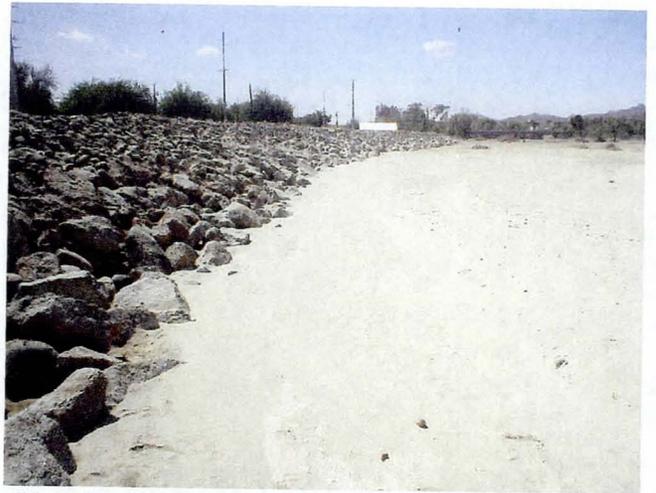
New bank protection on east bank, looking
downstream

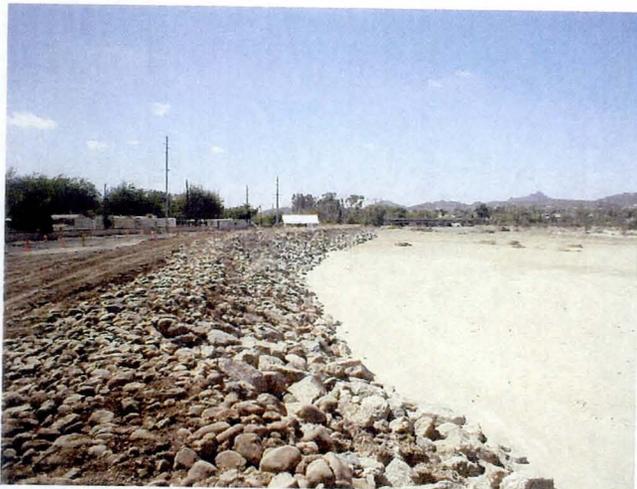
East bank protection looking downstream

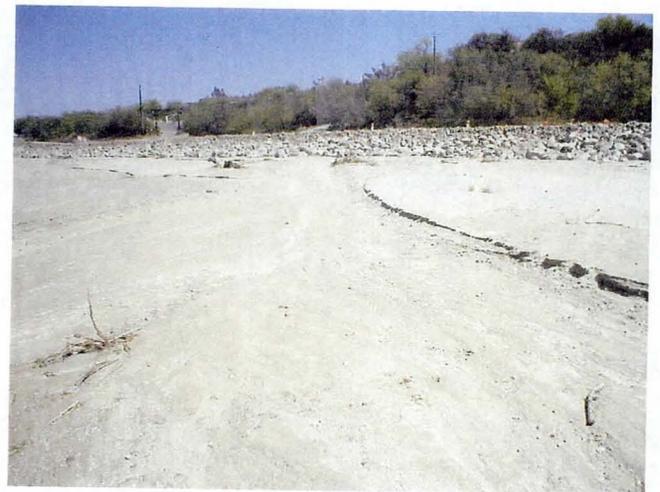
Looking at the east bank protection from the
riverbed

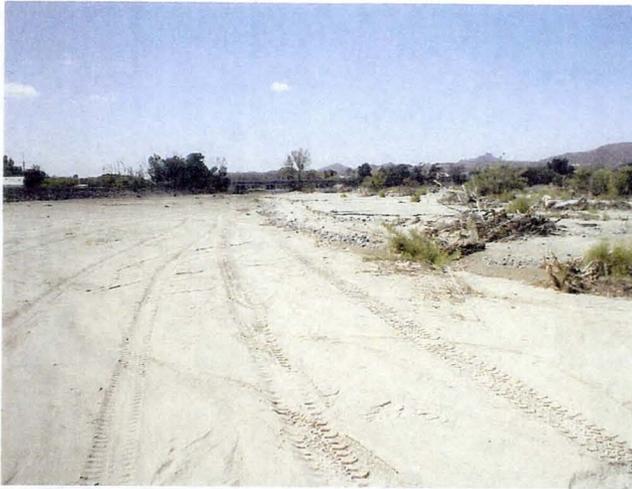
East conveyance of Hassayampa River

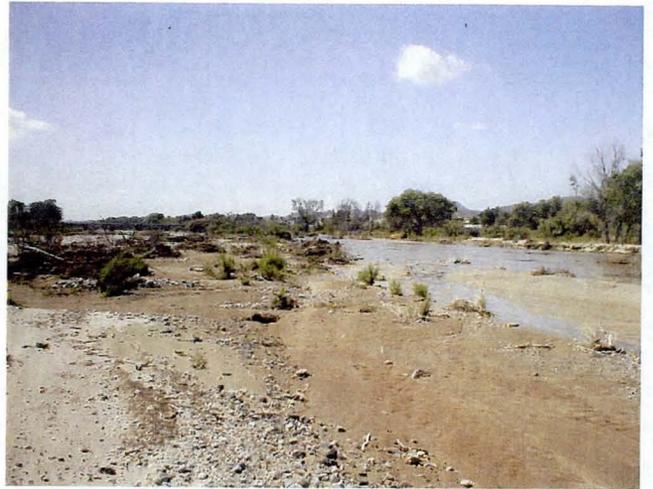
Hassayampa River upstream of bridge

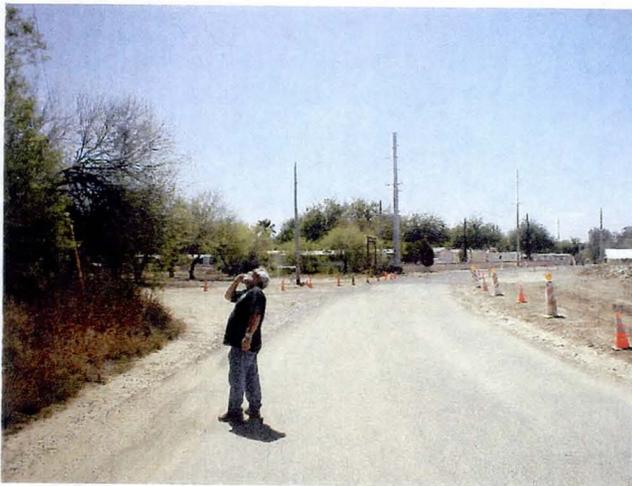
Damaged well on the west side of Jack Burden Rd.

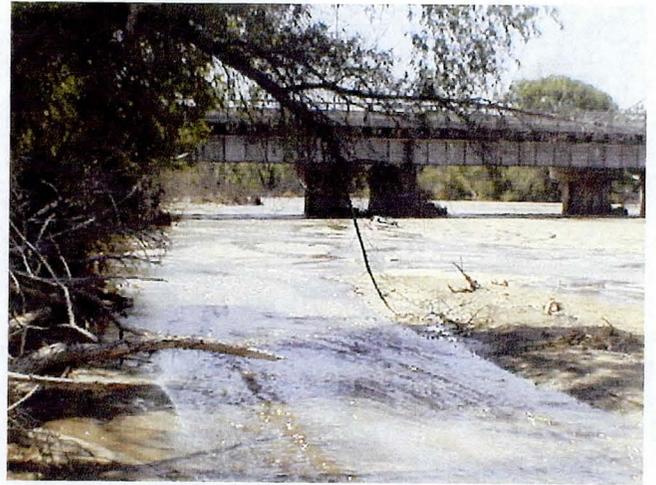
Debris from flood upstream of bridge

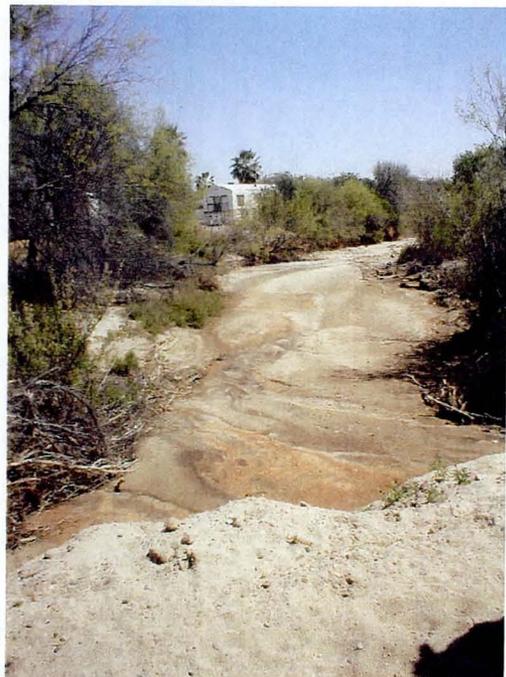
Looking towards Horspitality RV park on the temporary berm

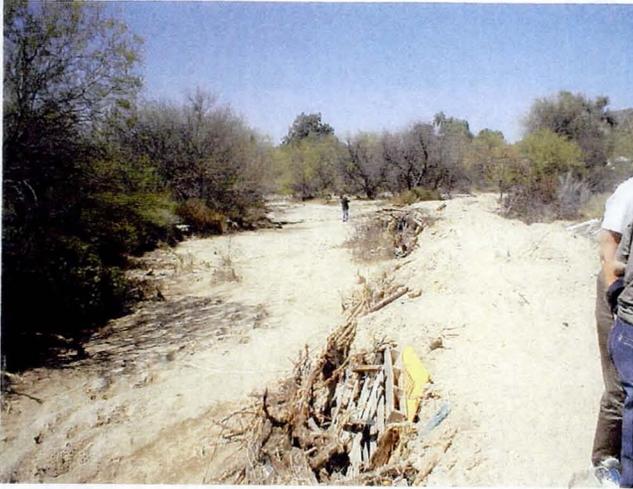
Temporary berm built behind Horspitality RV Park

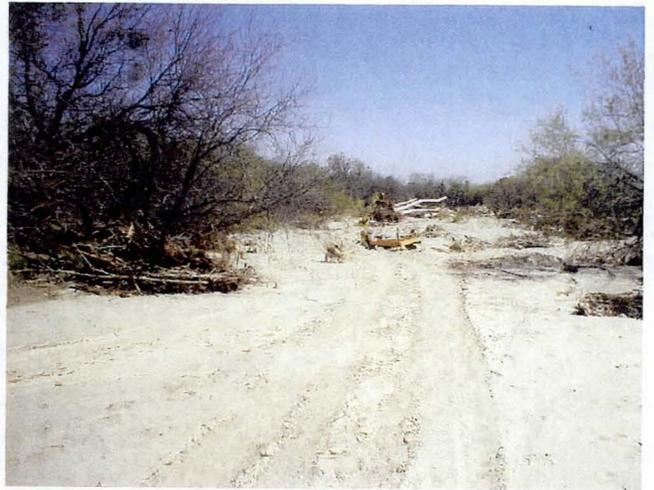
Debris in watercourse just upstream of Horspitality RV Park

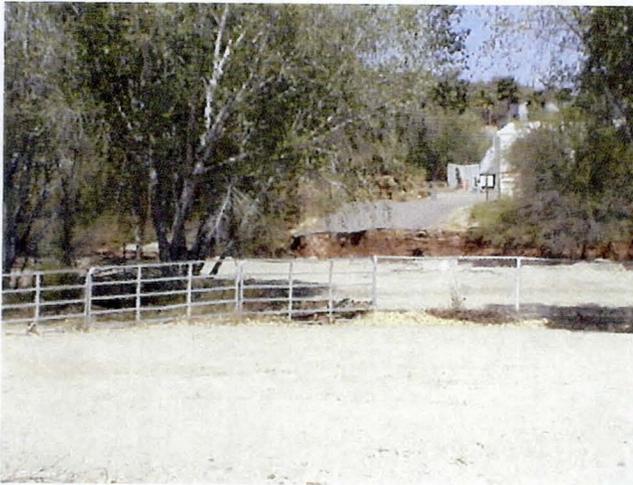
Horse pens at Horspitality RV park

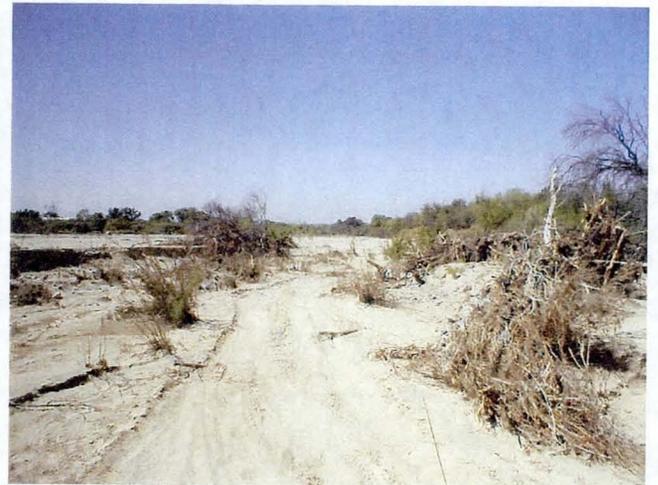
Upstream of Horspitality RV Park in river

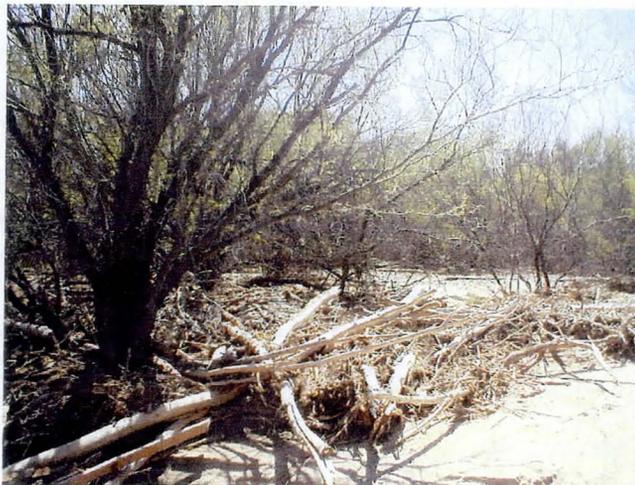
Flood debris, area behind Horspitality RV Park

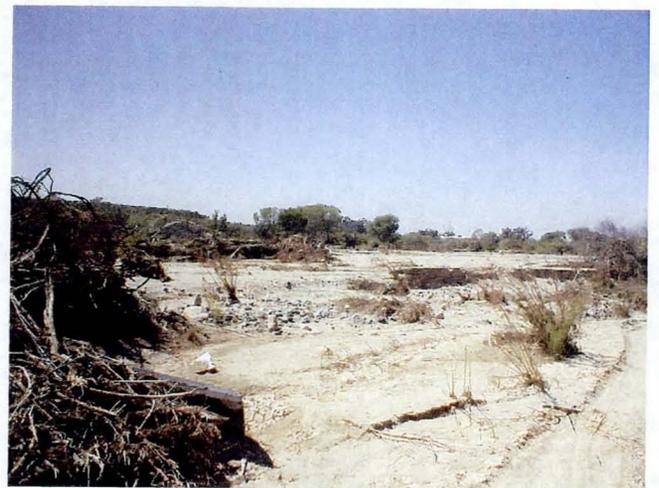
Debris in river just upstream of Horspitality RV park

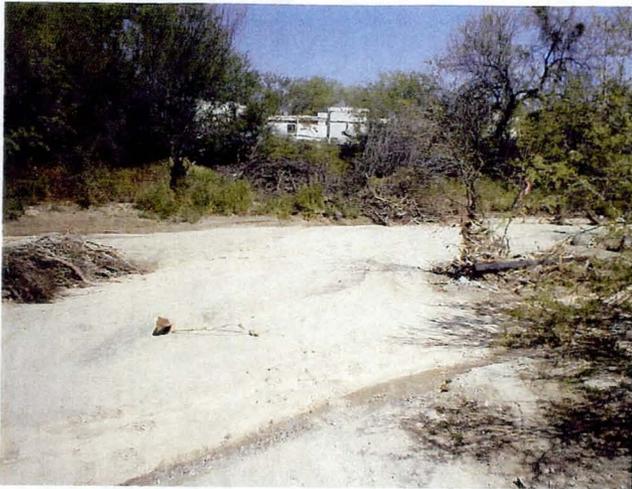
Looking towards Horspitality RV Park from river

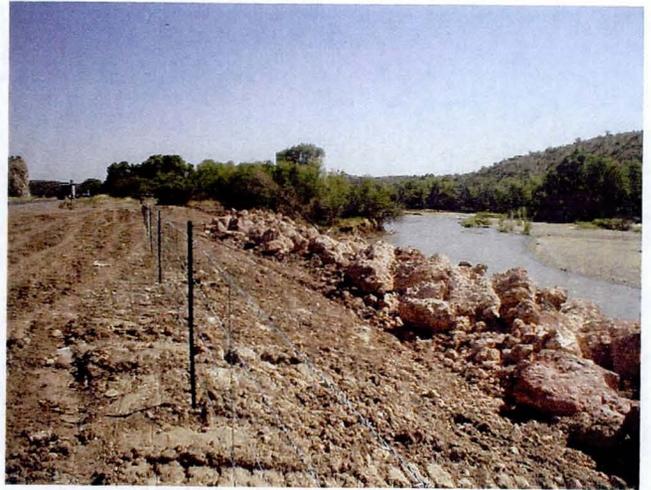
Rip-rap protection along US 60 by ADOT

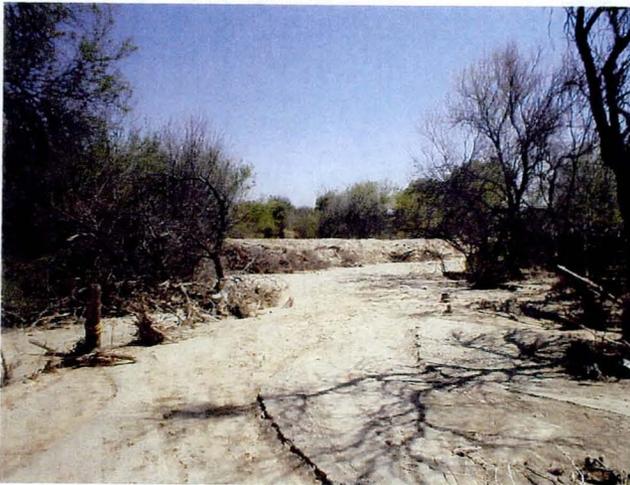
Looking downstream towards temporary berm

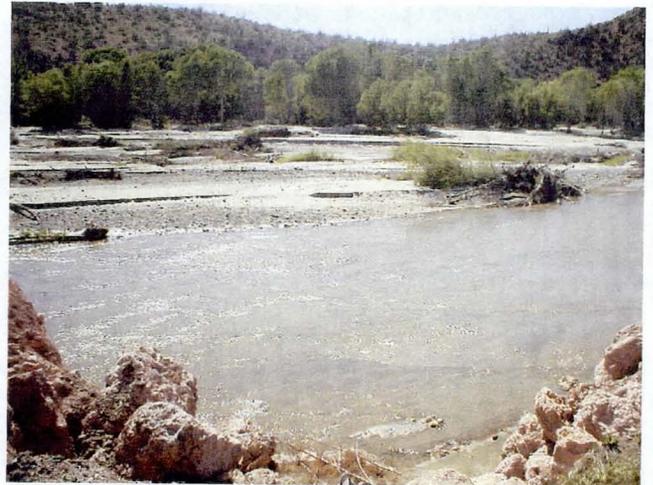
Rip-rap protection along US 60 by ADOT

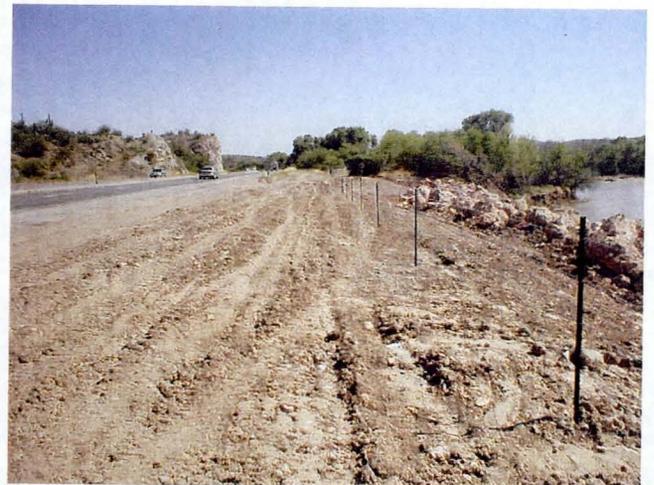
Rip-rap protection and ABC fill along US 60 by ADOT

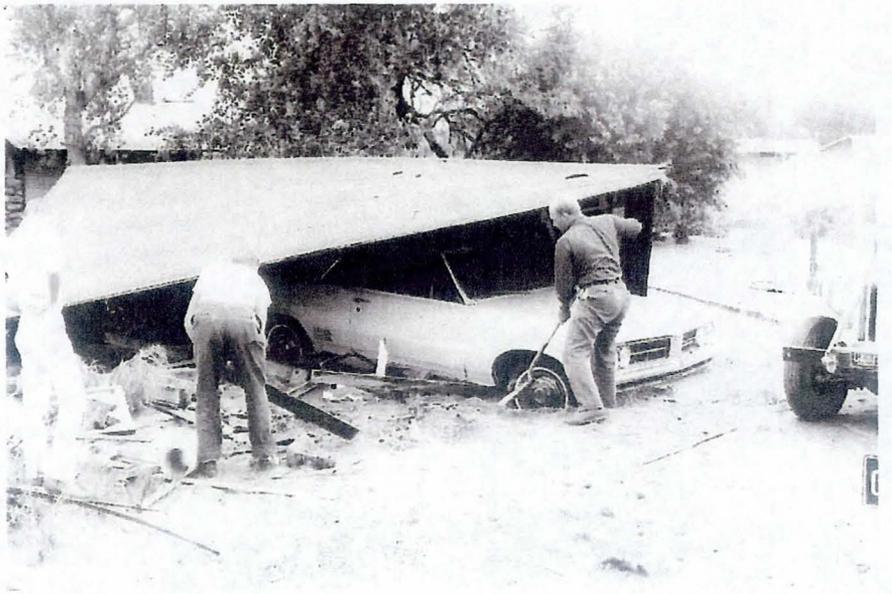
7/15/64

Powder House Wash
Buried car at
Philbeck Residence.

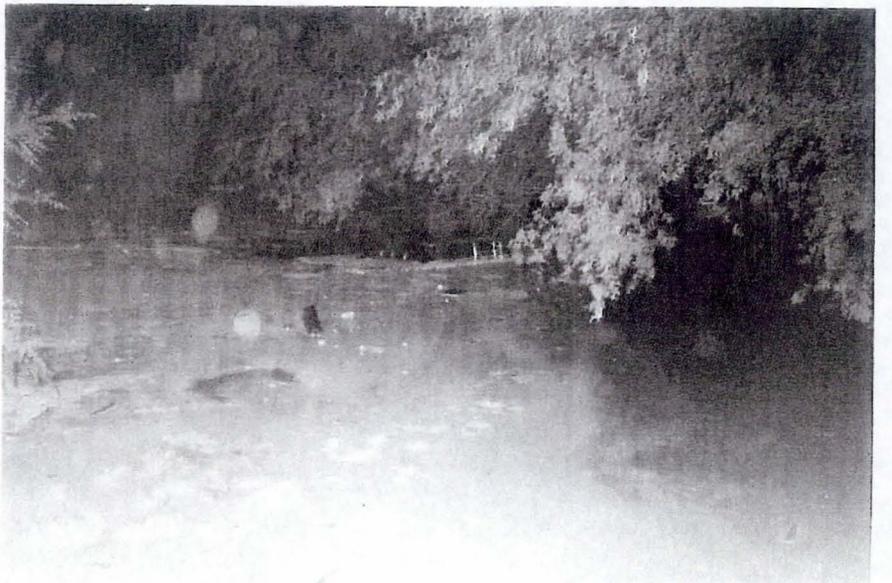
Powder House Wash
flooded car in
motel yard, East
Wickenburg.

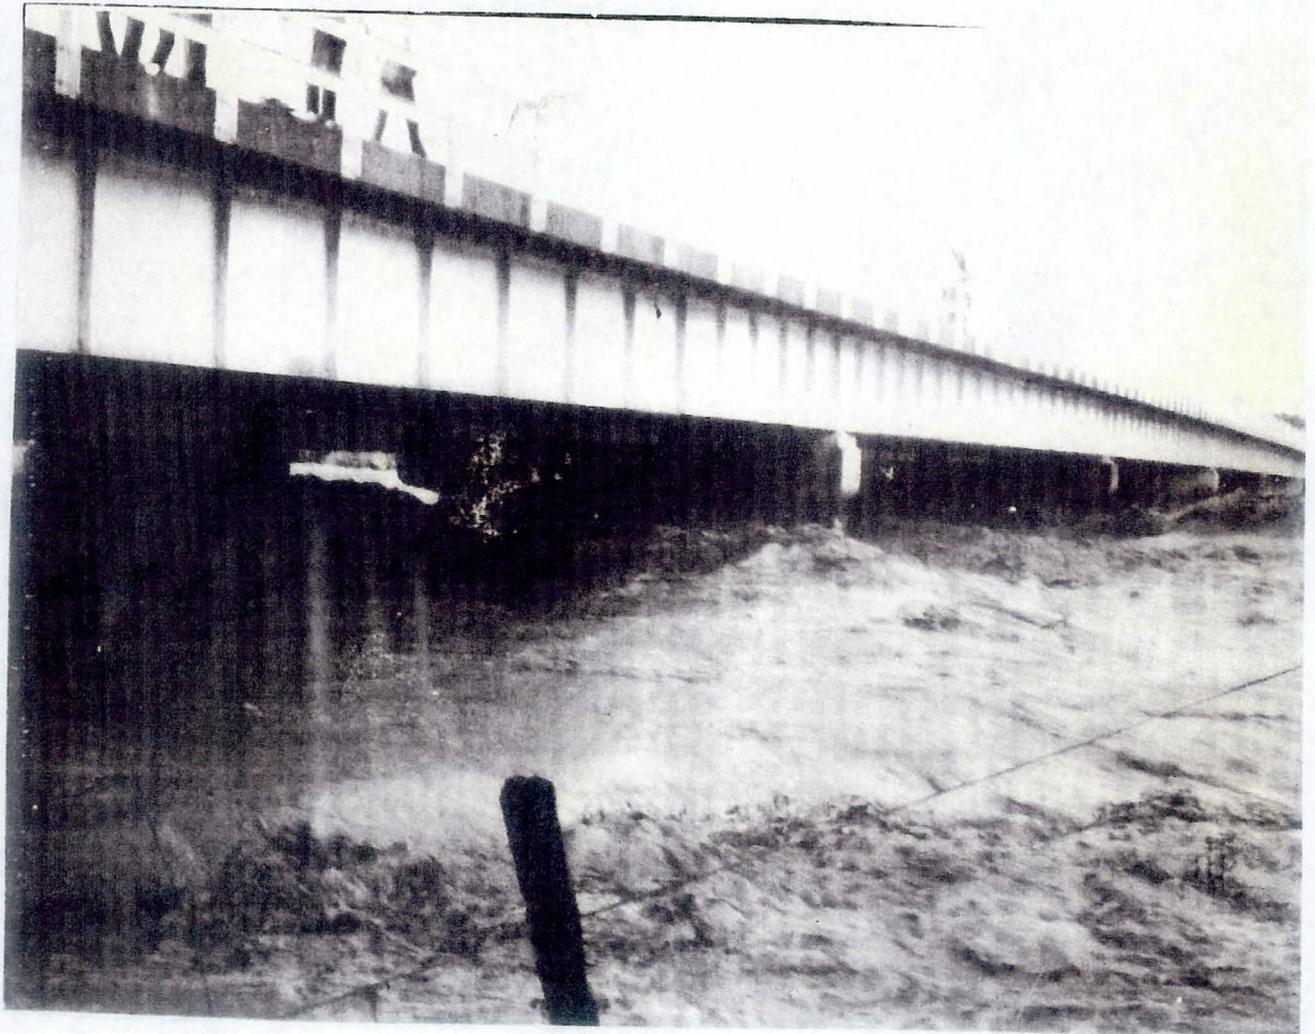
Wickenburg Sun, 9/10/70

Taken at 4:00 Saturday afternoon (Sept 5). The river started to recede shortly afterward.

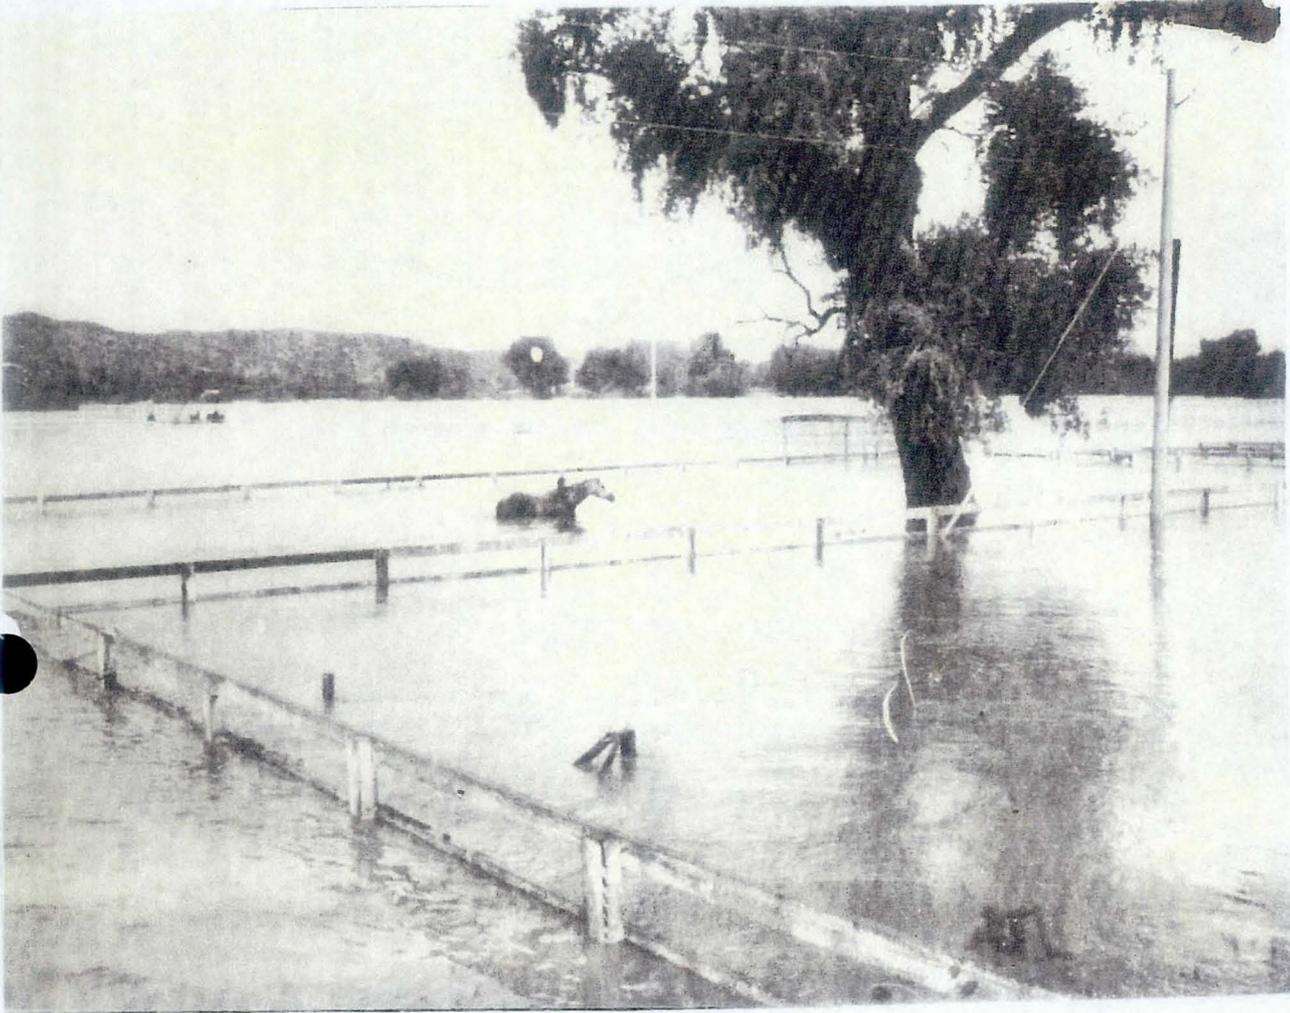
Wickenburg Sun, 9/10/70

The devastating Hassayampa has all the appearance of a quiet, peaceful lake in this photograph of Max Kirkpatrick's horse operation between Chestnut St. and Remuda Ranch.

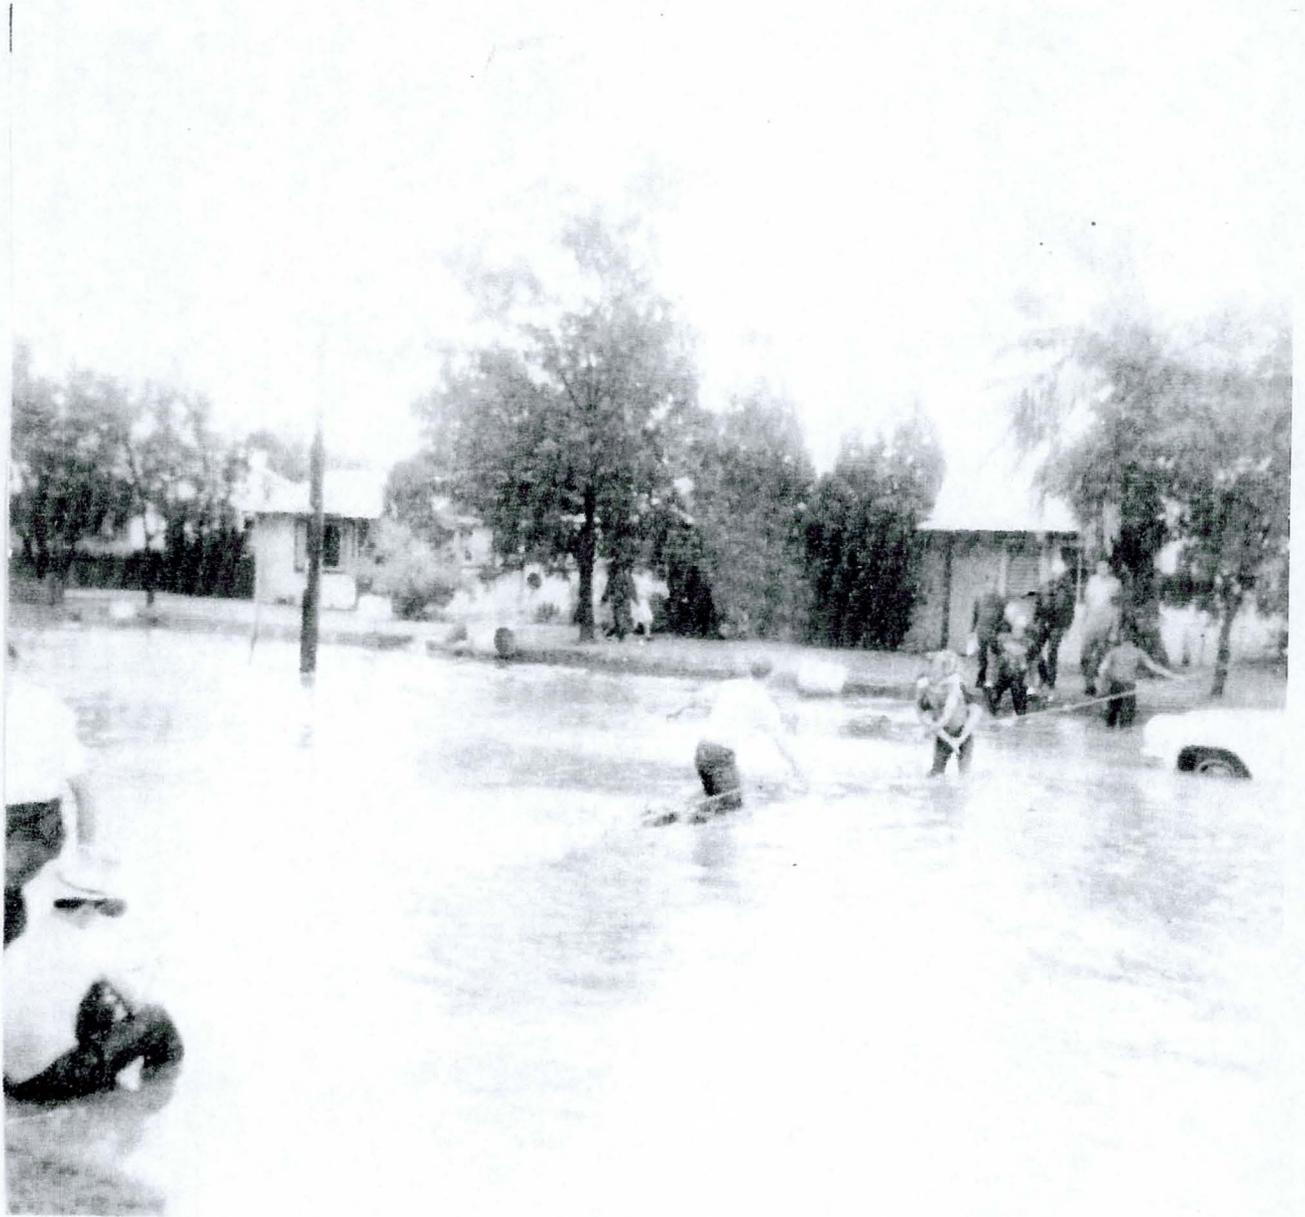
Wickenburg Sun, 9/10/70

Rescue operation on Chestnut St. Eight-year-old Marie Hopkins is carried by Earl Herber who clings to cable stretched just above the rushing waters. Dave Underdown (left corner) is holding to the cable. Other volunteer helper, center, is not identified. Marie is the daughter of Mrs. Pat White, waitress at the Bar 7 Restaurant.

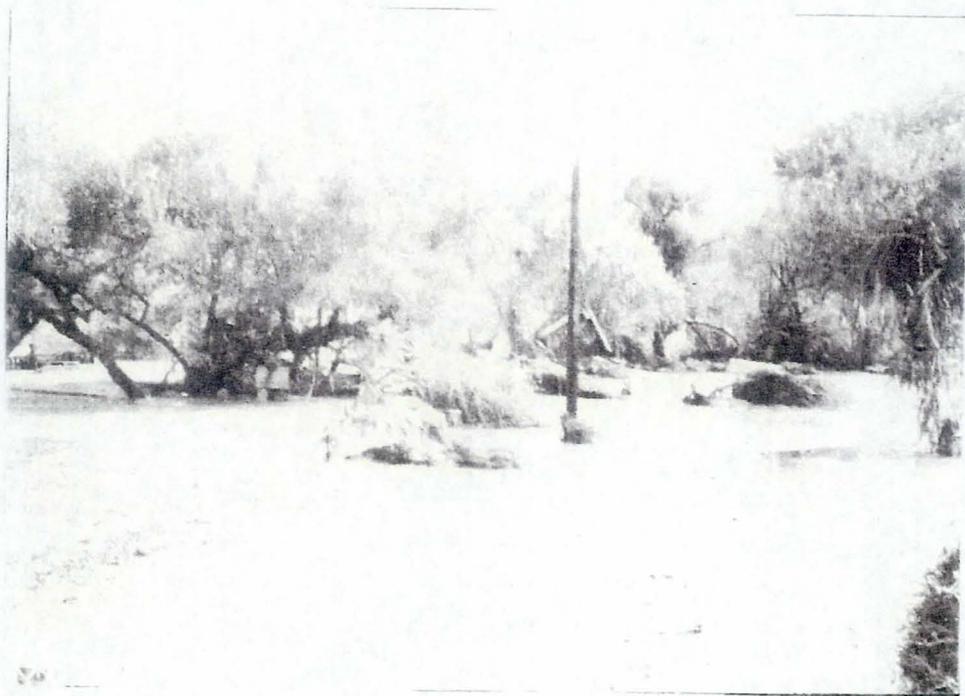
Wickenburg Sun, 9/10/70

Home of P. L. Kinnick, disabled World War II veteran, once stood on this spot along the Phoenix Hwy near Monarch Wash. Now it is gone, washed away and shattered into kindling wood against the thicket on the far left. Remains of camper in center background.

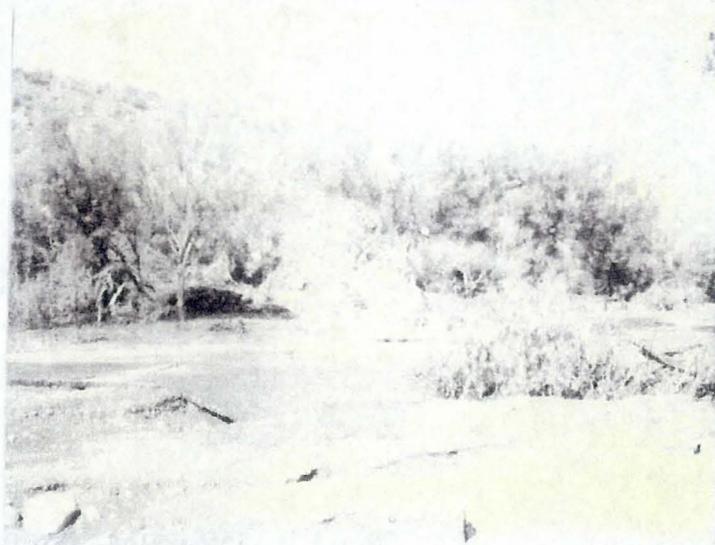
Wickenburg Sun 9/10/70

Roadside park on Phoenix Hwy in shambles. Surfaced roads gone, trees and shrubs uprooted and fireplaces demolished.

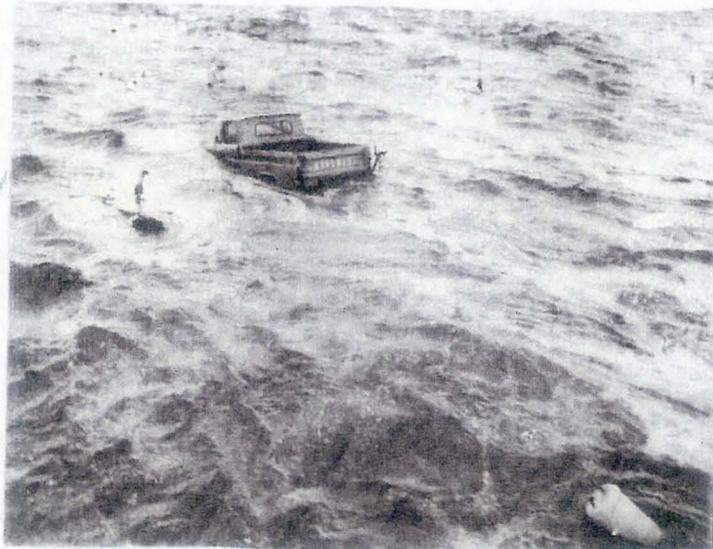
Wickenburg Sun 9/10/70

Pickup truck of Mayor Brown's Wickenburg Plumbing is here seen as it was about to be carried under the bridge. The truck would up off shore near Watkins Chevrolet.

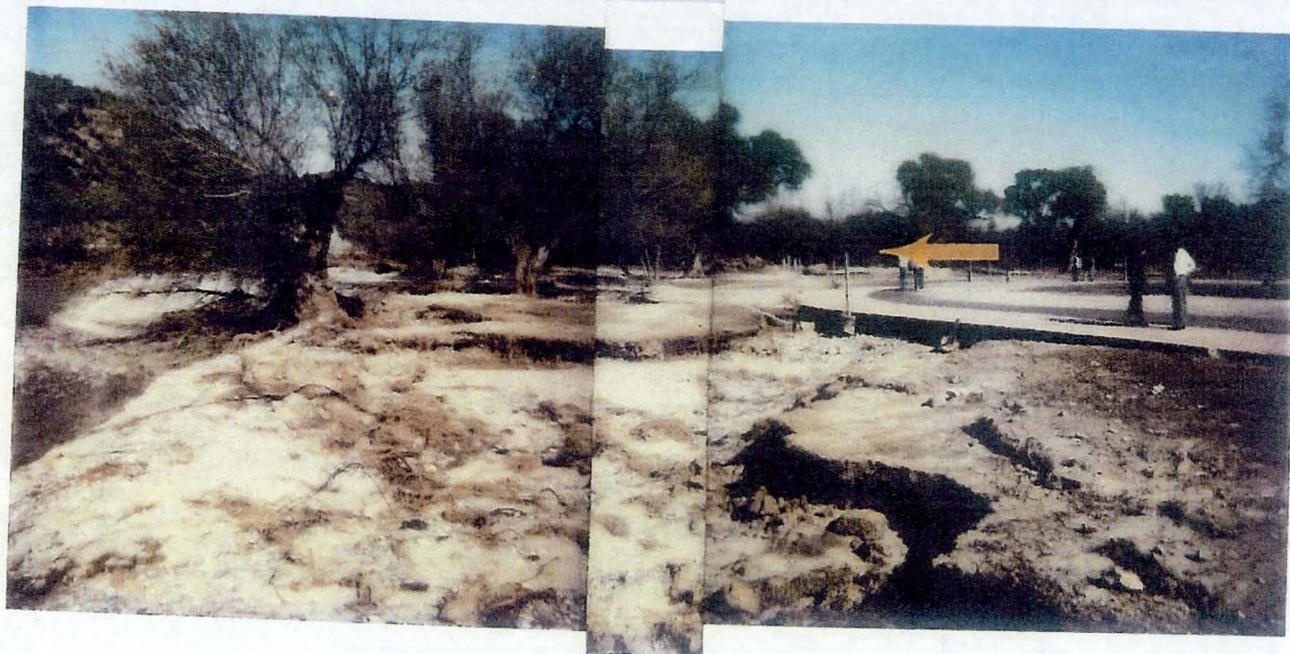
ADOT Rest Area along the Hassayampa R.
Looking upstream

Arrow marks debris line 3/5/93

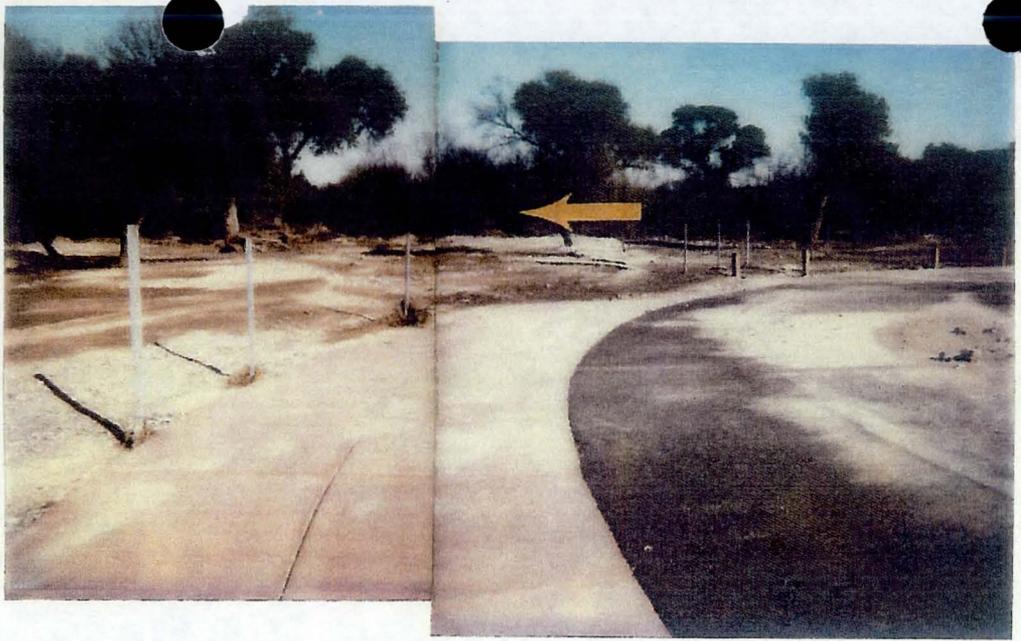
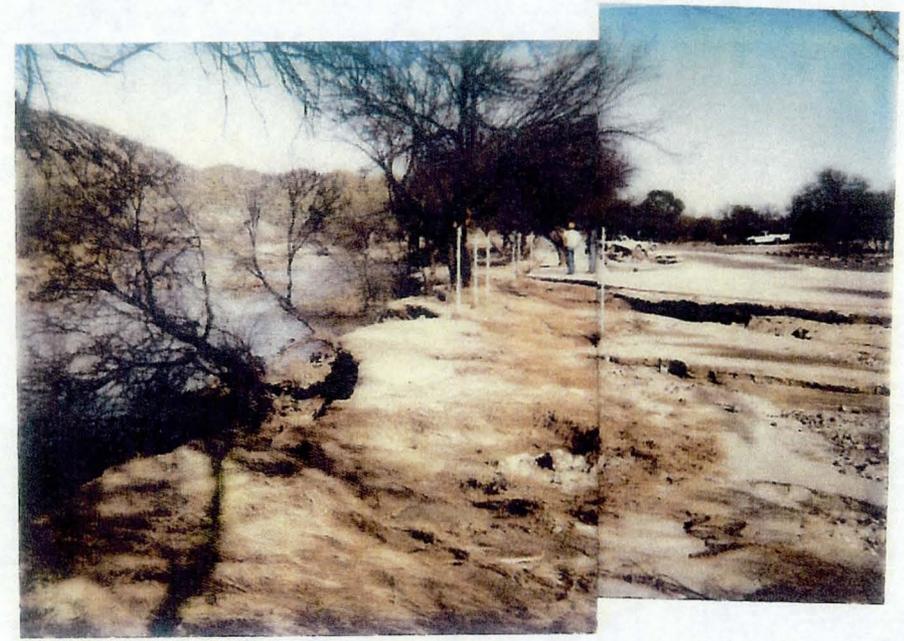
ADOT Rest Area along the Hassayampa R.
Looking upstream in both pictures
Arrow marks debris line
3/5/93

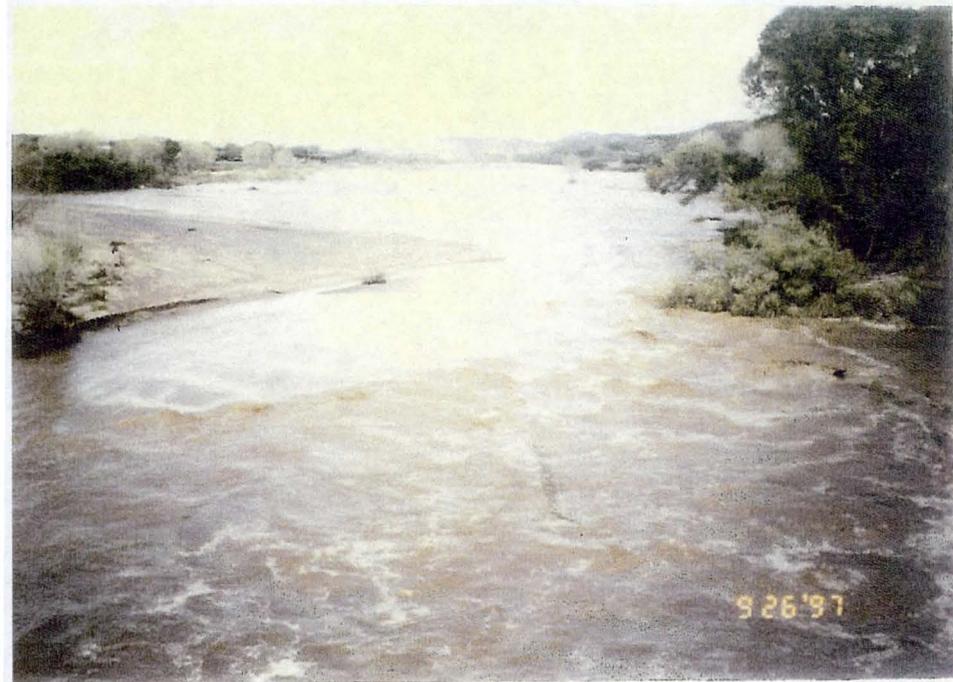
AGUILA FLOODING
NORA STORM
9-26-97 REG MWD
WICKENBURG
4-12
12:18 PM
HASSA XIMPO R., U.S. 60, LOOKING N.E.

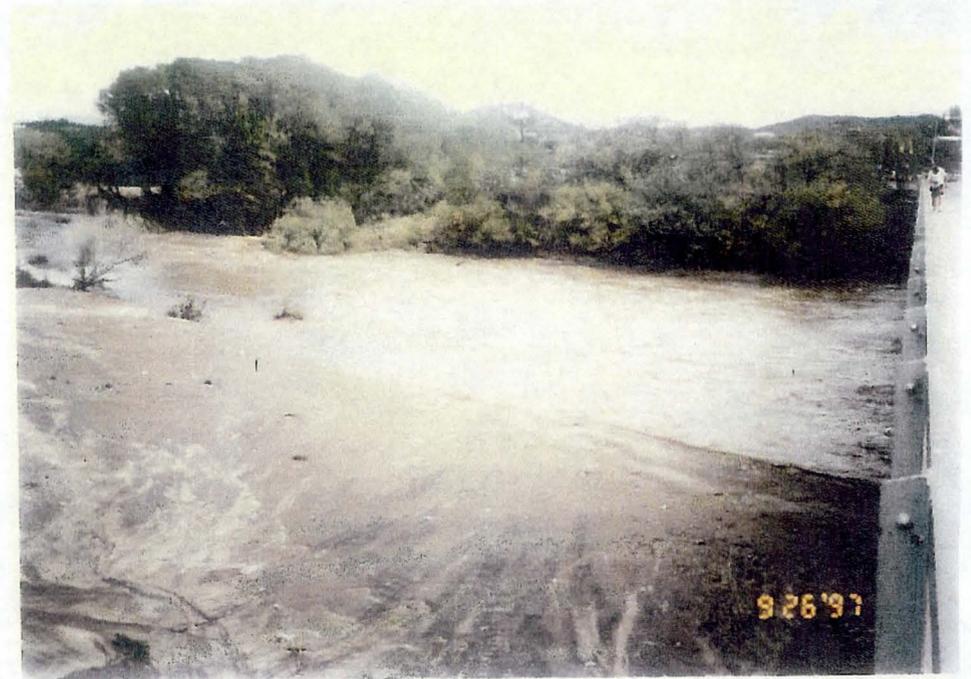
AGUILA FLOODING
NORA STORM
9-26-97 REG MWD
WICKENBURG
4-11
12:15 PM
KASSHAMP R., U.S. 60, LOOKING UPSTREAM

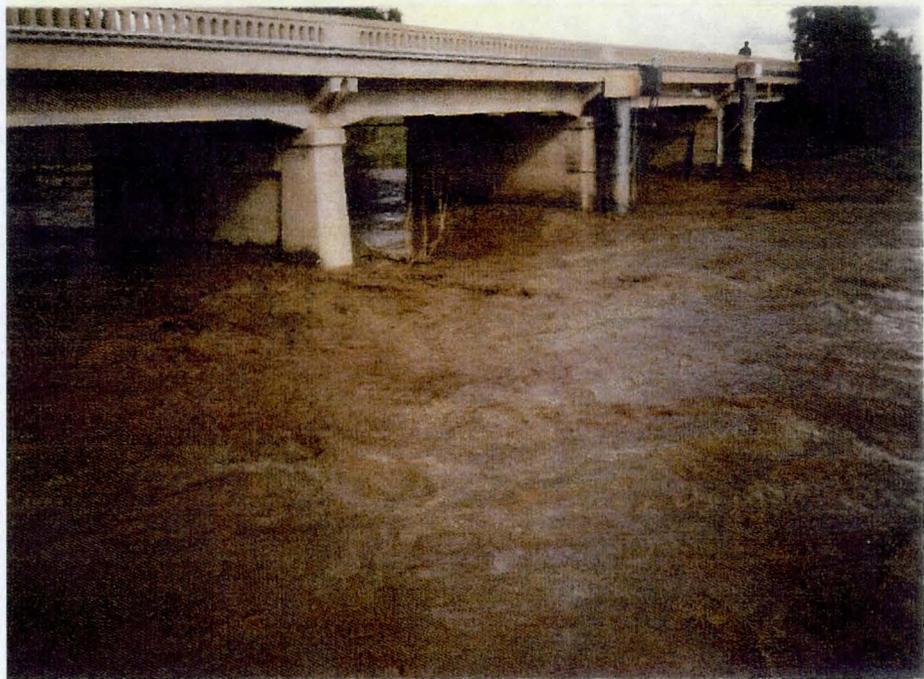
Wickenburg
US 60 & HASSY Road
S.W. Bank of Bridge
