Hassayampa River Post-Flood Study Final Report

June 17, 2005

Prepared For:
Flood Control District of Maricopa County
FCD 2002030

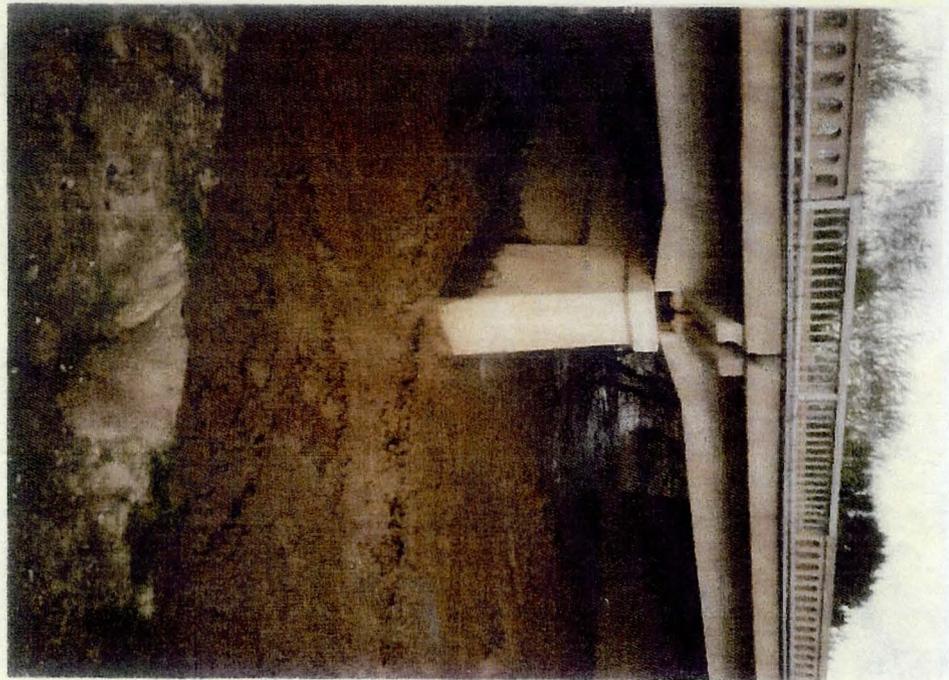
Wickenburg
S.E. Bank of US 60 and
HASSY Road Bridge
Down Stream

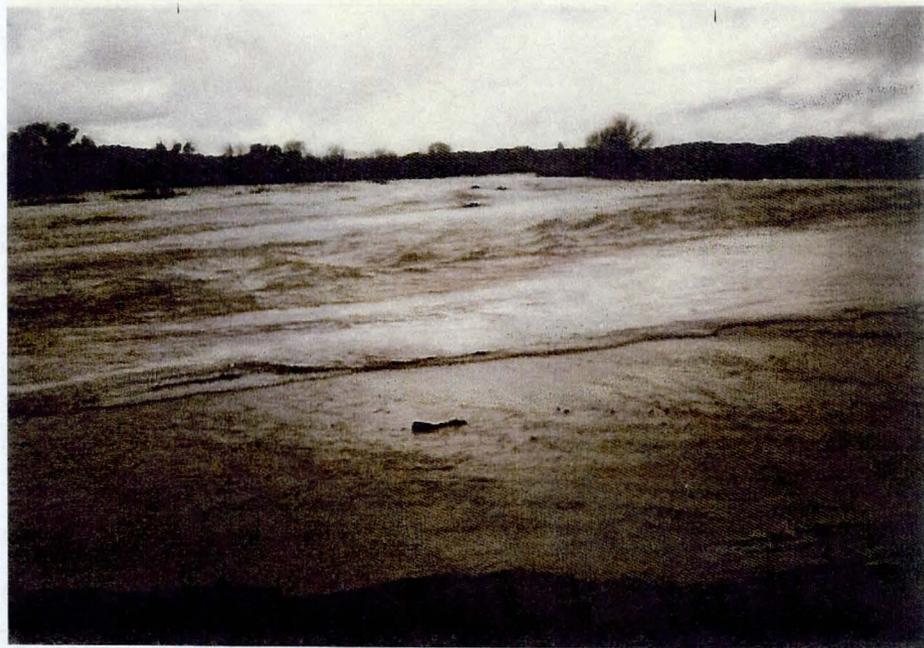
Wickenburg
Looking South on
US 60 and HASSY Road
Bridge (Down Stream)

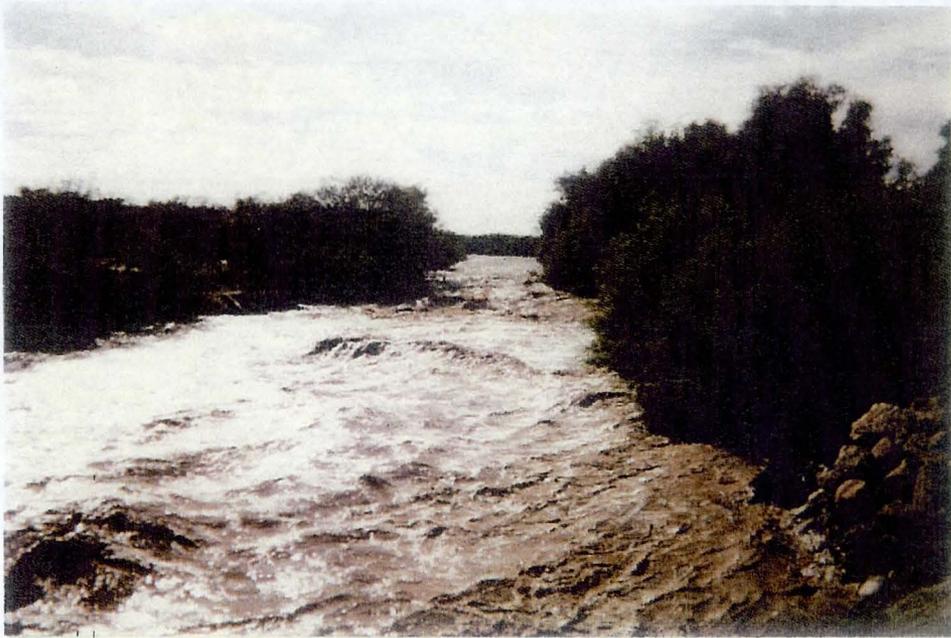
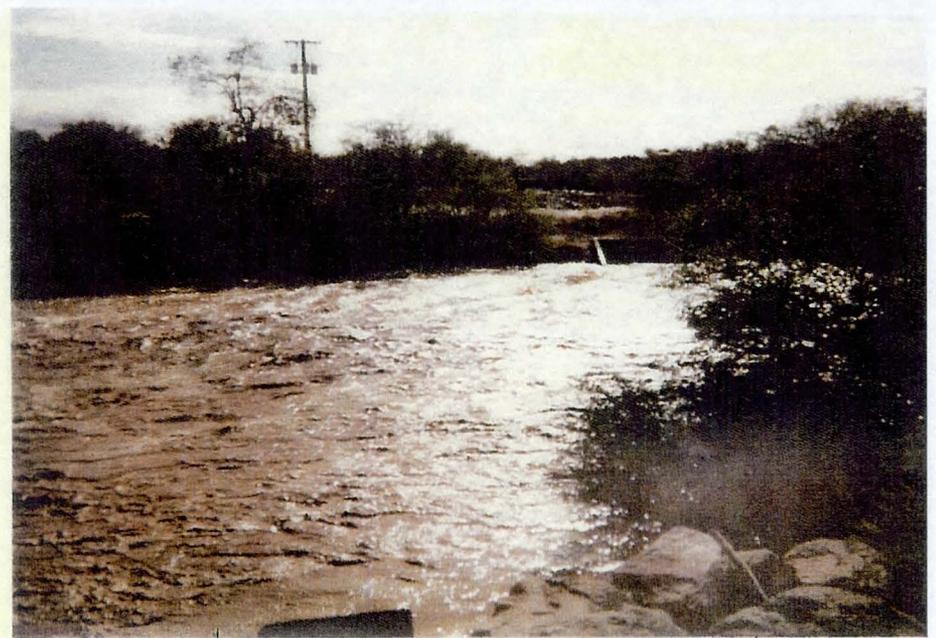
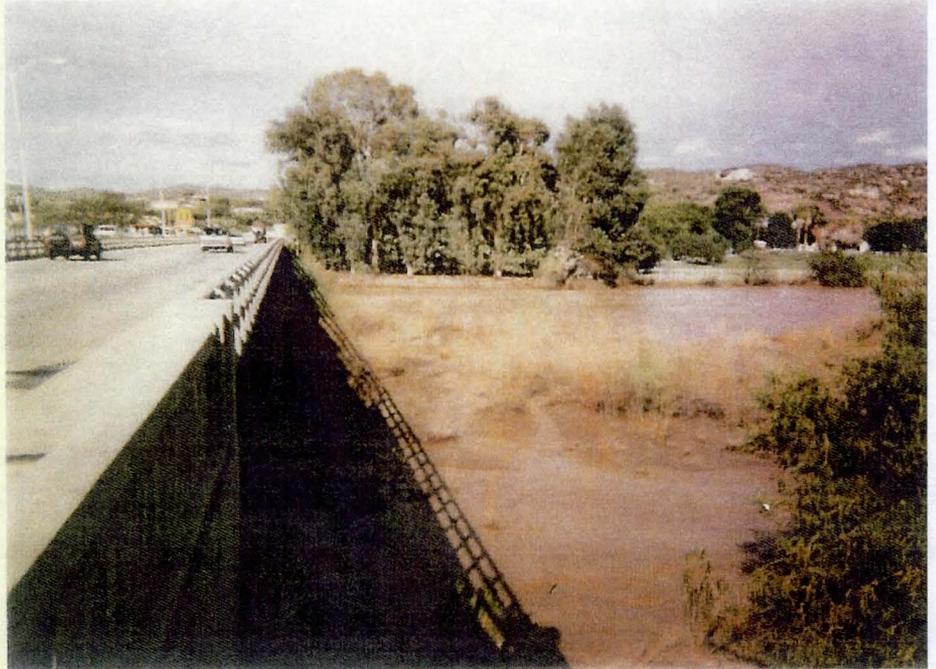
8/29/00
WICKENBURG, CENTENNIAL
Sols Wash @ SR 89
9/6/00 ENG SDW
@1630

8/29/00
WICKENBURG, CENTENNIAL
Sols wasL at SR 89
9/6/00 ENG SDW
@1630
